**Departmental investigation into  
a fall from aloft aboard the  
CONCORDIA  
on 5 December 1996**

**Report No. 105**

**Navigation Act 1912**  
**Navigation (Marine Casualty) Regulations**  
**investigation into the explosion and fatality**  
**aboard the Bahamas sail training vessel**  
**CONCORDIA**  
**off New Year Is, Northern Territory, on 5 December 1996**  
**Report No 105**

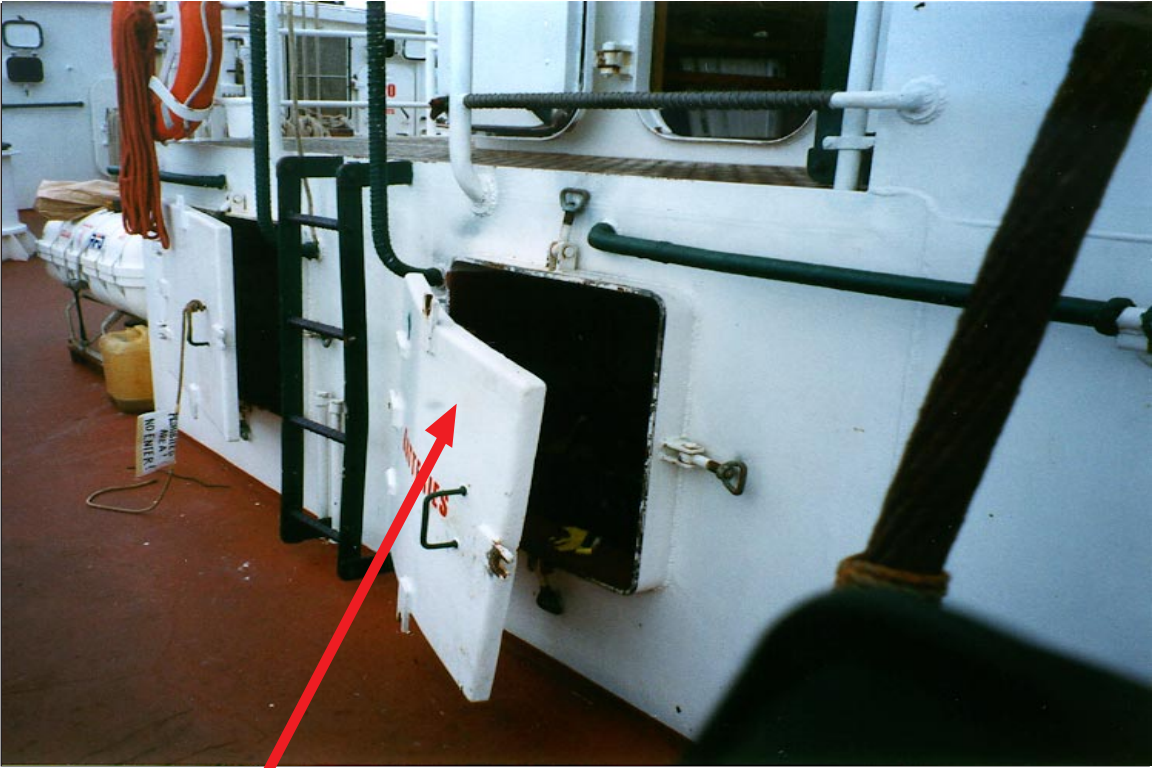
Port side main deck battery locker door

Close examination of the battery locker door hinges showed signs of a tensile failure (necking at the point of fracture) and the door was perfectly formed in an arc shape about its vertical axis, with a displacement at

Door deformed in an arc shape about its vertical axis, displacement about 80 mm

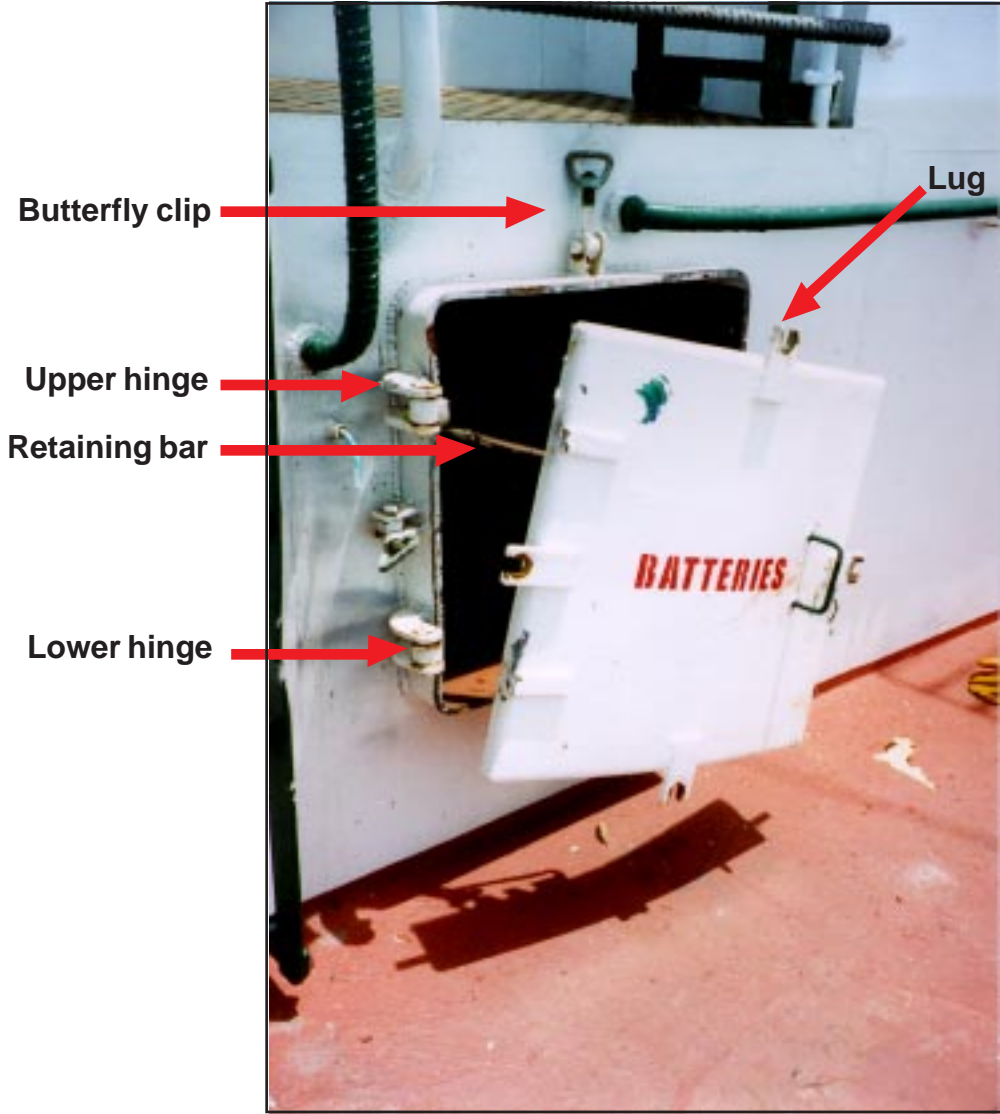
Port side main deck battery locker door

Following the explosion, the door was found in a canted position against an adjacent ladder, held only by the retaining bar; both hinges had failed. Internally, the after bulkhead structure of the battery locker was distorted, showing heavy bulging with a displacement of up to 100 mm. A small, light steel door, covering a fire hydrant 2 m aft and above the battery locker door, was found on deck with its brass hinges fractured and a large fold across its surface.

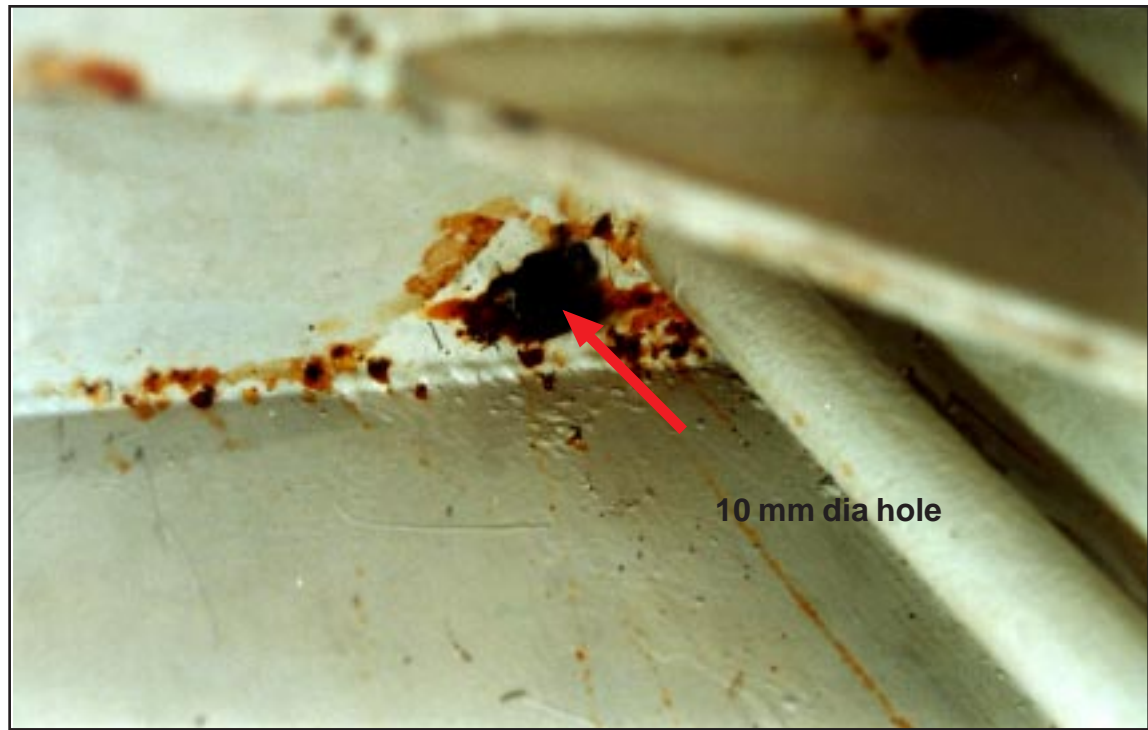
**Locker deckhead**

It should be noted that for the required airflow in either case, an inlet ventilator of equivalent size must also be provided. There was no inlet for air to the battery locker aboard Concordia. The two openings in Concordia’s battery locker (the 4 mm pipe in the bulkhead and a 10 mm diameter hole in the deckhead) would have allowed no effective

ventilation and was totally inadequate to maintain a safe atmosphere inside the battery compartment.
