ATTACHMENT 1

- chart of area

At about 0340 hours Eastern Standard Time on 25 March 1985 the Australian registered ship 'TNT Alltrans' grounded on Lady Musgrave Island in the Capricorn Group, Great Barrier Reef, while on a voyage from Gladstone, Queensland to the port of Bluff in New Zealand. A chartlet of the area is at Attachment 1.

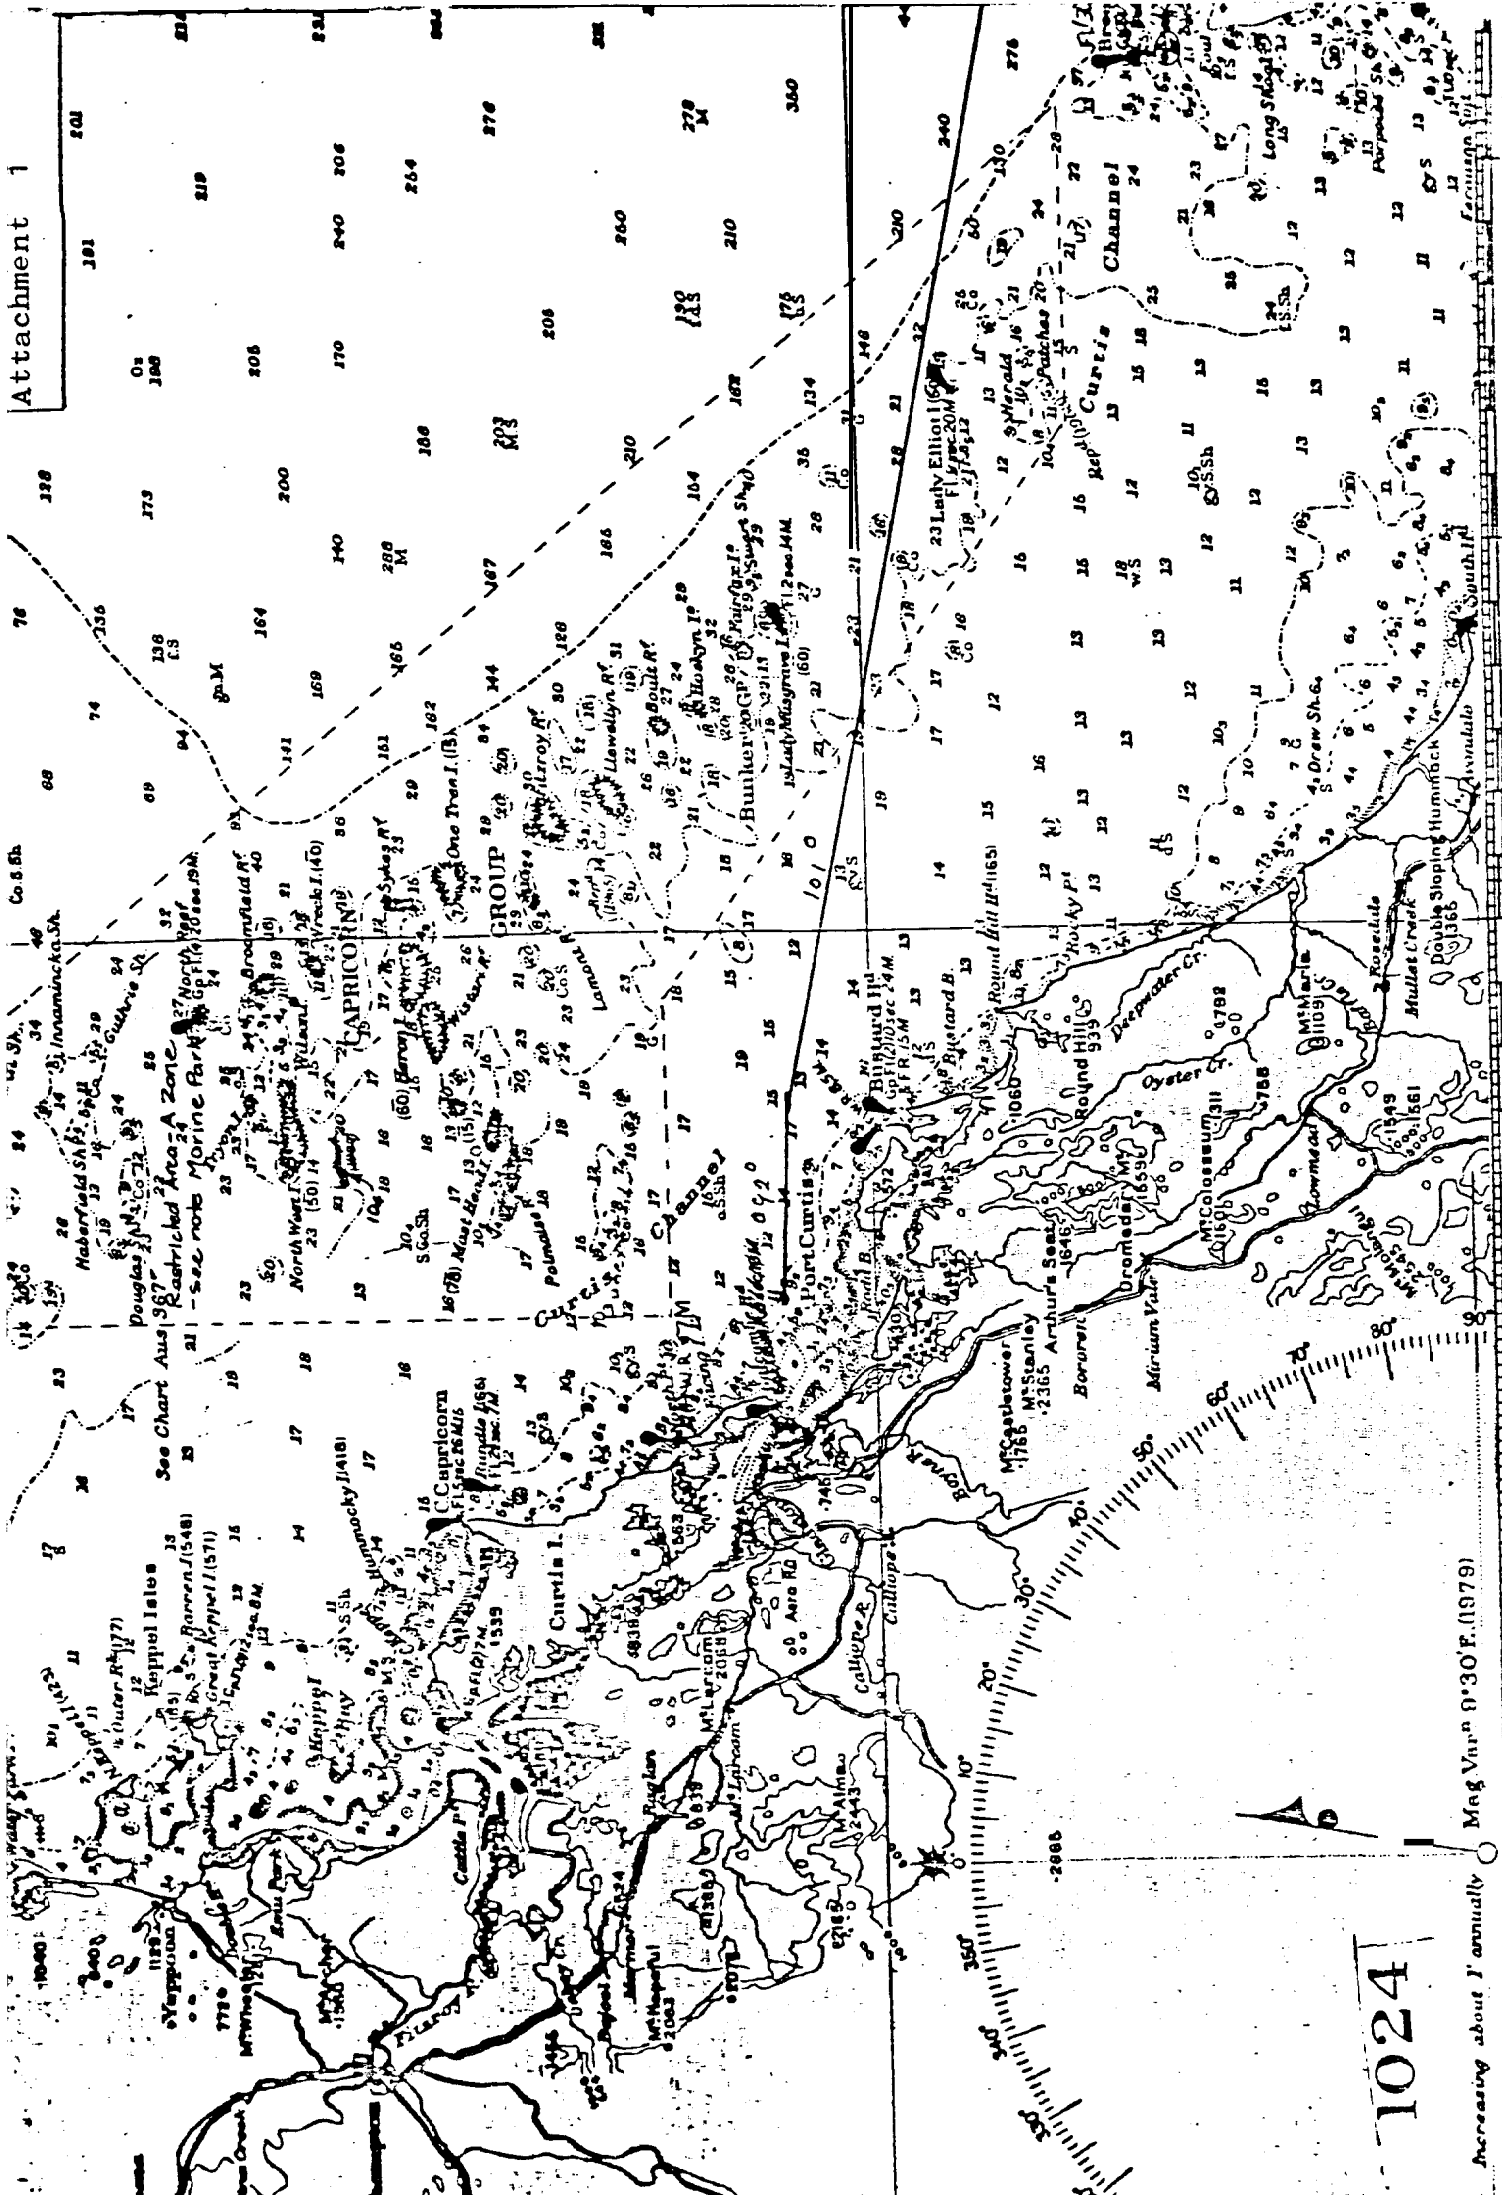
1. That the 'TNT Alltrans' grounded on the reef off Lady Musgrave Island at about 0340 hours 25 March 1985, becoming hard fast on the reef in a position with the island's light bearing 075 degrees true distant about 0.35 miles; that the ship's engines continued to run ahead until about 0400 hours when they were stopped by the Chief Officer; and that the fact of grounding was not determined conclusively by those on board until about 0410 hours, 25 March 1985.
2. That the grounding was directly caused by the failure of the officer of the watch to control the navigation of the ship over an extended period, from about 0030 hours 25 March 1985 to the time of grounding, and specifically his failure to alter course at a position off Bustard Head in accordance with the courses laid down on the chart in use.

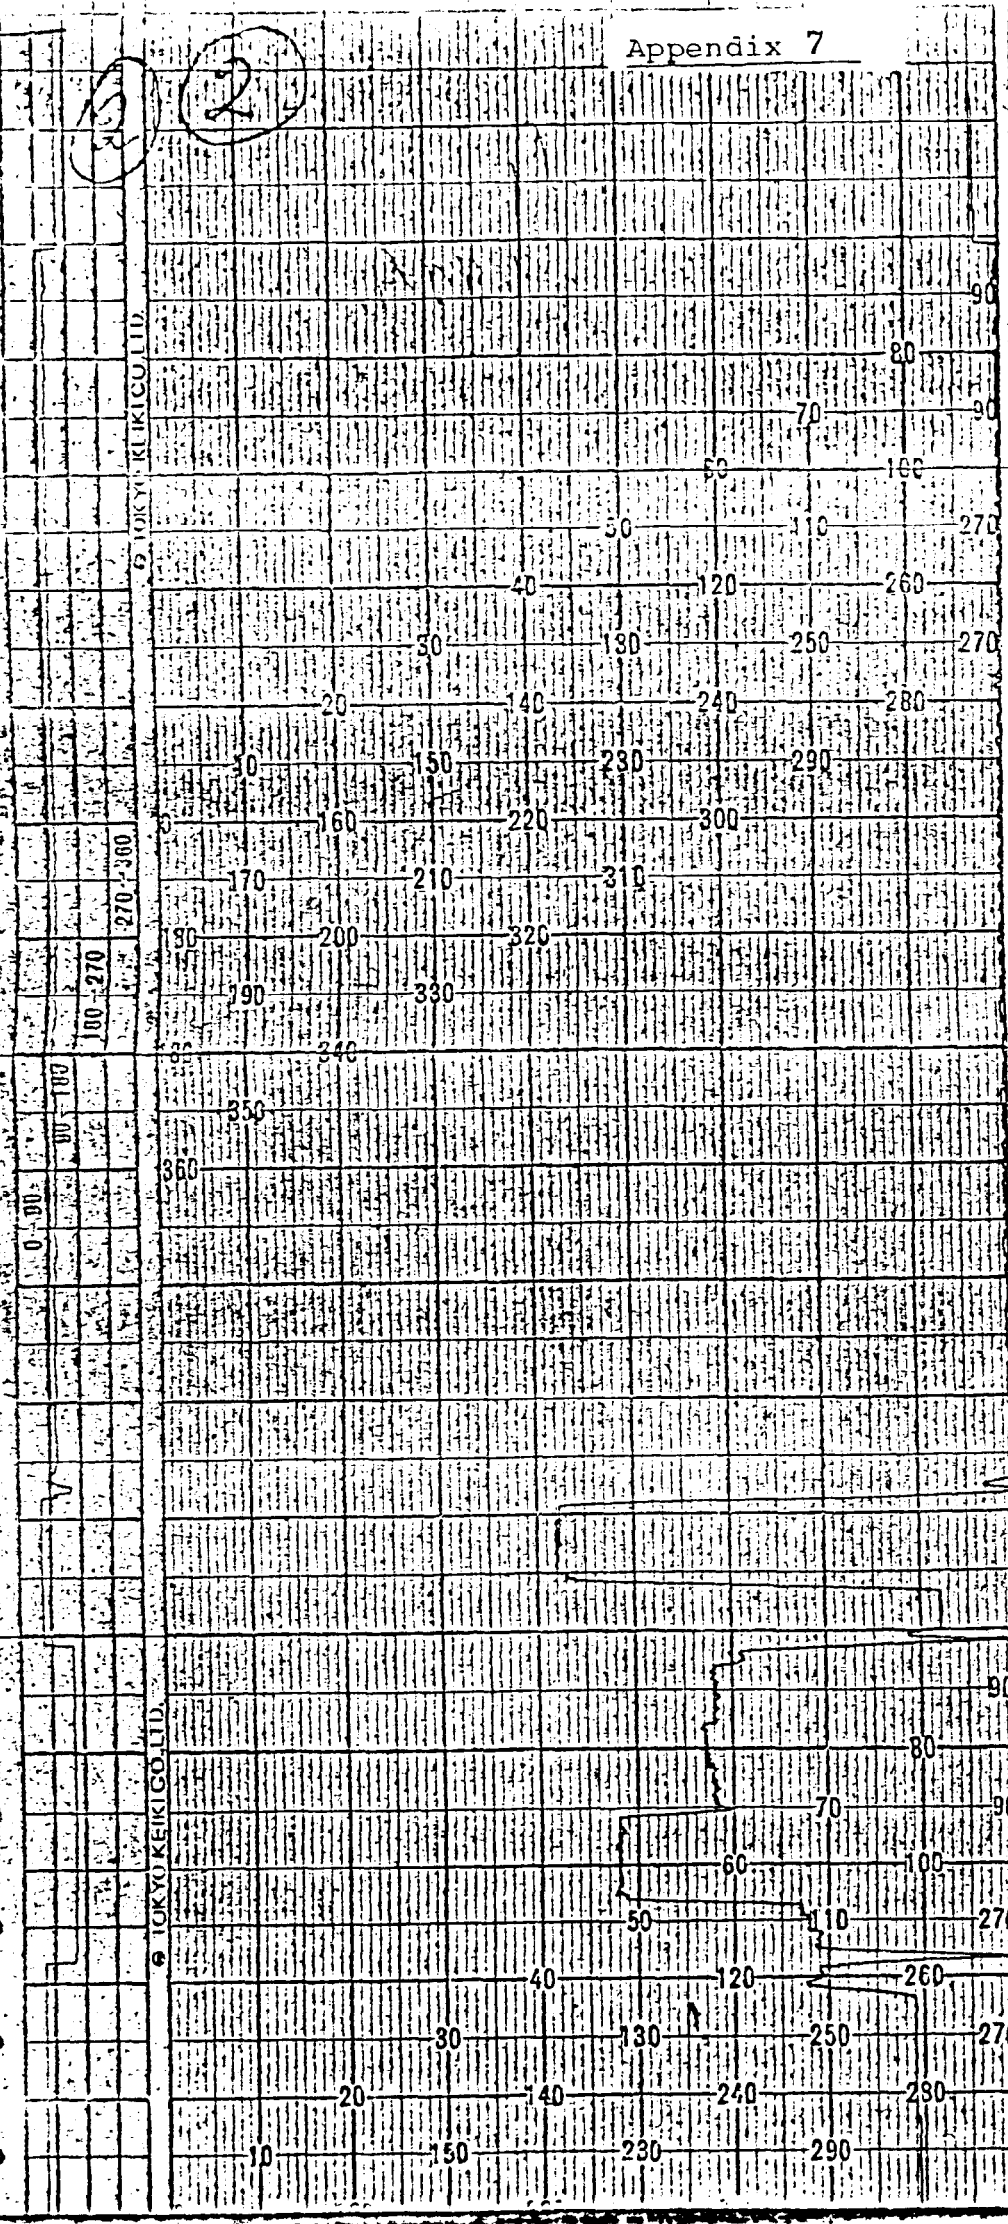
At about 0339 hours 25 March the graph indicates an alteration of course of 2 degrees to starboard. It is said that the ship had been steering prior to the rounding 092 degrees gyro and after the grounding was found to be heading 094 degrees, an alteration of 2 degrees to starboard.
