Collision between the boat *Norma Jean* and the barge *Seatow 61*

Carnarvon, Western Australia | 18 March 2007

ATSB Transport Safety Report
Marine Occurrence Investigation
237-MO-2007-237
Final – 3 October 2013

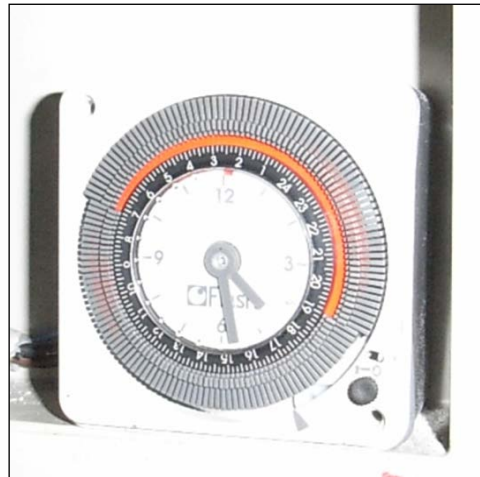
Figure 3: Navigation light timer

The navigation lights were switched on and off by a timer (Figure 3). At the time of the accident, they were set to turn on at about 1900 and turn off at about 0710.

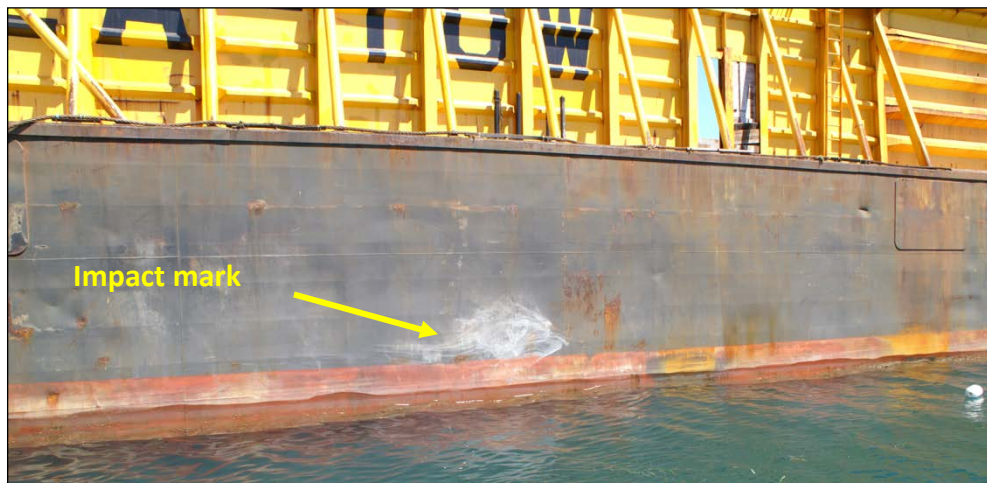
Figure 10: Impact mark on the hull of *Seatow 61*

At 1610, while *Kurutai* was standing by about 1 cable away from *Seatow 61*, the crew were able to identify an impact mark on the barge's port side (Figure 10) that they had not previously seen.

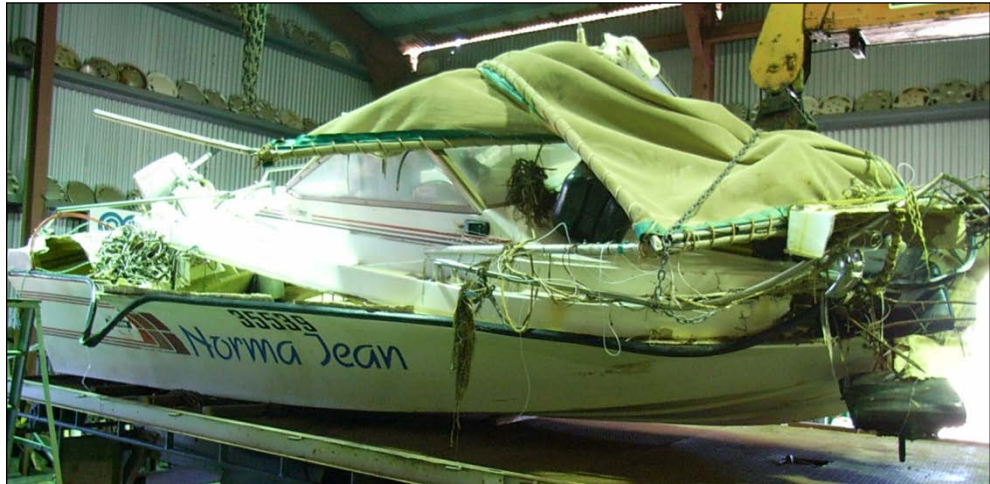
Figure 11: *Norma Jean's* recovered wreckage

At about 1200 on 19 March, the bodies of *Norma Jean*'s remaining three occupants were recovered from the sunken boat by divers. The boat was then re-floated, using flotation bags, and towed back to Carnarvon. It was then lifted from the water and placed on a flat-bed truck (Figure 11).

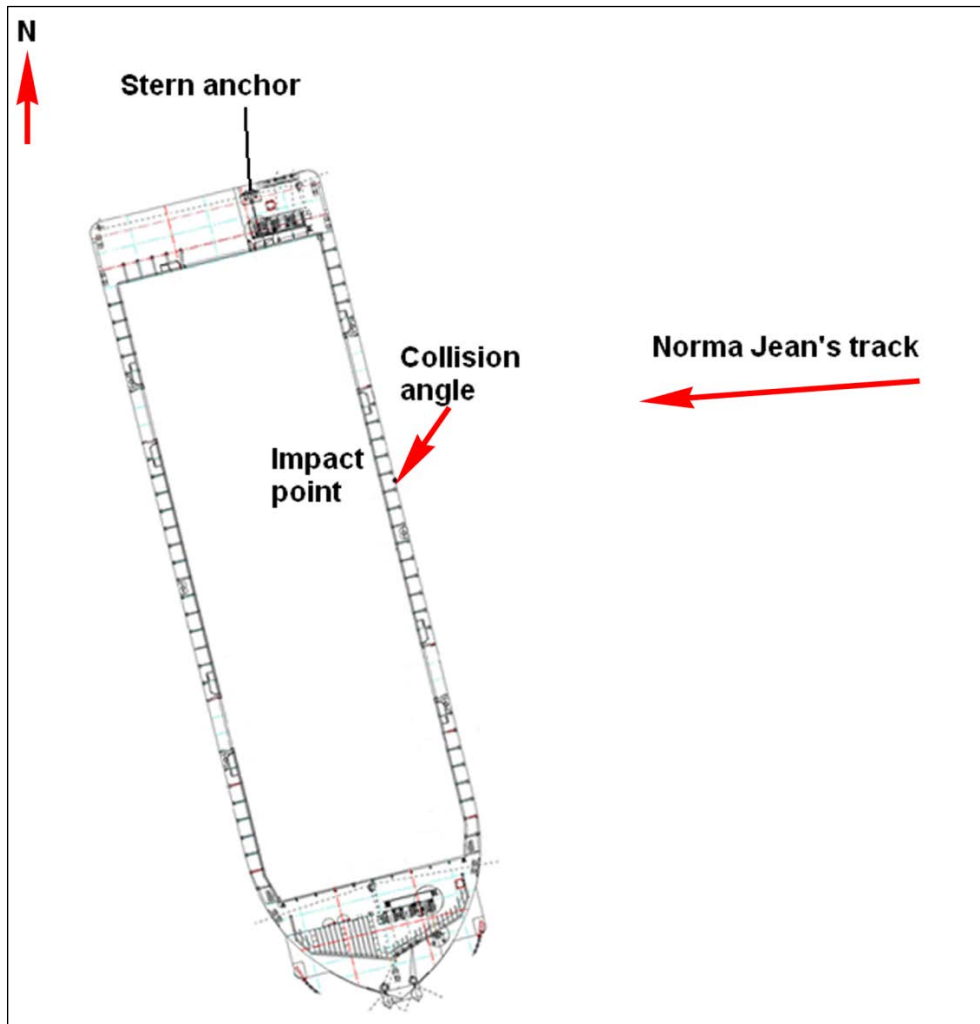
Figure 12: Diagrammatic representation of the collision

An inspection of *Norma Jean* following the collision indicated that the most severe impact damage was sustained by the boat's starboard bow, indicating that the boat collided at an oblique angle to the barge's centreline. While it is possible that the barge was lying at a different angle to that suggested above, an analysis of the most probable angle of the barge and *Norma Jean*'s probable course towards 'The Gap' indicates that *Norma Jean* probably changed course immediately before the collision occurred. This suggests that *Norma Jean*'s skipper may have seen the barge in the seconds before the collision and attempted to take avoiding action by altering course to port.

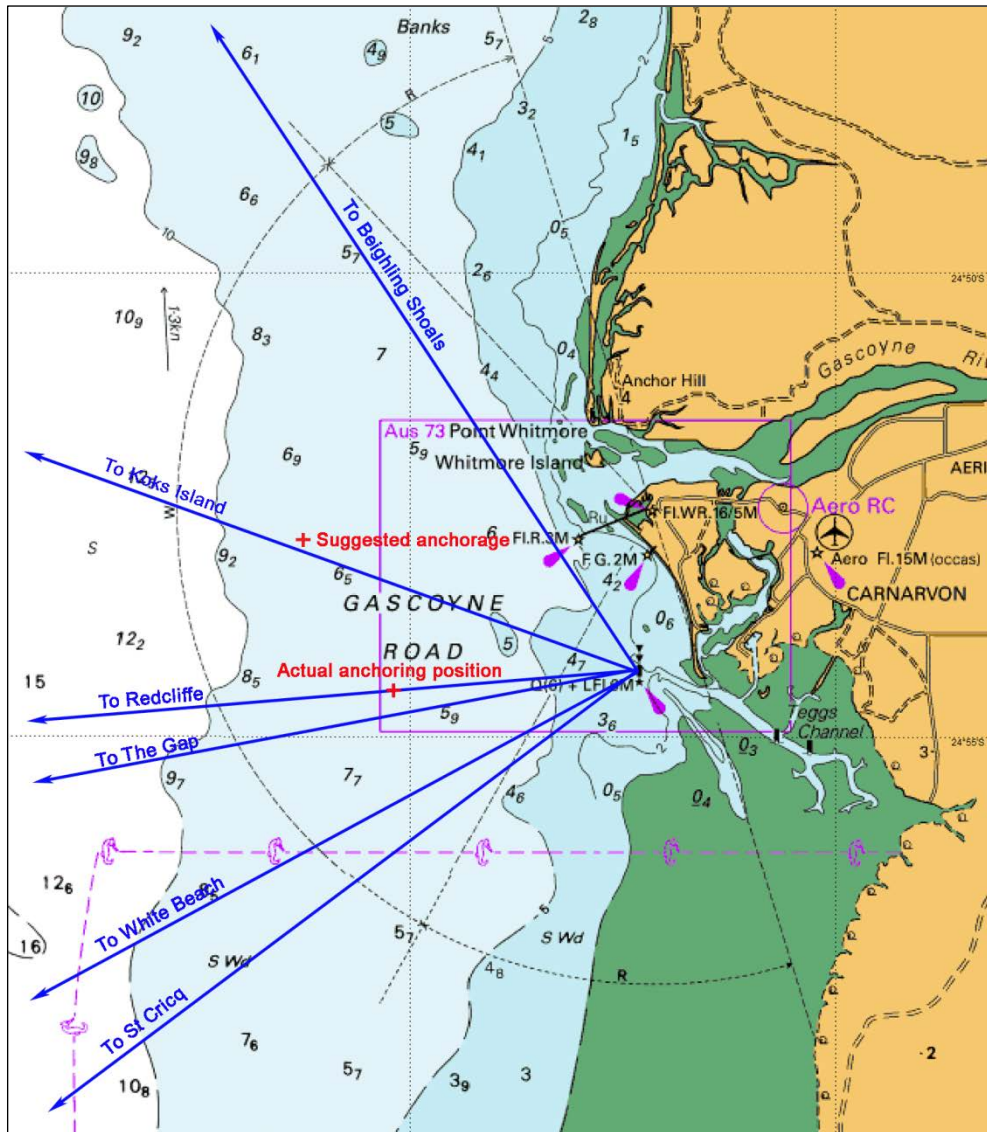
Figure 13: Section of chart Aus 747 showing the two anchorage positions, popular fishing destinations and the approximate tracks towards them

On 18 March, because of the near ideal weather conditions, there were about 50 recreational boats operating out of Carnarvon. About 30 of these boats had notified Carnarvon Volunteer Sea Rescue (CVSR) of their departure and their estimated return time. Of these boats, 30 per cent were heading across the bay to either 'The Gap' or 'Redcliffe' (Figure 13). The course to both of these destinations passed through the area in which *Seatow 61* was anchored. Therefore, based on the traffic patterns observed on 18 March, the barge's anchored position exposed it to the risk

of collision with about 30 per cent of the recreational traffic that departed from the boat harbour.

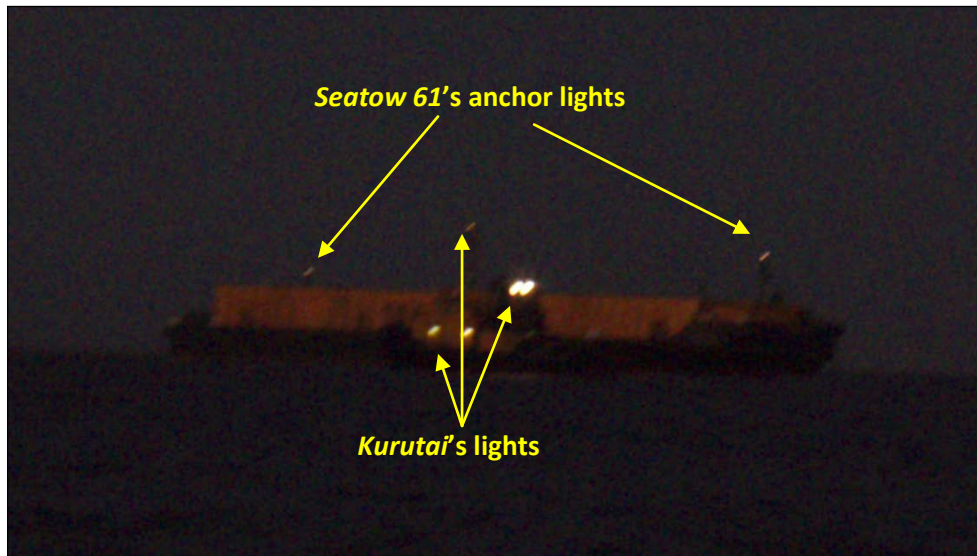
Figure 14: Tug and barge at 0711 on 13 March

The photograph taken by the RTO on the morning of 13 March (Figure 14) shows the navigation lights displayed on board *Seatow 61* at that time. This arrangement of lights met the COLREG requirements specified in Rule 30. However, the lights were set to automatically switch off at 0712, about 18 minutes before sunrise and, hence, did not strictly meet the requirements of Rule 20 (b).

Kurutai’s crew stated that, on 12 March, the barge’s navigation light system was switched on when they anchored it. Then, on the morning of 13 March, the RTO observed that the navigation lights were illuminated when he delivered a chart to *Kurutai*’s skipper (Figure 14).

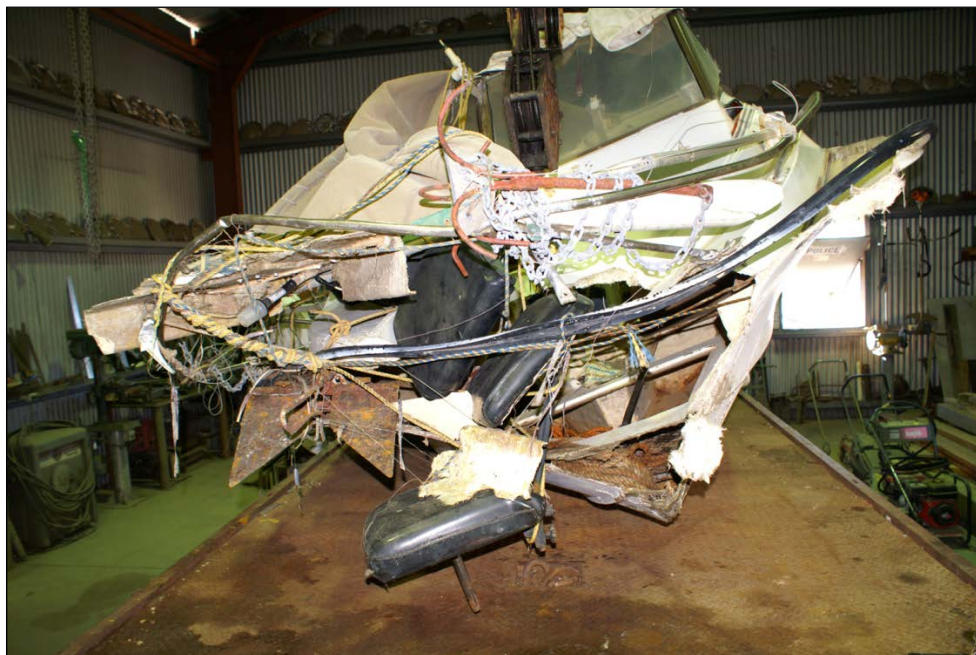
Figure 15: *Norma Jean's* damaged bow

Norma Jean was examined by ATSB investigators and an independent surveyor following the collision and subsequent recovery. The examinations showed that the boat had suffered substantial damage (Figure 15) as a result of the collision.

The forward part of the bow is missing from the stem aft for approximately 0.5 m on the port side and approximately 1.0 m on the starboard side. The bow guardrail was found bent and forced aft. The foremost part of the foredeck, complete with the cross shaped Samson post, was found separated from the remaining foredeck, facing aft and tangled with the bent bow guardrail and the collapsed forward part of the bimini type awning support structure...

The 115 hp Yamaha outboard motor was found in the tilt down position for normal operation. The power lever or throttle was found to be in the full ahead position. The underwater sequence of the police video also shows the power lever in the full ahead position prior to the recovery of the vessel.
