ATSB TRANSPORT SAFETY REPORT

Marine Occurrence Investigation
MO-2011-005
No. 286
Final

**Investigation into the capsizing of the
Australian registered tug**

Adonis

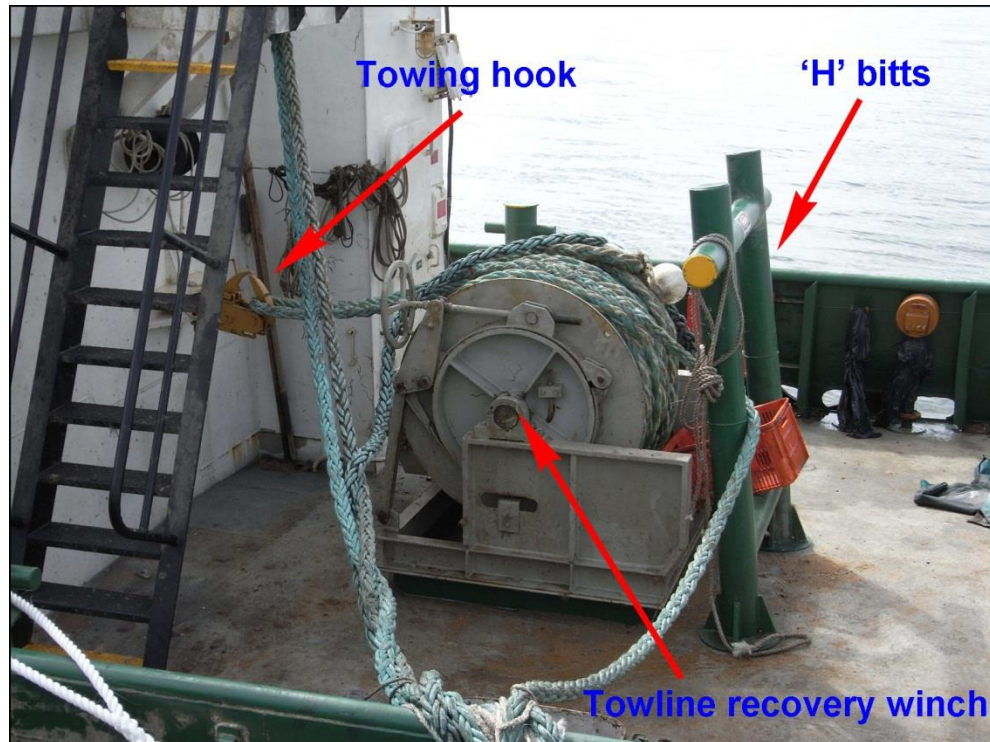
Figure 2: Towing hook, towline recovery winch and 'H' bitts

Adonis was equipped with a Mampaey Offshore Industries towing hook mounted on the bulkhead at the after end of the accommodation superstructure. The hook had a safe working load of 15 tonnes and was fitted during the tug's construction. Mounted immediately aft of the hook was a towline recovery winch and 'H' bitts (Figure 2). Both these items of equipment had been fitted to the tug some time following its initial build; the 'H' bitts were fitted by Sea Swift in 2010 and the winch by previous owners of the tug.

However, when the 'H' bitts were fitted in 2010, their placement aft of the towing hook meant that when a towline made contact with the 'H' bitts, as it did on 11 June 2011, the towing point became the 'H' bitts. Therefore, the tug's towing point moved 2.56 m further aft and any towline force acting on the 'H' bitts applied a larger turning moment to the tug, now through a lever of 4.68 m. As a result, the

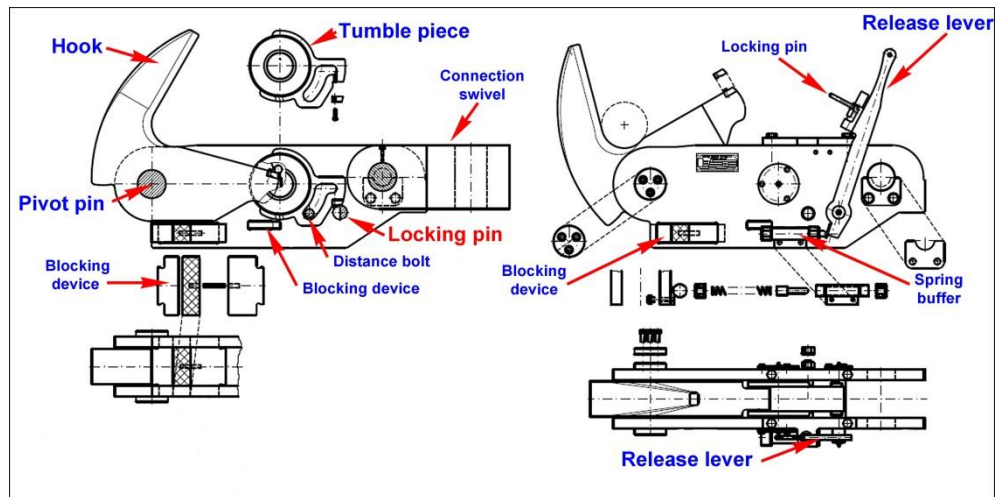
Figure 3: Diagram of the towing hook

The towing hook was equipped with a quick release arrangement to enable the hook to be 'tripped' during a tow, thus releasing the towline (Figure 3). The release lever, when pushed forward, turned a locking pin (labelled in red in Figure 3) which allowed a tumble piece to rotate in a downwards direction. This released the hook, which in turn rotated counter-clockwise around a pivot pin, thus releasing any attached towline.

This means that the arrangement is not 'fail safe'. That is, if it were to be bumped, vibrated or moved out of the unlocked position in any way, the pin would fall into, rather than out of, the locking hole. Were the design of the locking pin mount on the release lever reversed and mounted on the release lever under the locking hole, then the pin would fall out of the locking hole. The possibility of inadvertently locking the release lever would thereby be 'designed out' of the system.

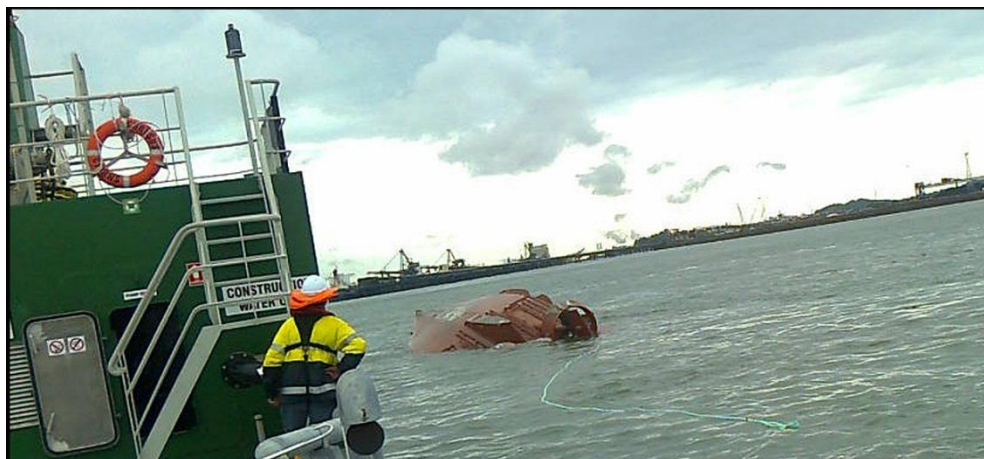
Figure 14: The capsized *Adonis*, as seen from *Chrysus's* deck

At about 1300, *Wolli*'s deckhand was directed to cut through *Adonis*'s towline with an axe (Figure 14).

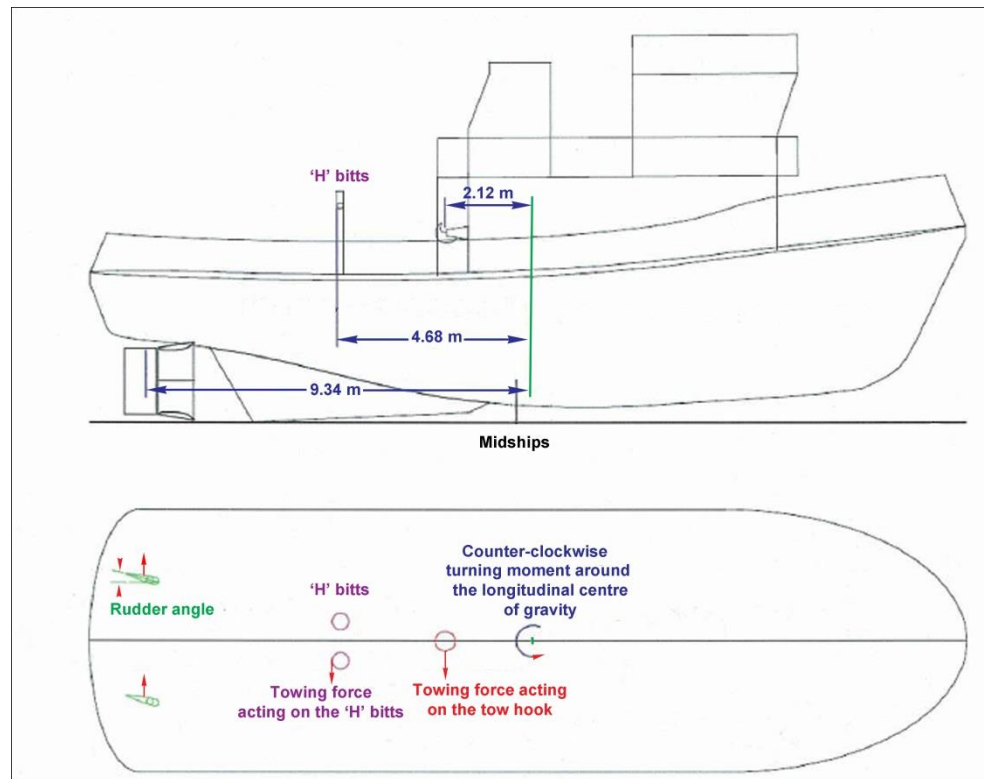
Figure 19: Rudder and towline turning moment around LCG

The naval architect's calculations show that in its original condition (i.e. without the 'H' bitts fitted), at a speed over the ground of 8.4 knots, *Adonis*'s rudders would have had to be at about 11.5° to maintain a heading and compensate for a transverse towline force of 10.78 tonnes, the defined bollard pull of the tug. However, with the 'H' bitts fitted, this rudder angle required was about 25° to compensate for the same towline force.

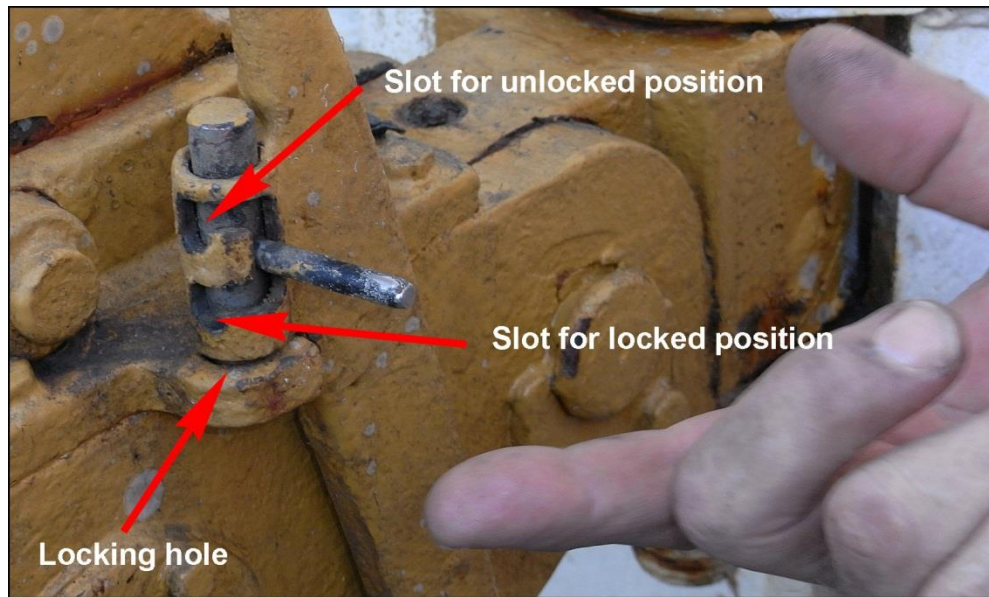
Figure 24: Towing hook on refloating with locking pin partially in the locked position

When the tug was refloated, the locking pin was observed to be neither locked nor unlocked (Figure 24). The pin was very easy to move and it is possible that during the refloating of the tug, the pin moved from the unlocked position to that of the partially locked position.

Why the release lever did not move when *Adonis*'s engineer pushed on it could not be determined during the investigations.

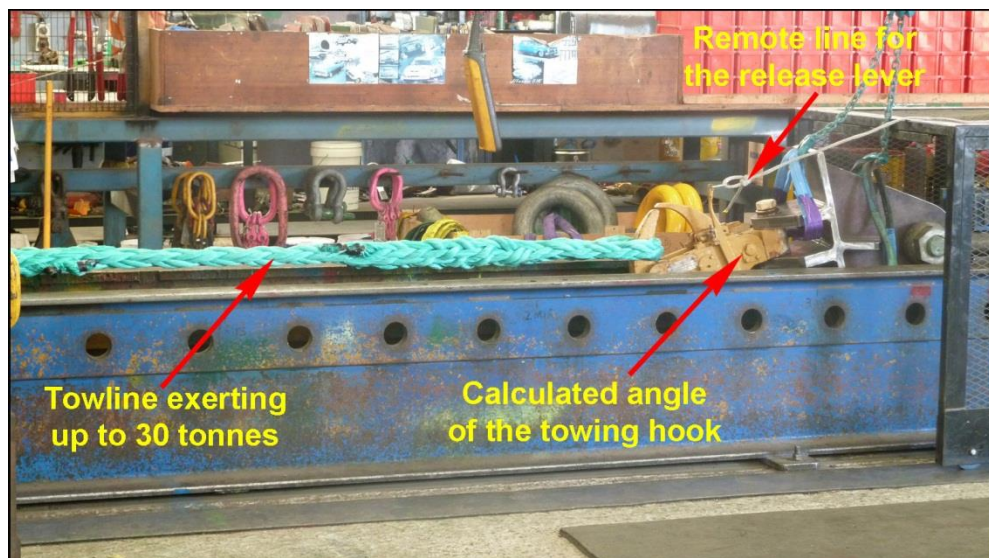
Figure 25: Testing of the towing hook in Brisbane

In an attempt to recreate conditions which the towing hook was subjected to immediately before the tug capsized, a test rig was made to simulate the angles that the towing hook was calculated to be at when *Adonis*'s engineer tried to release the towline (Figure 25). The towing hook was fitted to the test rig and its operation was tested at various loads up to and including 30 tonnes. On each occasion, the towing hook release operated satisfactorily.

Having received your information about the hook-test at the local test bench, which resulted in a proper release, we cannot find a cause for the hook not being released under the mentioned conditions.

Accordingly, the weight of the evidence shows that there was no malfunction of the hook or of its locking device. There is no evidence showing any defect in the design of the hook or its locking device.
