# Stevedore fatality on board *Tasmanian Achiever*

Webb Dock, Melbourne, Victoria, 20 May 2014

**ATSB Transport Safety Report**  
Marine Occurrence Investigation  
309-MO-2014-004  
Final – 2 September 2014

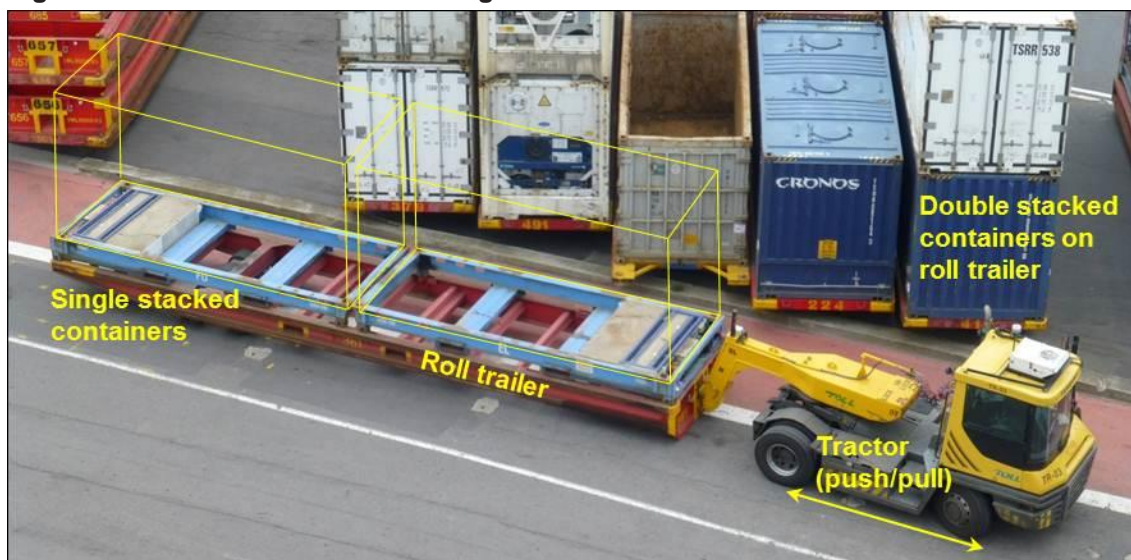
**Figure 1: Roll trailer and tractor configuration**

Three single stacked roll trailers (Figure 1) were loaded at the port forward end of the weather deck via the aft port side ramp. Each was driven into position by a rear mounted prime mover (tractor).

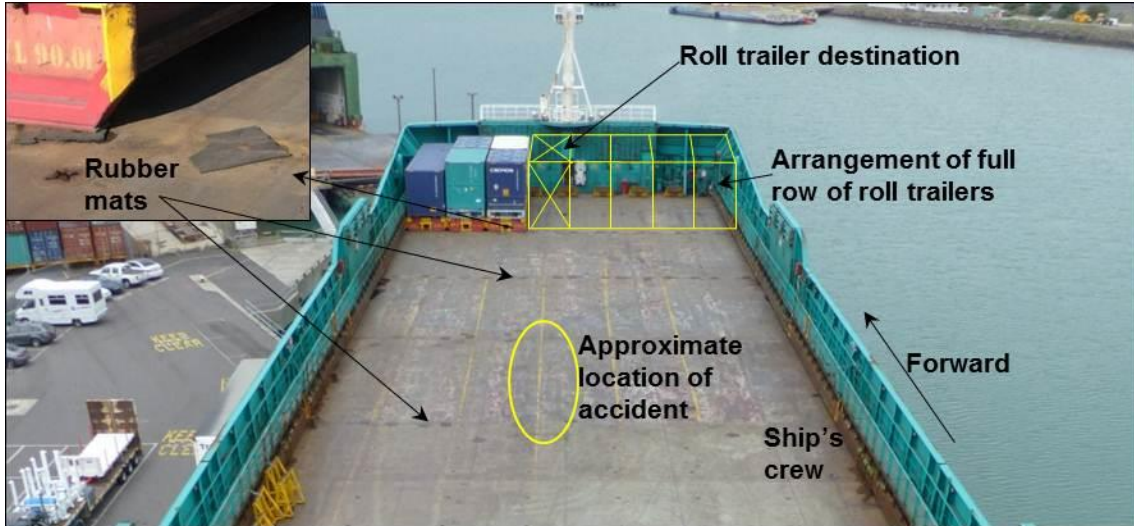
**Figure 2: Weather deck layout at time of accident (inset showing use of rubber mats under roll trailer foot)**

As the next roll trailer was driven up the ramp to the weather deck, the stevedore picked up some mats that he needed to position on the deck. Then, as the trailer came on the deck and aligned with the next vacant slot alongside the already loaded trailers (Figure 2), the stevedore moved towards the area in which he was going to position the mats. This location was in the path of the trailer and not visible to the tractor driver.

The ship's crew members could see the stevedore moving towards them and assumed that he saw the approaching trailer. When they realised that the stevedore was in the direct path of the trailer, they attempted to warn him and the tractor driver, but their calls went unheard. The trailer then struck the stevedore and travelled about 13 m before the driver was advised of what had happened and he stopped the tractor.

- a review of ship loading operations to improve control of the types and flow of cargo onto and off the ship
- placed an additional stevedore on deck to improve coordination of personnel and traffic
- provided additional radios for stevedores and ship's crew
- implemented clearly defined traffic control for vehicle entry onto deck

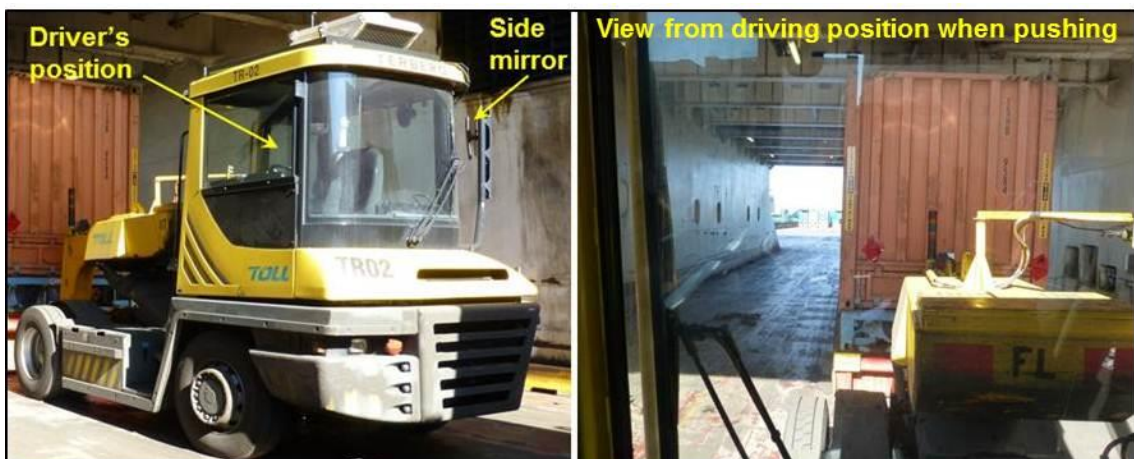
**Figure 3: Tractor and driver's perspective**

It was normal for loaded roll trailers to be pushed by the tractor onto the ship for loading onto the forward end of the weather deck. In this configuration, the driver's view ahead was restricted by the containers on the trailer (Figure 3). The driving position allowed for a clear view along the left hand side of the load but almost no visibility down the right hand side. The tractor was fitted a rear view mirror, but in the push configuration this mirror was positioned behind the driver and, hence, provided no assistance.
