Fatality on board *Skandi Pacific*

off the Pilbara coast, Western Australia | 14 July 2015

ATSB Transport Safety Report
Marine Occurrence Investigation
322-MO-2015-005
Final – 23 November 2016

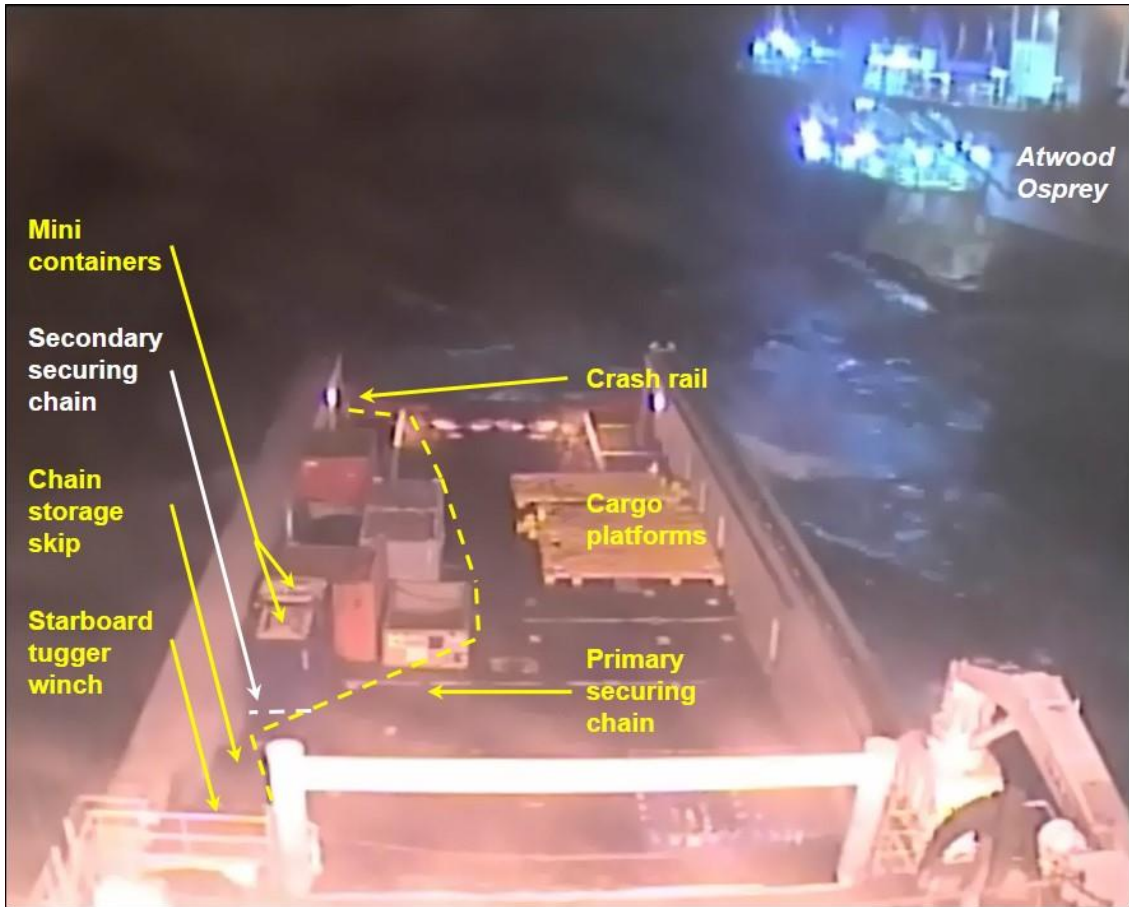
Figure 4: Skandi Pacific's aft deck securing chain arrangement

At about 0520, when the IRs checked the forward part of the stow, they found the two forward mini-containers were not properly secured by the primary chain. They decided to secure them using a secondary chain secured to the crash barrier between the mini-containers and the skip, and then to the primary chain (Figure 4). When tightened, the secondary chain would tighten the primary chain against the mini-containers. That would require the primary chain to be slackened off (tensioned down – the term used on board the vessel).

Source: Skandi Pacific's CCTV at 0521 on 14 July 2015 (annotated by ATSB)

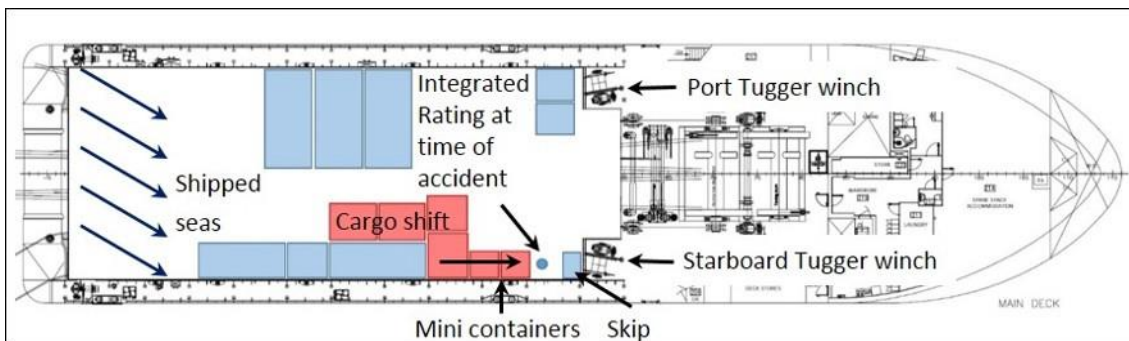
Figure 5: Aft deck plan showing stowage and other key positions

At 0523,¹¹ as the large quantity of water washed forward along the deck, it shifted some of the starboard side cargo containers (Figure 5) and continued as far forward as the Skandi Pacific's superstructure. The IR rigging the secondary chain just forward of the mini-containers tried to move clear of the advancing containers but did not have enough time to get clear. He was trapped in between the forward mini-container and the primary chain, and was crushed against a skip.

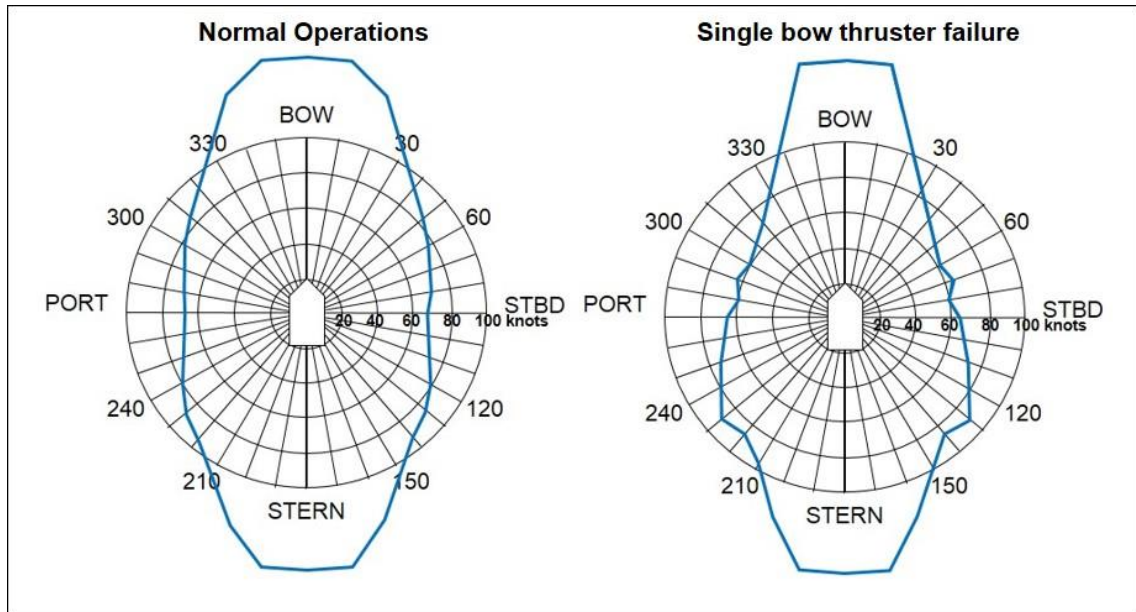
Figure 7: *Skandi Pacific's* DP capability plots

Skandi Pacific's DP capability plots (Figure 7) show the 'normal operations' and 'single bow thruster failure'. The plots show the limiting wind speed 360 degree envelopes (blue line), where each point on the envelope represents the wind speed at which it is calculated that the vessel will be unable to maintain position in DP mode. With a single bow thruster failure, the vessel had reduced capability when winds exceeded 60 knots.

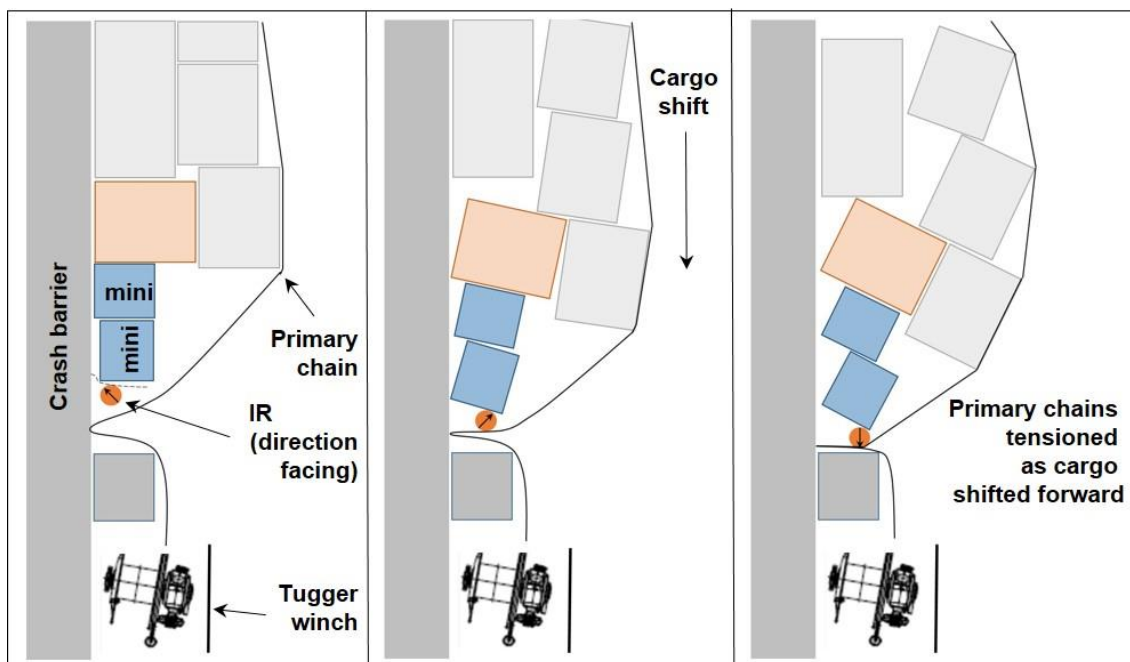
Figure 9: Diagrams to illustrate the event sequence leading to the accident

At about 0520, after the IRs had lashed the cargo they found two mini-containers on the starboard side forward, not properly secured by the primary chain. In order to better secure the containers, the IRs decided to use a secondary chain secured to the crash barrier and then to the primary chain. Tightening the secondary chain would tighten the primary chain against the mini-containers. Their plan required tensioning down the tugger wire (and hence the primary chain). When they slackened the chain, the block of cargo on the starboard side was unsecured.

At 0523, two large waves came over the vessel's stern in quick succession, shifting the unsecured containers on the starboard side. Their movement caused the primary chain to tension (Figure 9). As a result, the slack chain was lifted up, blocking the escape route of the IR who had stepped inside the primary chain to secure the secondary chain to the crash barrier. Although he tried to move clear of the advancing containers, in the few moments he had (to get clear) his escape route (route) was impeded by the chain and he could not get clear.

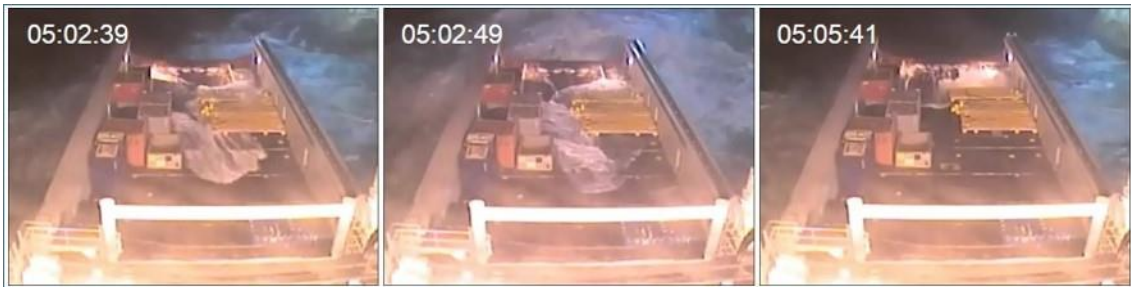
Figure 11: Seas washing across the aft deck at 0502 and 0505

Between 0140 and 0502, seas were occasionally shipped on deck, increasing in regularity and size before 0500. Between 0502 and 0503, two large waves were shipped over the aft deck in quick succession, followed by another one at 0505 (Figure 11).

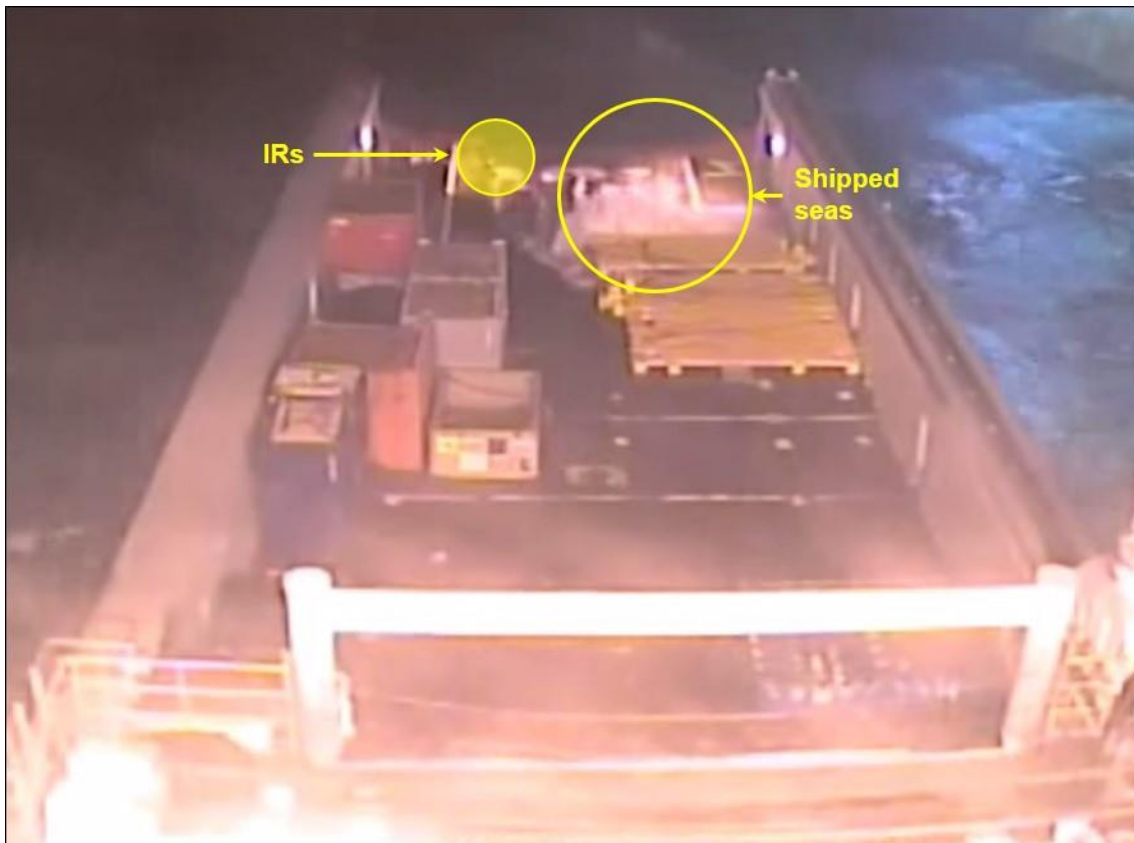
Figure 12: The CCTV frame at 0519

Between 0507 and the time of the accident, after *Skandi Pacific* had stepped out from the rig, waves continued to be shipped on the aft deck from time to time. However, the IRs continued working, moving around the deck. At 0519, while they were at the aft end of the deck on the starboard side, a wave washed over the port side (Figure 12).

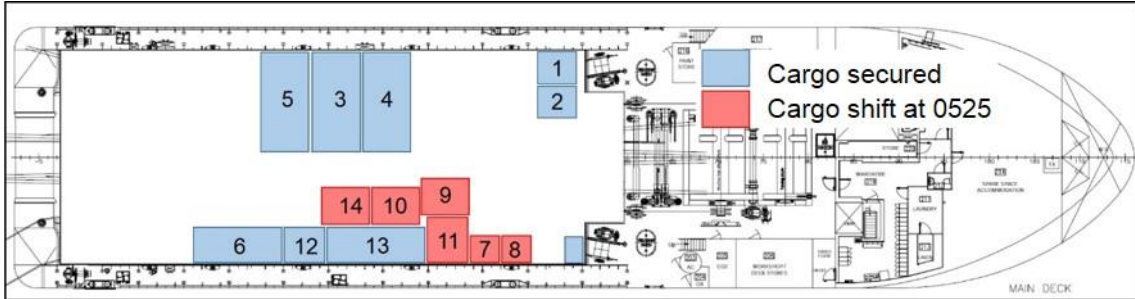
Figure 13: Stowage arrangement after cargo operations were stopped on 13 July

By about 0518, the IRs had hauled in the starboard tugger wire and tensioned the primary chain around the cargo. When checking the lashing, however, they found that forward two mini-containers were not secured and decided to use a secondary chain to secure them.

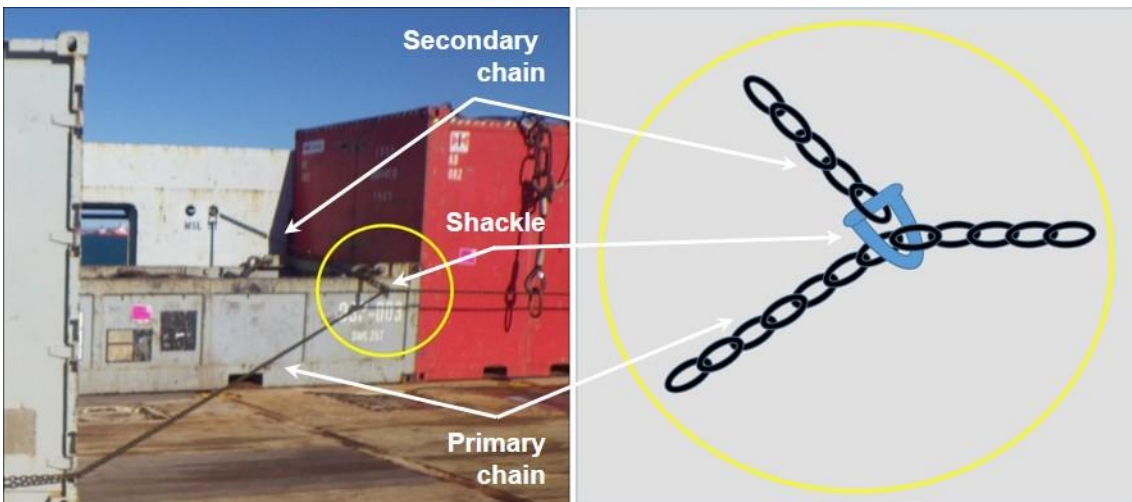
Figure 14: Utilising a secondary chain to secure cargo deck

Their plan involved tensioning down the primary chain and securing a secondary chain to it. They decided to shackle the end of the secondary chain to the primary, to allow it to run along without snagging (Figure 14).

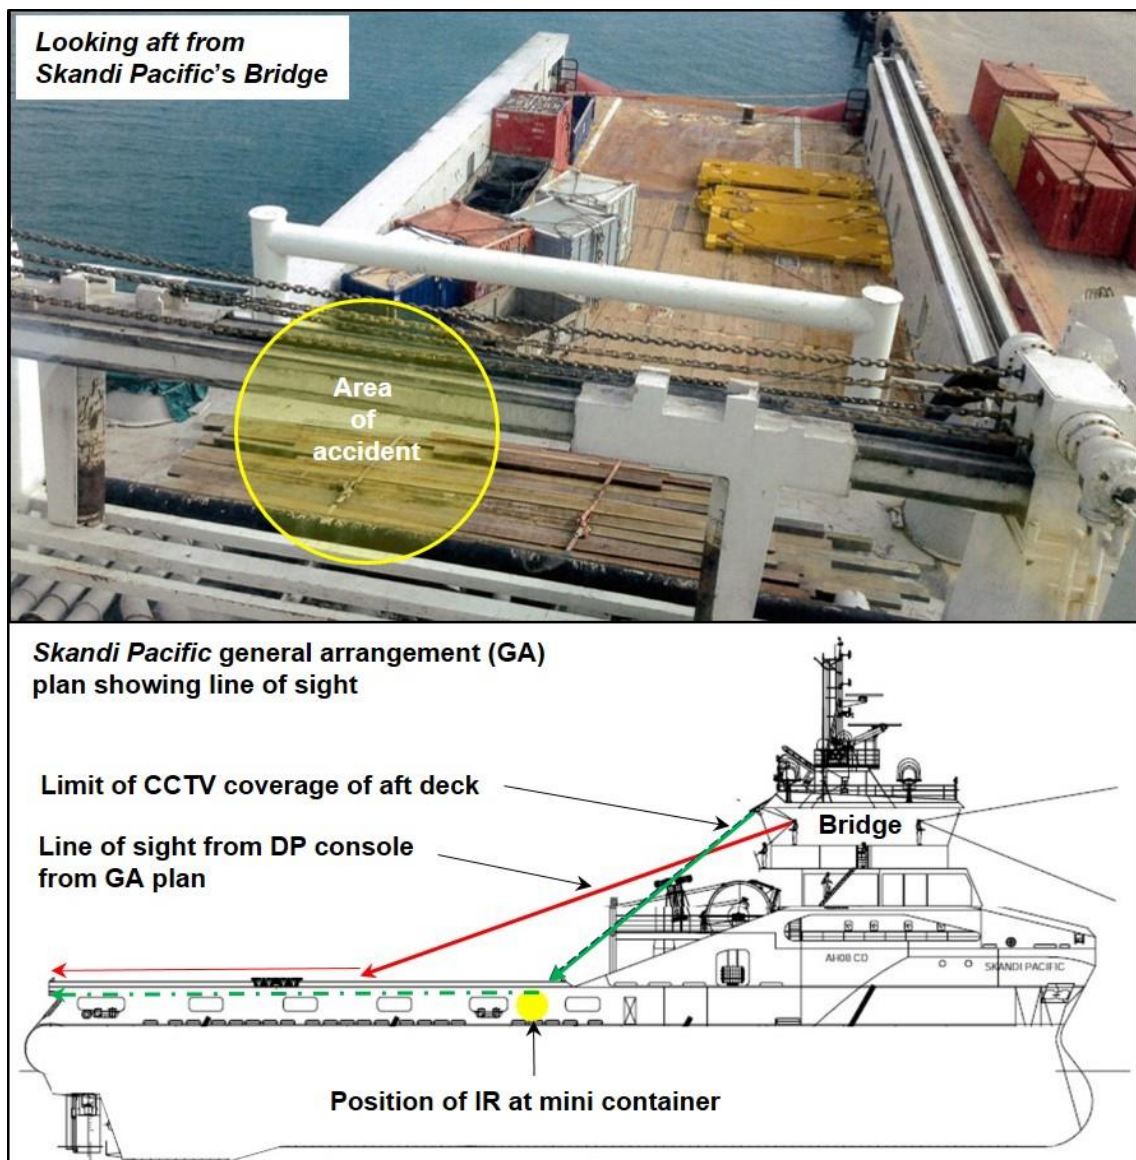
Figure 15: Line of sight of *Skandi Pacific’s* aft deck from the Bridge

After the IRs had initially tensioned the tugger wire at about 0518, the chief mate observing from the DP console (Figure 15) on the bridge, believed that the cargo handling operations had been completed. After the accident, the chief mate stated 'I thought they were almost finished as they were both out of sight and I could see the chains tightening'.
