Contact with buoy by *Navios Northern Star*

Prince of Wales Channel, Torres Strait, Australia | 15 March 2016

ATSB Transport Safety Report
Marine Occurrence Investigation
325-MO-2016-003
Final – 23 June 2017

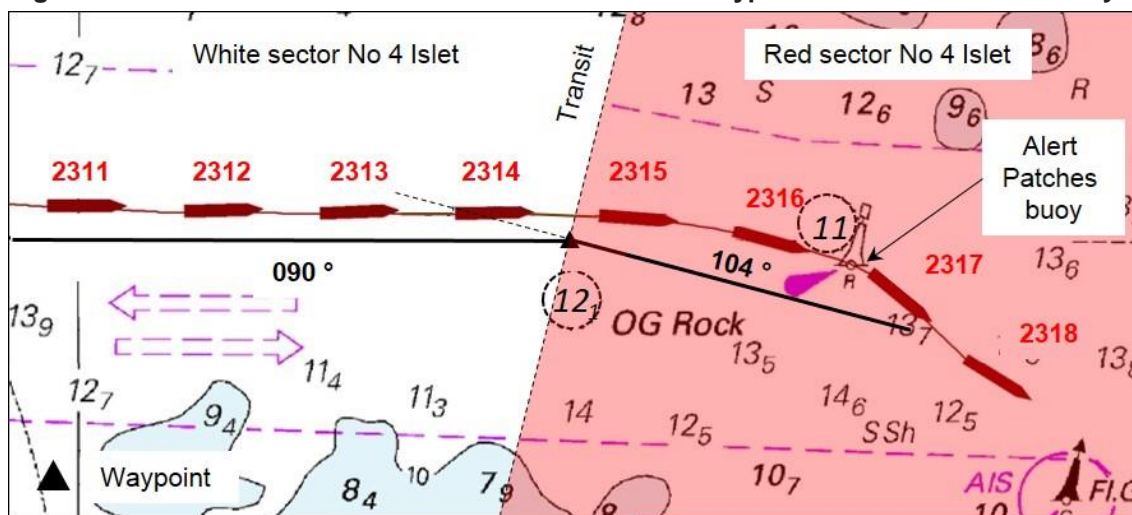
Figure 5: *Navios Northern Star*’s track to the OG Rock waypoint and Alert Patches buoy

At about 2312, the third mate advised 7 cables to go to waypoint north of OG Rock (OG Rock waypoint) and the pilot acknowledged the information (Figure 5). The tidal stream at that time was about 1.2 knots x 098° and the wind was from the north-west at force 5 (17 to 21 knots). The ships speed was now steady about 12.5 knots.

About 25 seconds later, at 2314, the pilot ordered 10° starboard rudder. The ship (that is, its bridge) was now about 2 cables from the OG Rock waypoint and 6½ cables from the Alert

Patches buoy. Shortly after, the pilot ordered 5° starboard rudder and, at about the same time, he was unable to find the echo return of the buoy on the radar's display.

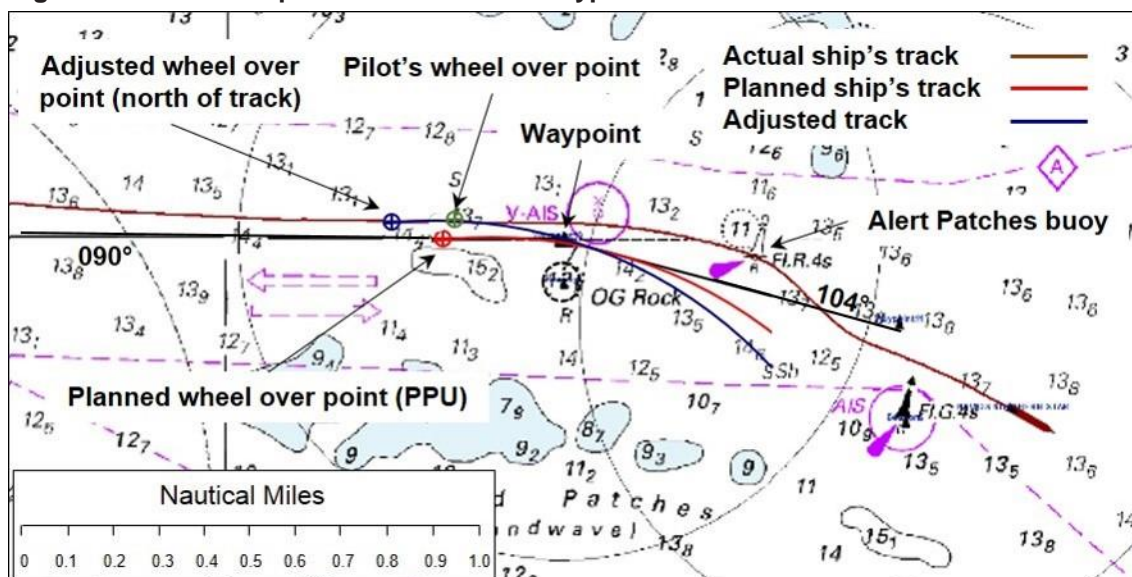
Figure 8: Wheel over point from OG Rock waypoint

The course alteration at the OG Rock waypoint was from 090° to 104°, a 14° course alteration. With the ship's planned speed at 12.2 knots, the pilot's PPU had a default 1 mile radius of turn²⁷ used to calculate the WoP with a required 11.7°/min rate of turn (RoT). This WoP (Figure 8) in the PPU was about 2½ cables from the OG Rock waypoint (7 cables from the Alert Patches buoy).

On March 15, as the ship approached the waypoint north of OG Rock, it was north of the charted track, hence the WoP was further west. For the same turn radius and rate of turn, the adjusted WoP was 3½ cables from the waypoint or 8 cables from the buoy. However, it was not until the ship was 6½ cables from the buoy that the pilot gave the first helm order. Additionally, with the ship’s actual speed of 12.5 knots, a RoT of 11.9°/min was required but not achieved throughout the turn (Figure 7).

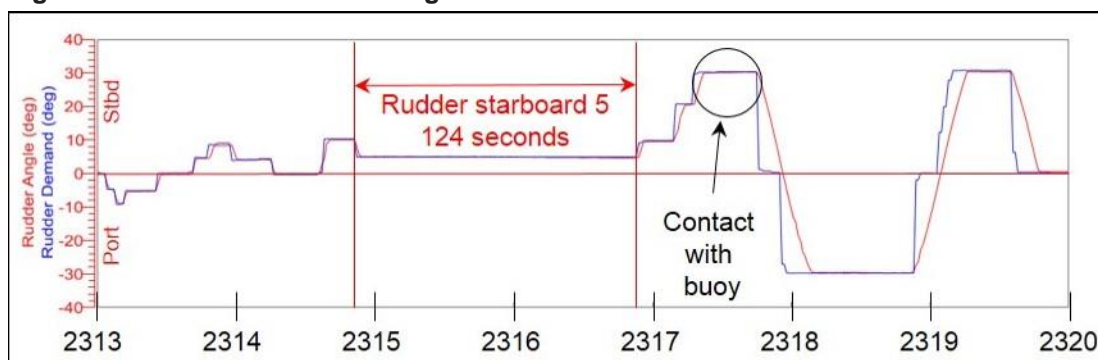
Figure 9: Rudder demand and angle from 2313 to 2320

As the ship approached the OG Rock waypoint, the pilot was using the s-band radar to determine the distance from Alert Patches buoy. His usual practice was to use a 7 cable distance from the buoy as his WOP. About the same time he ordered starboard 5° for the course alteration, he was unable to find the echo return on the radar’s display. The pilot became fixated on regaining the lost echo. For the next 2 minutes (Figure 9) the rudder angle remained at starboard 5°.

The pilot did not monitor the ship’s progress by any of the multiple cues or monitoring tools that were available and he was unaware that the ship was not swinging fast enough to safely make the turn.

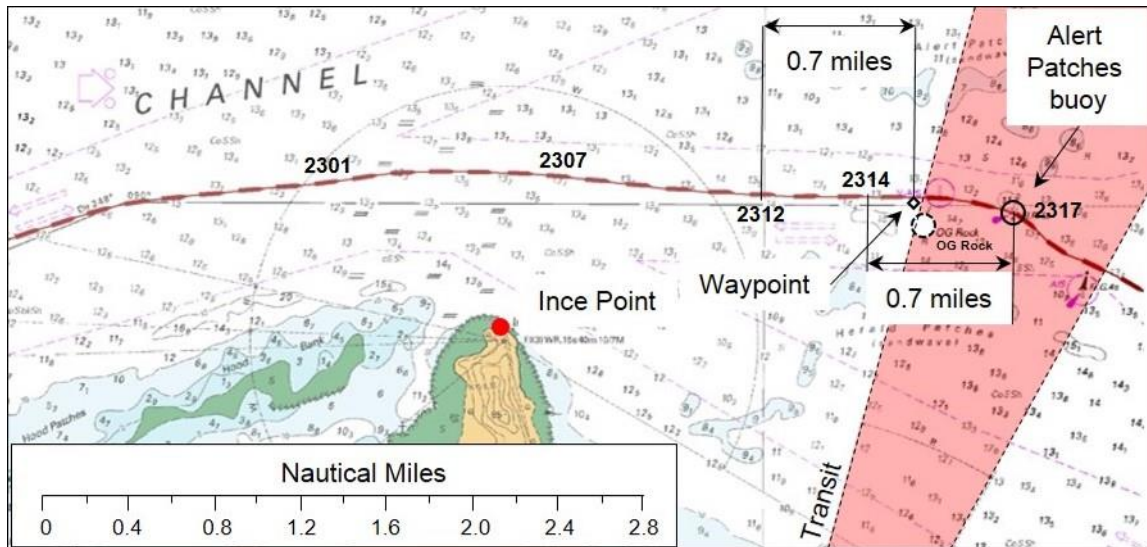
Figure 10 – Navigational chart Aus 293 showing *Navios Northern Star's* track to OG Rock

Further, the pilot did not inform the ship's bridge team, nor the trainee, about not using light sectors or when on a transit at OG Rock nor his plan for altering course. Therefore, the ship's bridge team and the trainee's expectations were different to the pilot's intentions in that situation. As the ship progressed, their comprehension of the situation did not trigger any actions for clarification or correction of the situation.

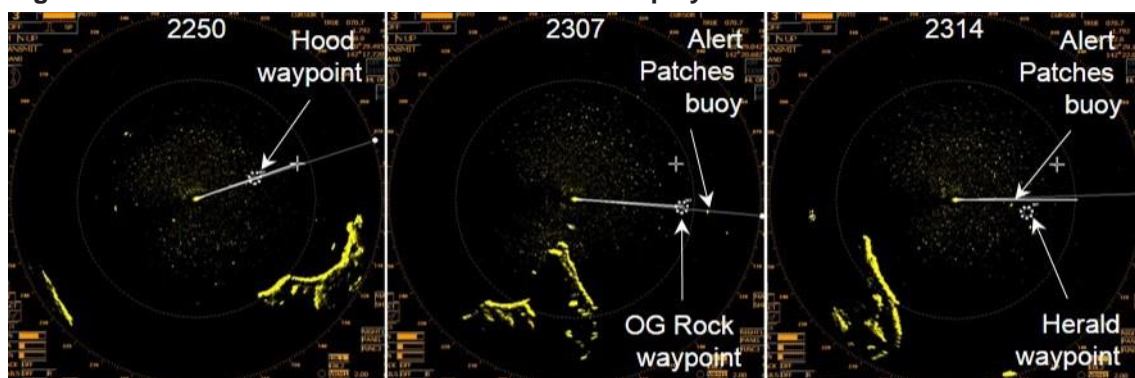
Figure 12: Navios Northern Star's X-band radar display from 2250 to 2314

The OOW stated he frequently moved from the chart table to use the ship's x-band radar (the pilot used the s-band radar). However, in the 27 minutes before the contact (2250 to 2317), none of the radar's tools or features including EBLs, VRMs, PIs nor clearing indexes (Figure 12) were used. Further, there was no other indication the x-band radar had been used, including a reduction in range as the ship approached the OG Rock waypoint.
