Grounding of *Searoad Mersey*

Grassy Harbour, King Island, Tasmania | 30 October 2016

ATSB Transport Safety Report
Marine Occurrence Investigation
327-MO-2016-004
Final – 4 April 2017

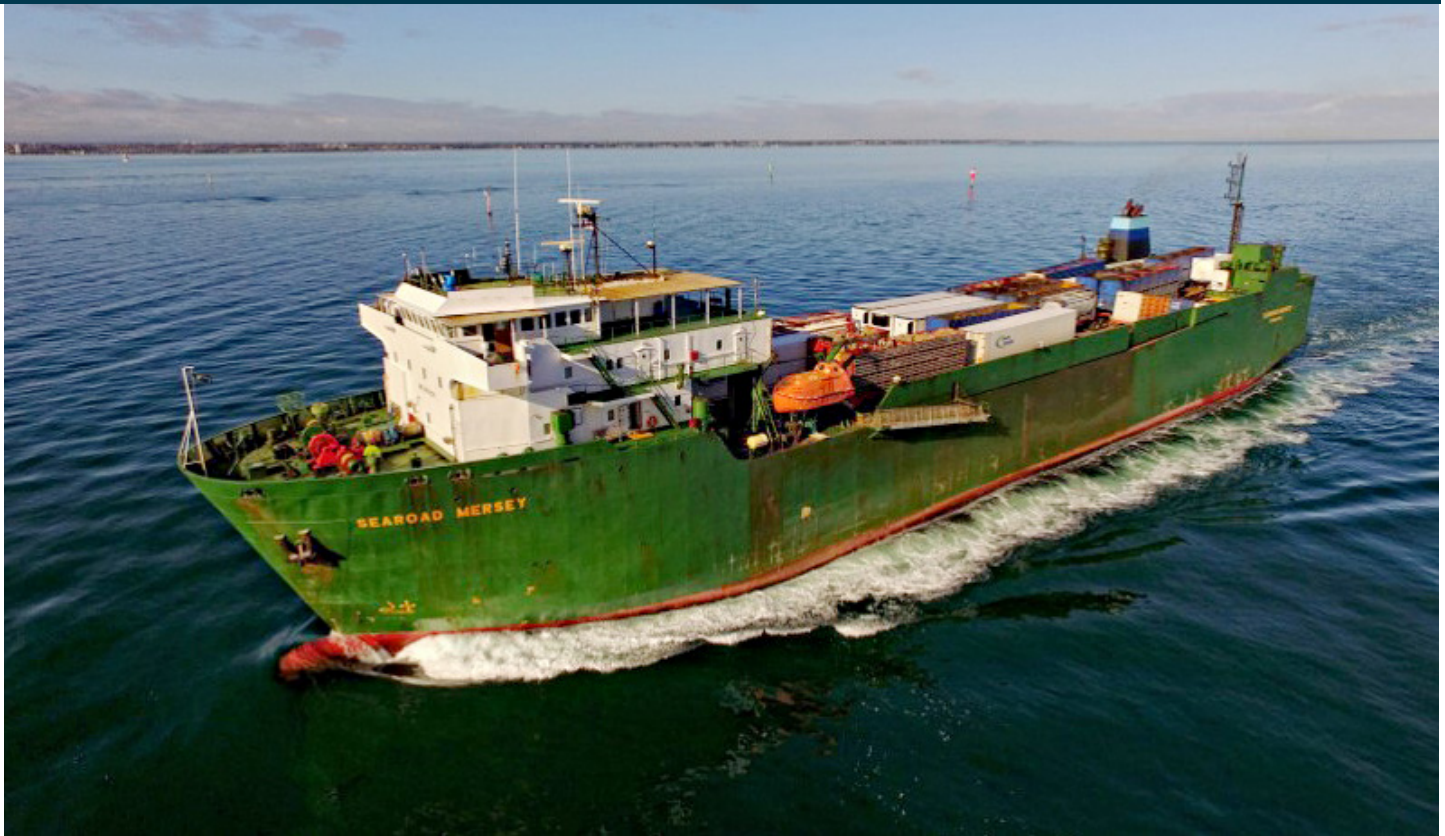
On 30 October morning, the 119 m general cargo ship *Searoad Mersey* (Cover) arrived off Grassy Harbour, King Island (Figure 1) from Melbourne, Victoria. The ship was operating a 7-day schedule between Melbourne, King Island and Devonport, Tasmania. At about 0700,¹ the ship's master received a weather report for the harbour. The wind was from the north-west at 25 to 28 knots² as per the forecast.

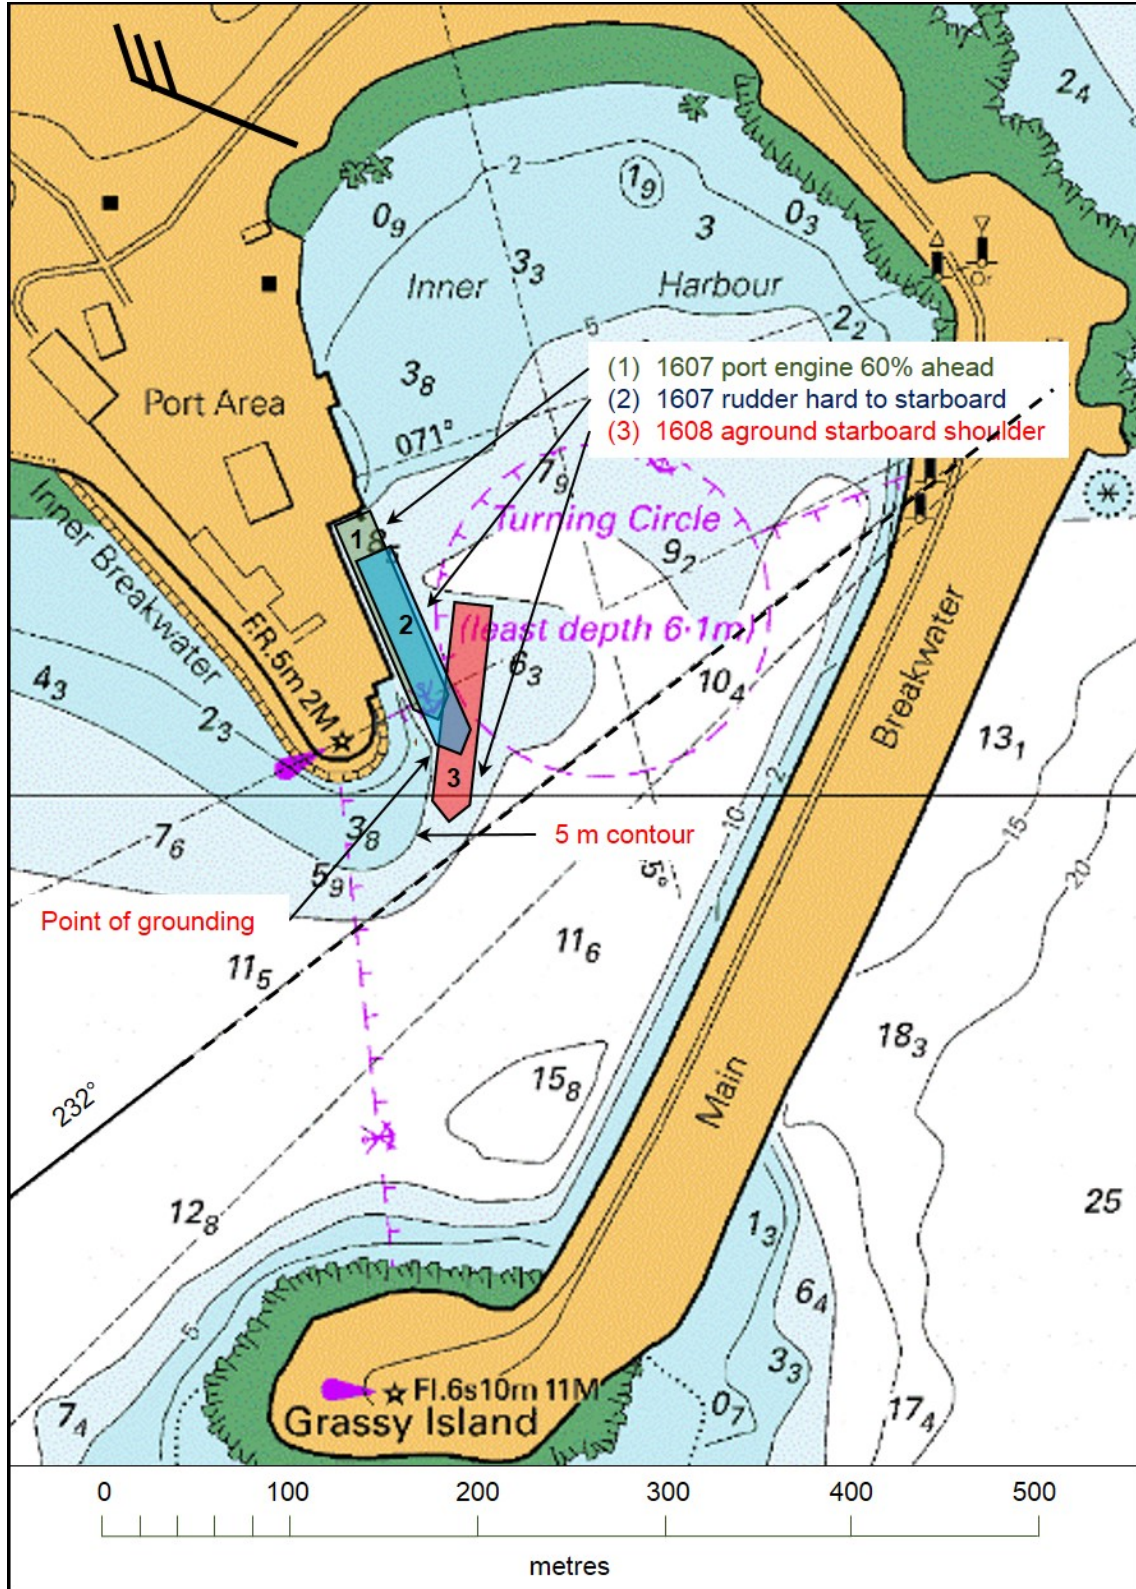
Figure 2: Searoad Mersey's grounding in the Inner Harbour

At 1608, the ship had moved ahead about 90 m and had started swinging to starboard. Shortly after, the ship grounded on the sandy bottom to the east of the inner breakwater (Figure 2).

The master stopped the port engine and put the bow thruster full to port. He then increased the starboard engine to 70 per cent ahead and the rudder hard to port. However, the ship's starboard shoulder⁵ remained grounded. Shortly after, the master unsuccessfully attempted to move the ship astern using both engines.

Since the last hydrographic survey in 2015, it is probable that silting had occurred near the inner breakwater. It is likely that the reduction in water depth to the charted depths were the result of the predominant westerly winds blowing sand from the nearby beach into the channel together with the movement of sand within the harbour.

Masters, harbour masters and others responsible for ships calling safely at ports need to assure themselves of the reliability of charted depths, particularly in some small, remote ports. A possible reduction in charted depths due to local conditions, reference to the charted zone of confidence diagrams and the date of the last hydrographic survey are among the factors that should be taken into account.
