ATSB TRANSPORT SAFETY INVESTIGATION REPORT

Rail Occurrence Investigation – 2006/007

**Derailment of Train 2CM3
near Seymour, Victoria**

12 September 2006

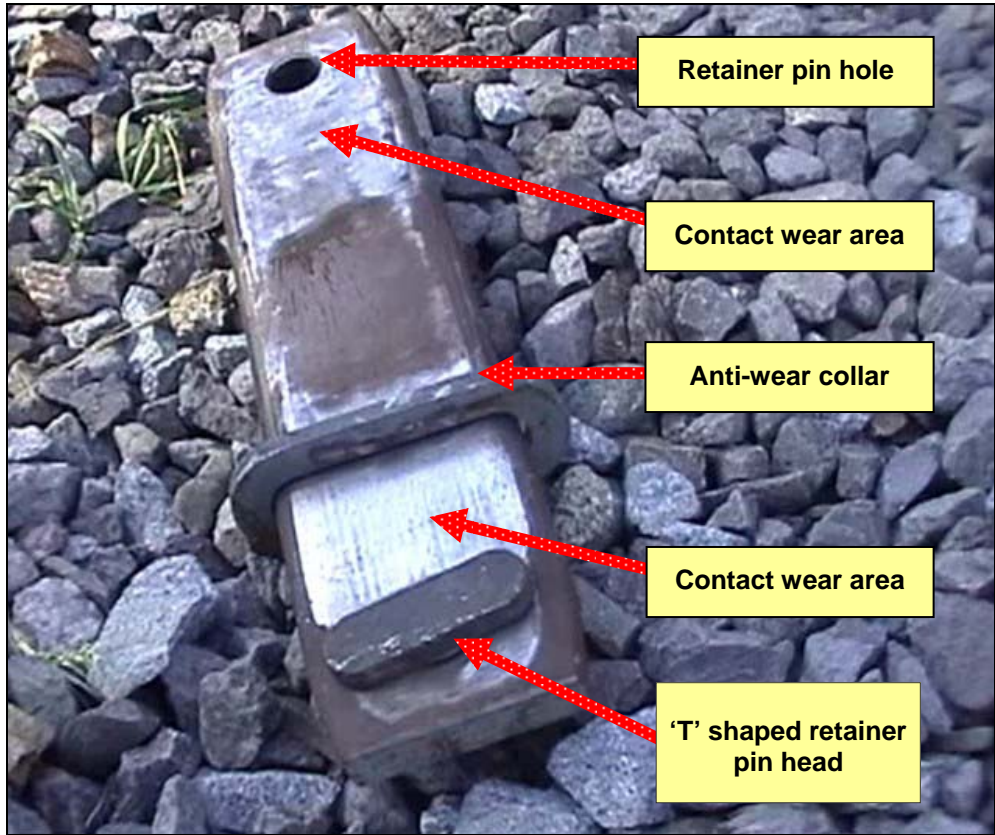
Figure 9: Draft key top view with retainer pin showing pronounced wear near retainer pin ends

The top face of the draft key from wagon CQBY 0118A was not deformed although it displayed pronounced wear on each end where the draft key passes through the slots in the coupler and underframe. The abnormal wear was consistent with the coupler shank binding on the draft key. This meant that any lateral movement of the coupler (which would occur in service when the wagon was negotiating curves) was probably resulting in a significant lateral force being transmitted via the draft key to the draft key retainer pin which resulted in hard contact between the pin and the anti-wear collar.

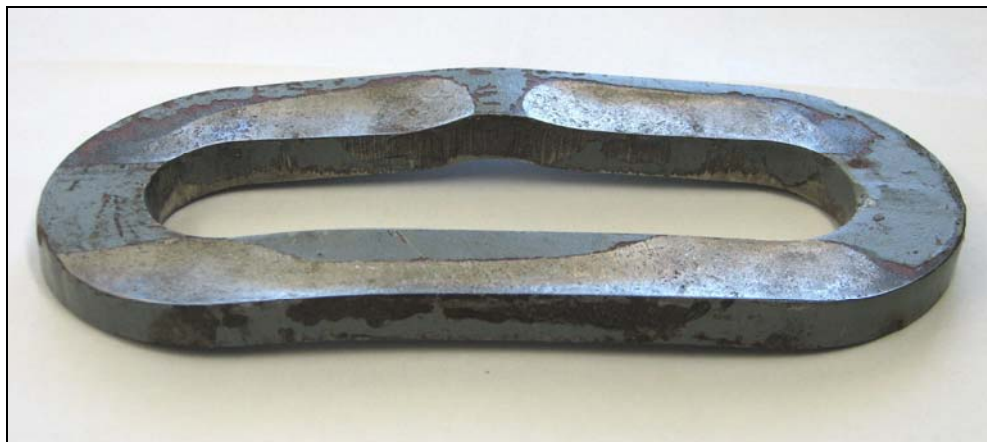
Figure 10: Draft key anti-wear collar from CQBY 0118A showing wear and deformation

The installation of anti-wear collars also meant that these items could be periodically replaced if they became worn, mostly eliminating the need to refinish draft sill lip faces during subsequent maintenance. It was evident that prior to the fitment of the anti-wear collars on CQBY 0118A, the worn draft sill lips had not been refinished to an original condition. As a result of severe contact forces applied through the draft key to the retainer pin, the anti-wear collar had deformed to the worn shape of the draft sill lip.

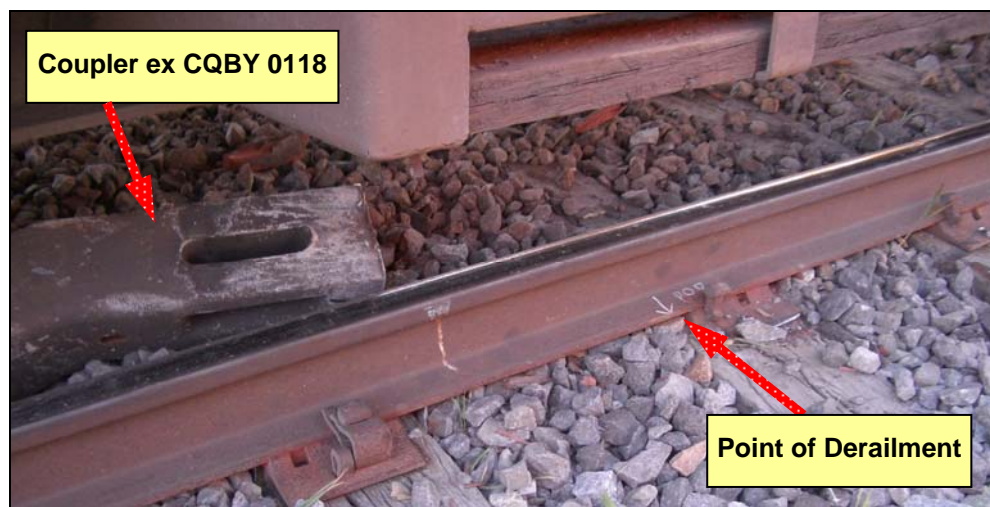
On inspection it was found that the coupler from the leading end of the eighth wagon (CQBY 0118A) had fallen onto the track. The dislodged coupler had bounced under the trailing vehicles causing minor damage to brake rigging and other low mounted equipment before being caught under the 11th wagon (CQBY 0130N) where it derailed both wheels of the rear axle on the leading bogie. The train continued over the dislodged coupler (Figure 13) that was later found

Figure 13: Dislodged coupler under NQPY 14587T and point of derailment

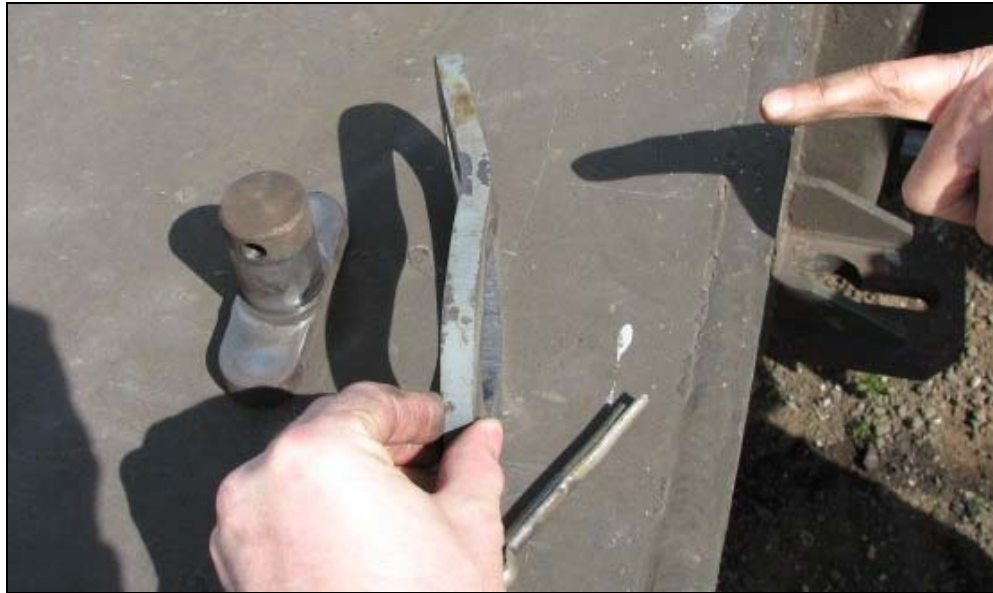
Figure 15: Retainer pin, distorted anti-wear collar and split pin inspected on site

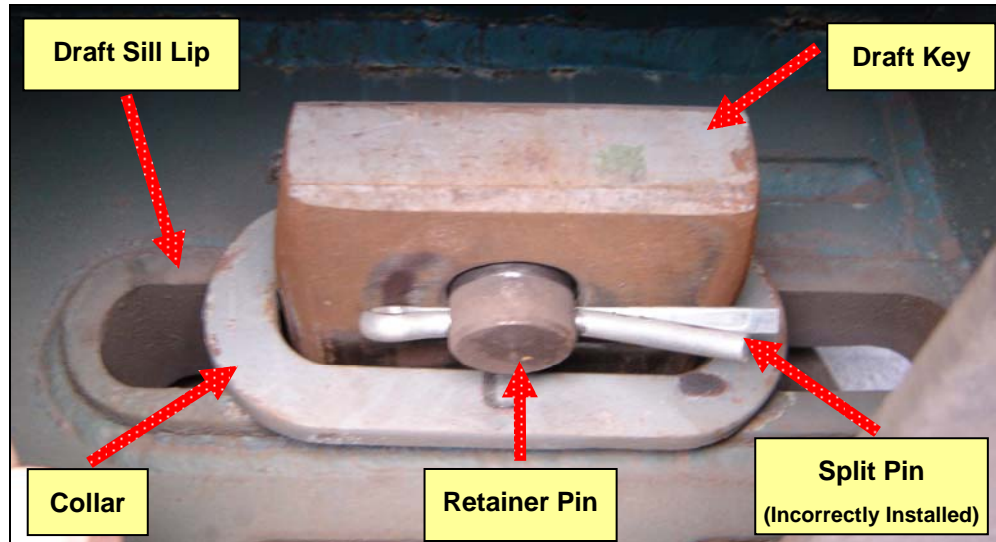
On 30 March 2005 (wagon CQBY 0104) and 27 February 2006 (wagon CQBY 0136) two further coupling failures occurred. It was noted that these wagons had been modified and both failures were attributed to the incorrect installation of the split pin within the retainer pin (Figure 16).

Figure 16: Draft key assembly in position through the draft sill aperture

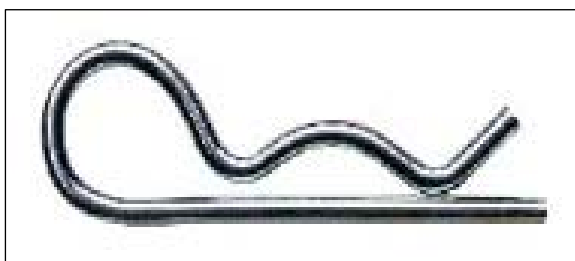
Other examples of inconsistent modifications were recorded including where two anti-wear collars had been fitted to one side of the draft key and another where 'R' type clips had been used in place of the split pin (Figure 17).

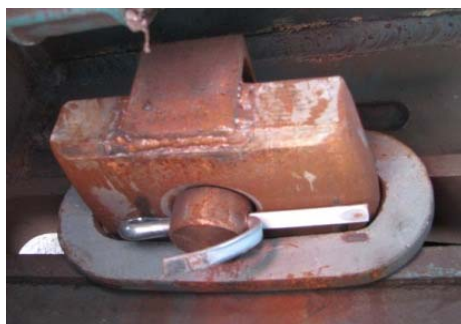
Figure 18: Welded angle retainer

The modifications shown in figures 18 and 19 were applied indiscriminately to the CQBY fleet and were a 'stop gap' method of ensuring the retainer pin could not

Although the ad hoc modifications made to retainer pins and anti-wear collars by welding steel angle and plates were effective (Figure 18, 19), these changes only prevented the retainer pin/s from riding up and out of the draft key in the short term. These modifications failed to address the underlying cause of the biased loading on the draft key and associated components that initiated the failures.

- welding a section of steel angle to the end of the draft key (Figure 18) so that the return leg of the angle is positioned above the head of the retainer pin. (this requires grinding or cutting to remove the draft key when the angle is welded to the retainer pins on both ends of the key);
- welding a section of flat bar to the top side of the anti-wear collar over the head of the retainer pin (Figure 19).

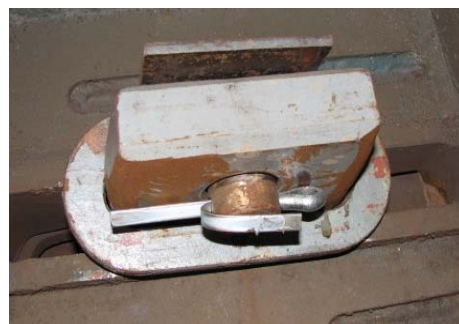
Figure 19: Flat Strip retainer

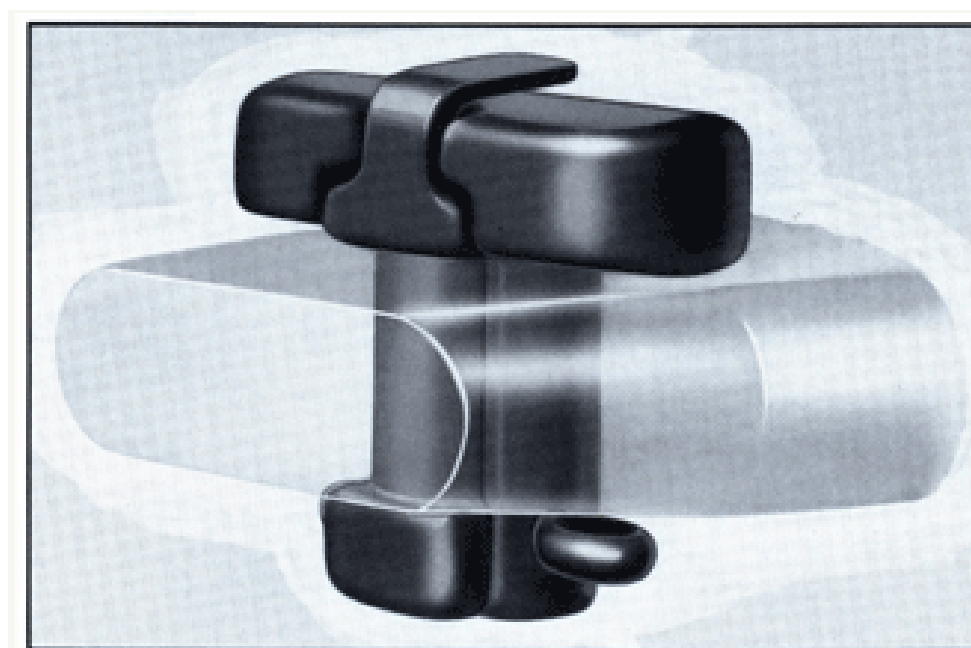
Figure 20: 'Azee' drop forged draft key retainer and keeper

CFCLA has subsequently reviewed the current draft key design deficiencies and has considered various options to reduce the likelihood of other retainer pins dislodging from the draft key. CFCLA have fitted out and trialled three wagons with 'Azee' drop forged draft key retainer pins¹⁴ and keepers (Figure 20). A field trial commenced in November 2006 and it has now been demonstrated that this type of retainer is superior to the original manufactured equipment.

Due to the success of the trial, CFCLA has committed to a program for the replacement of all draft key retainer pins fitted to Series 1 and Series 2 CQBY wagons and have issued *Maintenance Improvement Circular 21/07*. Work on this refit programme started in May 2007.

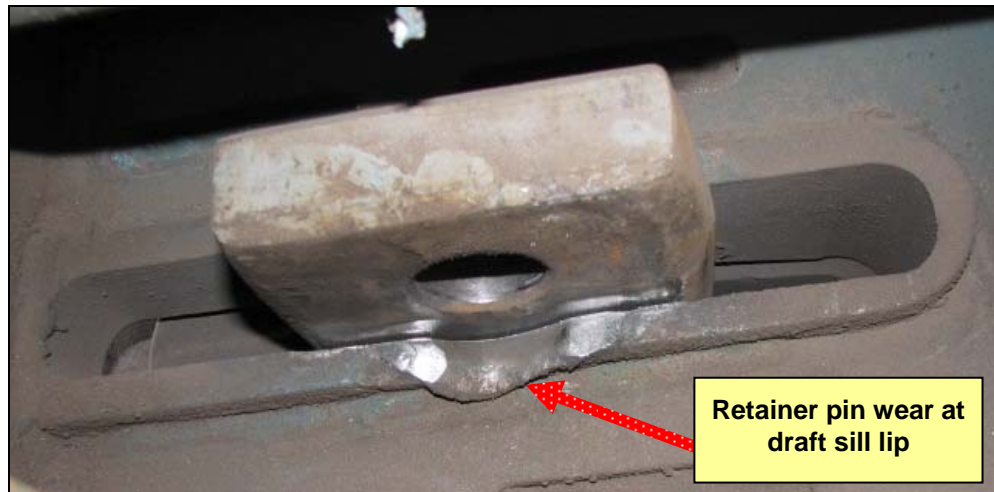
When the CQBY Series 1 wagons were commissioned in 2000 they were not fitted with the oval shaped anti-wear collars over the draft key ends. The primary aim of fitting anti-wear collars was to stop excessive point contact wear to the draft sill lips caused by regular contact of the retainer pins between these surfaces (Figure 21).

Figure 21: Draft key shown one side in the normal position indicating abnormal wear on the draft sill lip inflicted by the draft key retainer pin and split pin

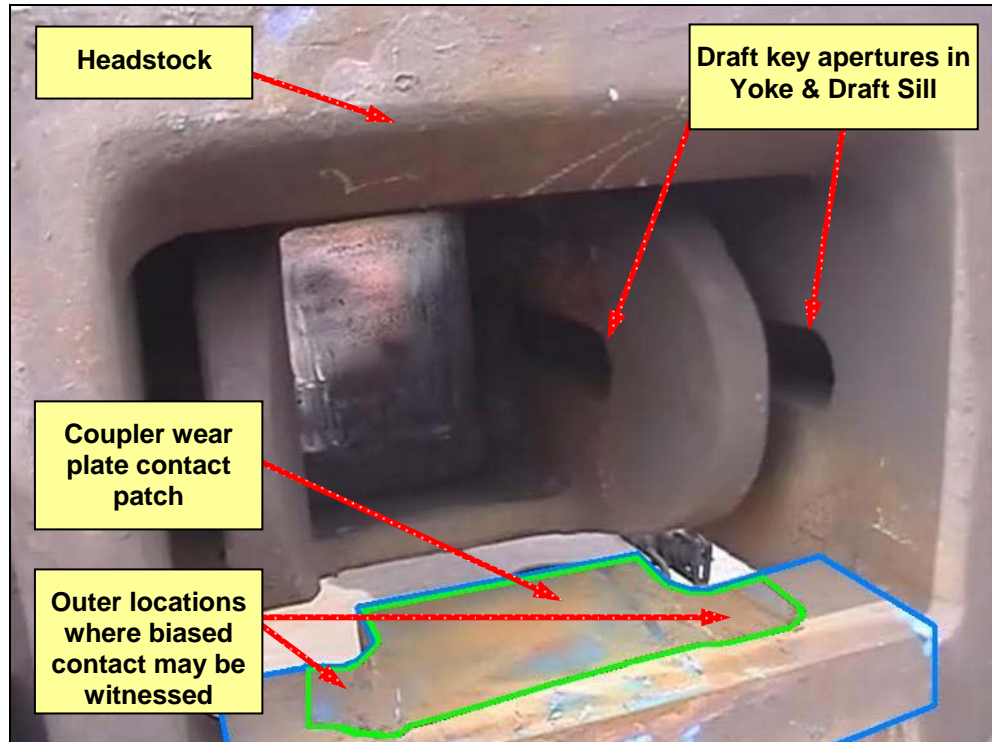
shanks displayed uneven wear marks to either the left or right of centre on the coupler wear plate where the coupler protrudes from the draft sill and headstock¹⁸ (Figure 22). Evidence of biased wear was seen on some Series 2 CQBY wagons

Figure 22: Wear plate (blue outline) showing contact surface area (green) (CQBY-series 1)

where the plastic coupler wear plate exhibited higher levels of surface scouring and swarf¹⁹.
