Derailment of freight train 9101

24 km south of Ouyen, Victoria | 10 August 2013

ATSB Transport Safety Report
Rail Occurrence Investigation
RO-2013-021
Final – 1 August 2014

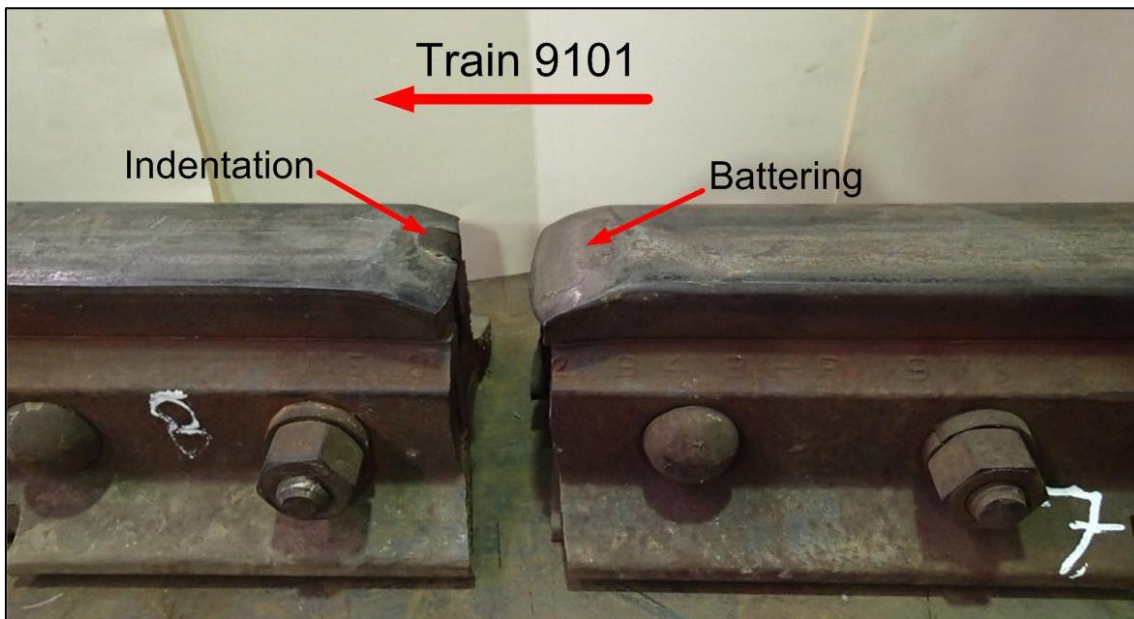
Figure 2: Failed mechanical rail joint

The train derailed due to the failure of a mechanical rail joint on the west rail located at about the 485.3 km mark. The fishplates of the rail joint had fractured transversely at about mid-length. The running faces at both rail ends were battered and an indentation consistent with impact from a wheel flange was found on one rail head (Figure 2). The extent of the battering of both rail ends indicated that the fracture was present for some period of time, as trains had passed in both directions over the joint after both fishplates had fractured and allowed vertical misalignment at the joint.

The derailment occurred as a result of a failed mechanical rail joint (joint A). Both fishplates in the joint had fractured due to the development and propagation of fatigue cracks and the subsequent overload failure of the fishplates prior to the passage of train 9101. Movement of the rail during the passage of train 9101 resulted in a lateral discontinuity of the running rail at the joint and the derailment of the train. It is probable that the fishplate fracture in a nearby joint (joint B) occurred subsequent to the derailment.

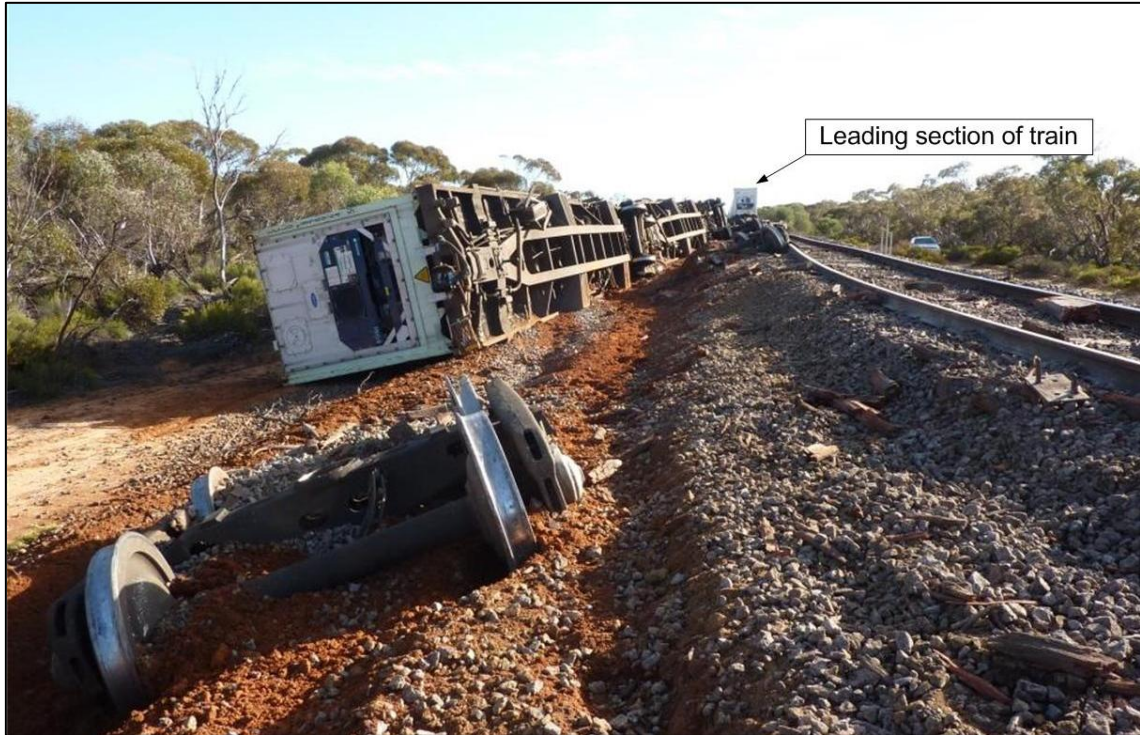
Figure 3: Leading section on rails and rolled wagons

Of the nine wagons that derailed, the 22nd, 23rd and 24th wagons ended on their sides, the front-end of the 22nd wagon resting about 27 m from the upright 21st wagon (Figure 3).

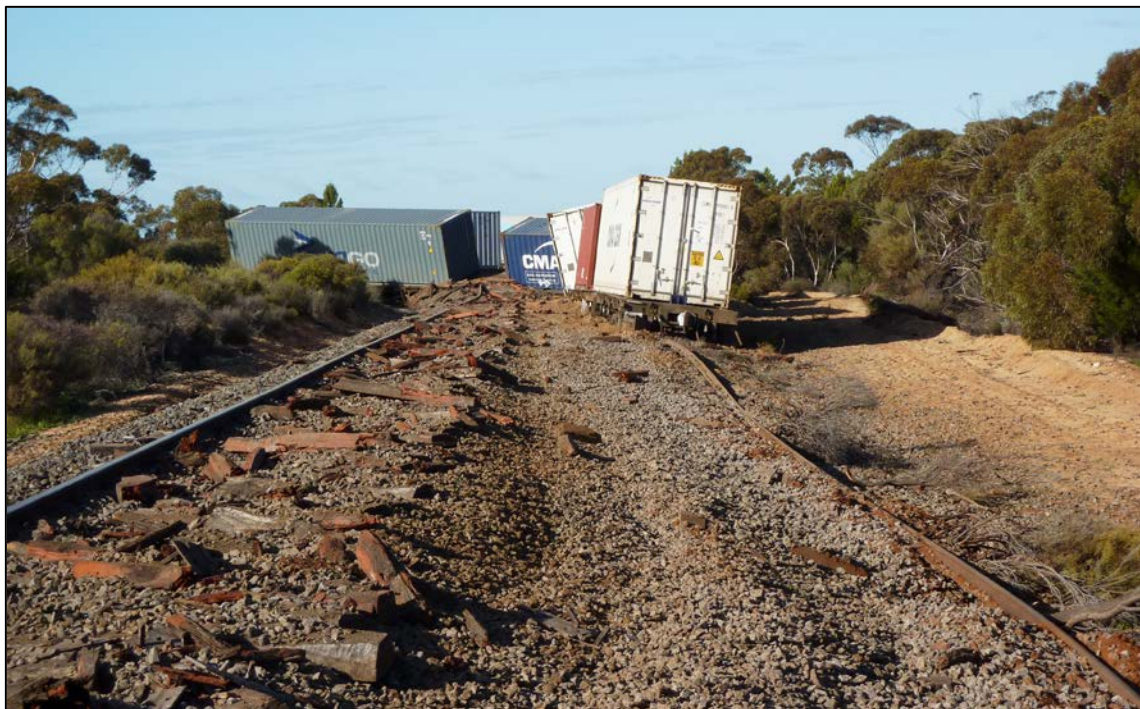
Figure 4: Derailed but upright wagons and track damage

The next six wagons that derailed stayed upright among the disarranged track about 127 m from the wagons on their sides (Figure 4).

Approximately 300 m of track was destroyed. The line was out of service until 26 August 2013.

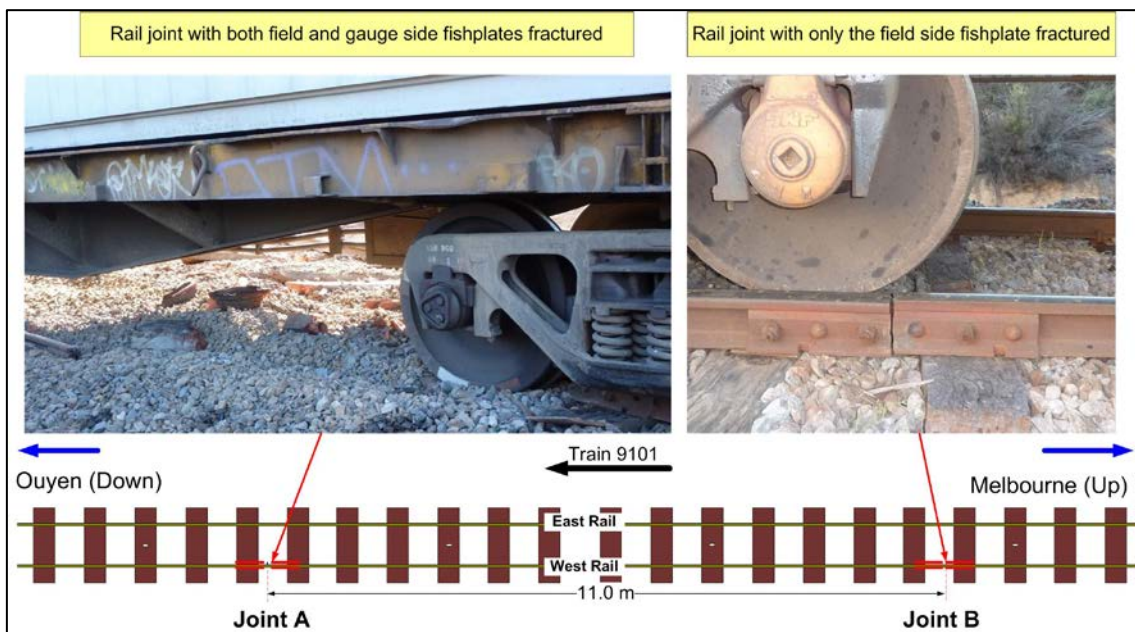
Figure 6: Failed mechanical rail joints

Two mechanical rail joints had failed in the west rail around the 485.3 km mark (Figure 6). One (joint A) failed completely and initiated the derailment. A second (joint B), that was located about 11 m before joint A, had a fractured fishplate on the field side, but the rail remained in place held by the intact gauge-side⁹ fishplate. Due to track disturbance and gauge spread, the left wheels of the wagon at joint B dropped in (Figure 6).

Examination of the fractured fishplate indicated a juvenile fatigue fracture that had progressed to a depth of about 10 mm from the top of the fishplate. The remainder of the fishplate fracture was free from oxidation and exhibited chevron markings characteristic of instantaneous overload radiating from the juvenile fatigue crack at the top of the cross section through to the bottom of the fishplate. The final fracture zone represented approximately 95 per cent of the fishplate cross section indicating it had been subjected to unusually high loading, almost certainly as a result of the train’s derailment at joint A.

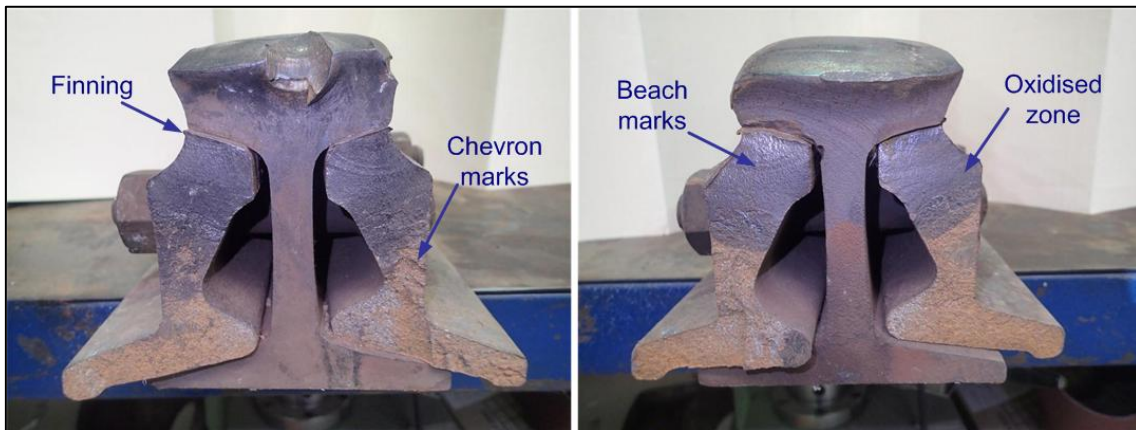
Figure 7: Fractographic observations of fishplates

The breaks in both fishplates had occurred transversely at mid-length. The fishplate fractures exhibited discolouration of the top end of the surfaces, consistent with long term oxidation of the fracture surfaces (Figure 7). The oxidised zones of the fracture surfaces exhibited beach marks consistent with fatigue fracture. The orientation of the beach marks indicated that the fractures had originated at the top surfaces of the fishplates. The fatigue had progressed to a depth of about 40 mm from the top of the fishplates.

The spacing of the beach marks was consistent with a moderate stress, moderate cycle fatigue in the initial part of the fracture surface. As the fatigue crack progressed, the beach mark spacing became coarser indicating a change in progression to a high stress, low cycle fatigue mechanism. These fracture surfaces had been worn by contact and abrasion in service and details of the fracture mechanism in the vicinity of the top end of the fatigue fractures had been removed as a result.

The final fractures zones, below the oxidised surfaces, exhibited ridges and valleys consistent with chevron markings that are characteristic of instantaneous overload fracture.

Track components are susceptible to fatigue due to the cyclic nature of loading during the passage of trains. The substantial fatigue cracks in joint A fishplates and the juvenile fatigue crack in one fishplate at joint B had all initiated in the plate top surface, indicating cyclic tensile stresses at the surface. The depth of the fatigue cracks at joint A indicated that the cracks had been developing for some time, with the rate of propagation increasing as the fishplates neared the point of overload failure. The overload failures at joint A were the result of the reduced intact cross sectional area in the fishplates, and occurred prior to the passage of train 9101. The battering of both rail ends indicated that trains had passed across the joint in both directions after the joint was allowed to vertically misalign with the fracture of the fishplates.

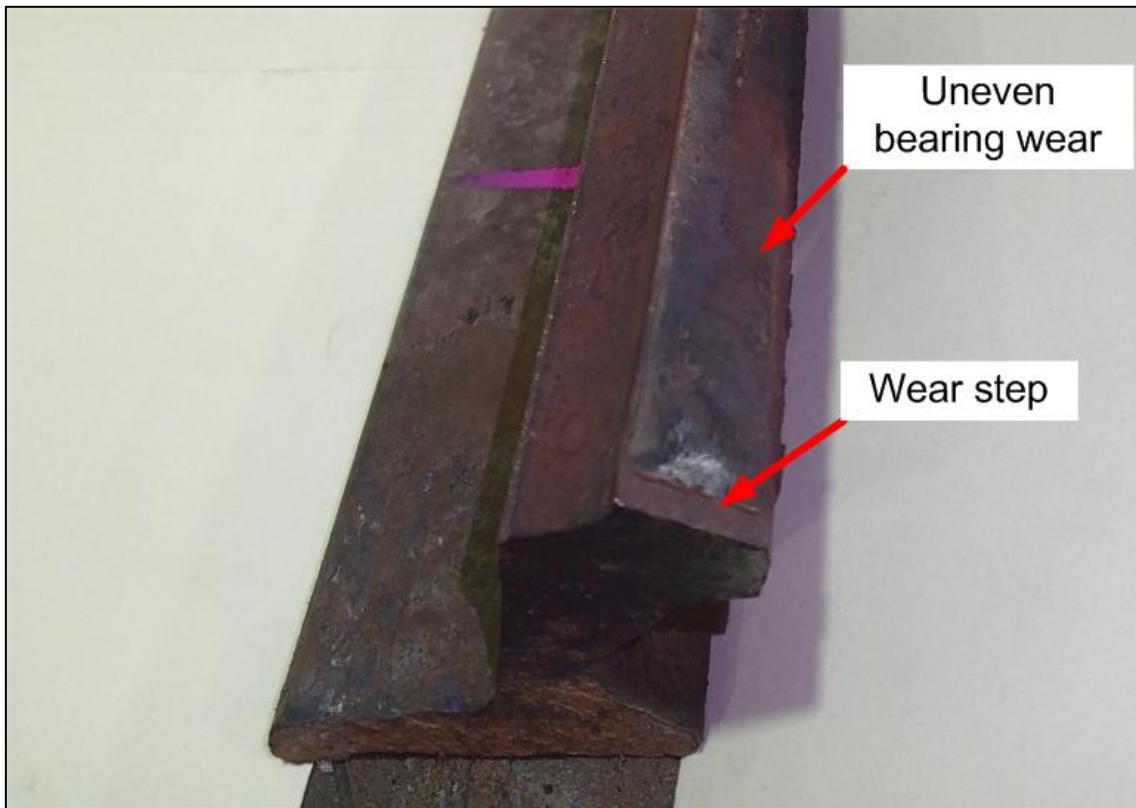
Figure 8: Bearing wear and wear step on fishing surface of fishplate

The top fishing surfaces of the fishplates exhibited finning¹¹ (Figure 7) and uneven bearing wear (Figure 8) that had culminated in wear steps at the joint gap adjacent to the fracture. Both wear features indicated that relative movement had occurred between the rail head and the fishing surface in service.
