# Axle failure on XPT ST24

Culcairn, NSW, 24 October 2014

**ATSB Transport Safety Report**  
Rail Occurrence Investigation  
RO-2014-019  
Final – 5 July 2016

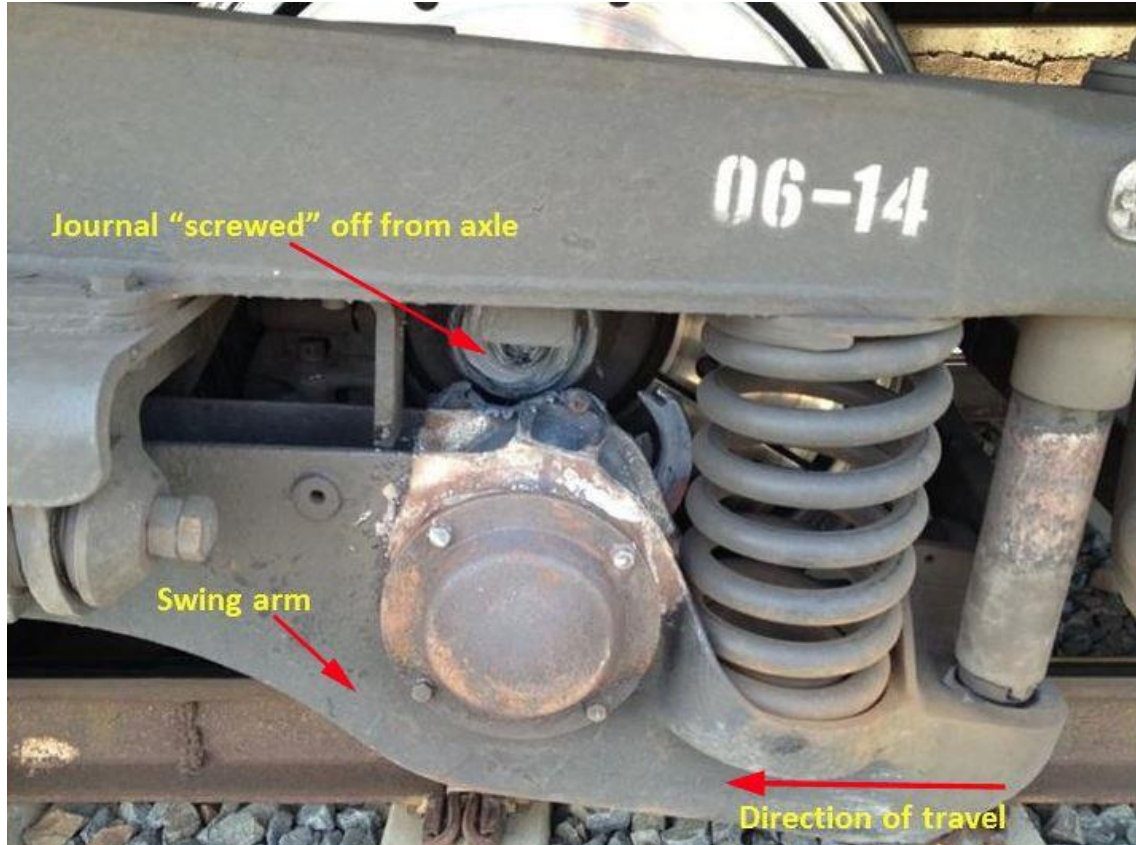
**Figure 2: Failed axle and swing arm hanging down.**

After inspecting the train, the driver notified TC that the trailing axle on car B (XL2235) had sheared off (Figure 2). He informed TC that the train was unable to continue its journey and alternative arrangements would be required for passengers to continue their journey. During the conversation, TC informed the driver of other reported fires in the Albury and Gerogery areas.

The image shows the failed axle journal, commonly referred to as a ‘screwed journal’. As the bearing housing no longer supports the axle, the swing arm has dropped. Source: NSW Trains, annotated by the ATSB

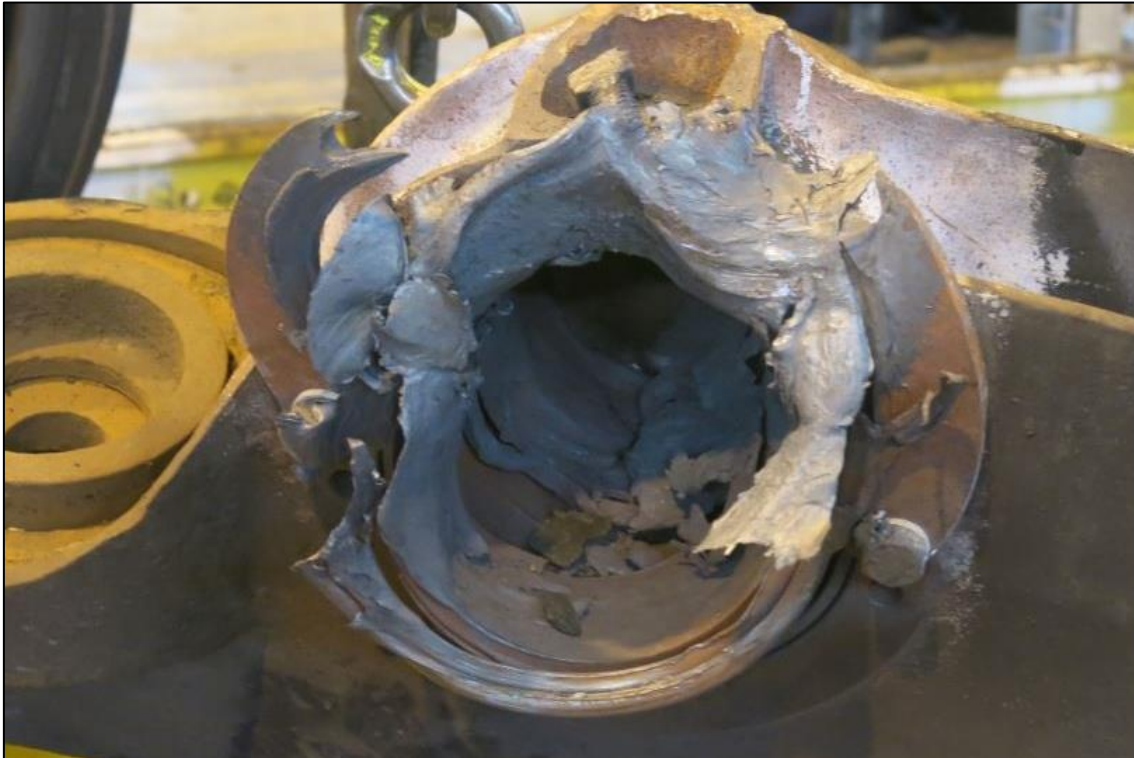
**Figure 6: Swing-arm bearing housing**

It was evident that the bearing had seized while the axle was still turning. The heat generated by the failed bearing was sufficient to heat the journal, to make it 'plastic' (Figure 6) and cause it to separate from the axle (commonly referred to as a screwed journal).

The XPT bogie swing-arm bearing housing, viewed from the inboard side. The heat damage is evident and the remaining bearing components can be seen inside the housing. Source: ATSB

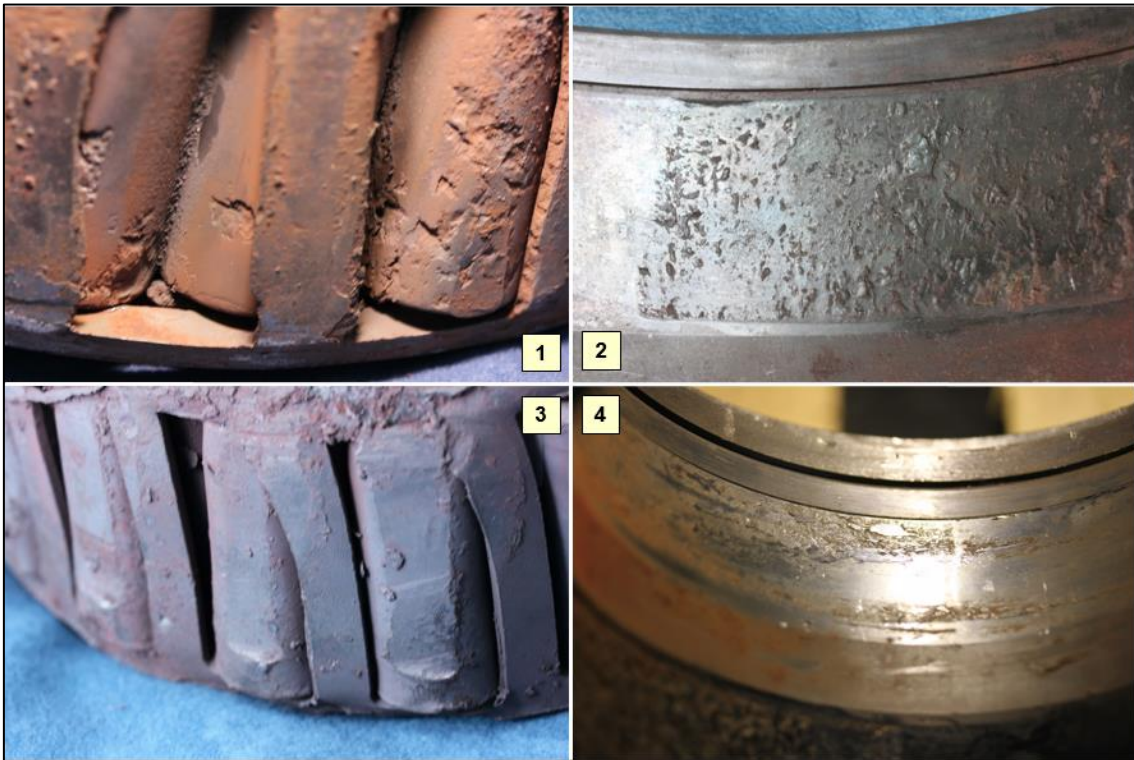
**Figure 7: Remains of the failed bearing**

The inboard raceway showed evidence of full-width spalling<sup>12</sup> fatigue (Figure 7-2). The spalling fatigue began from the 6 o'clock position and continued in the direction of rotation to the 9 o'clock position. There was also some fracturing of the shoulders on the unworn surfaces of the track.

The remains of the failed bearing, obtained from within the swing-arm bearing housing.  
 Image 1: Inboard cone, showing flattened, misaligned rollers with spalling fatigued surfaces.  
 Image 2: Inboard raceway, showing full-width spalling fatigue.  
 Image 3: Outboard cone, showing flattened rollers.  
 Image 4: Outboard raceway showing full-width galling and deposited metal. Source: ATSB

As most failure modes were considered less likely, the most probable cause of the bearing failure was a cage failure. The cage failure caused the bearing rollers to become misaligned and subsequently seize in the bearing housing. The seizure then caused friction resulting in excessive heat to build up in the bearing housing within the swing arm and journal. This generated enough heat into the bearing journal to cause it to go 'plastic' and separate from the bearing journal.

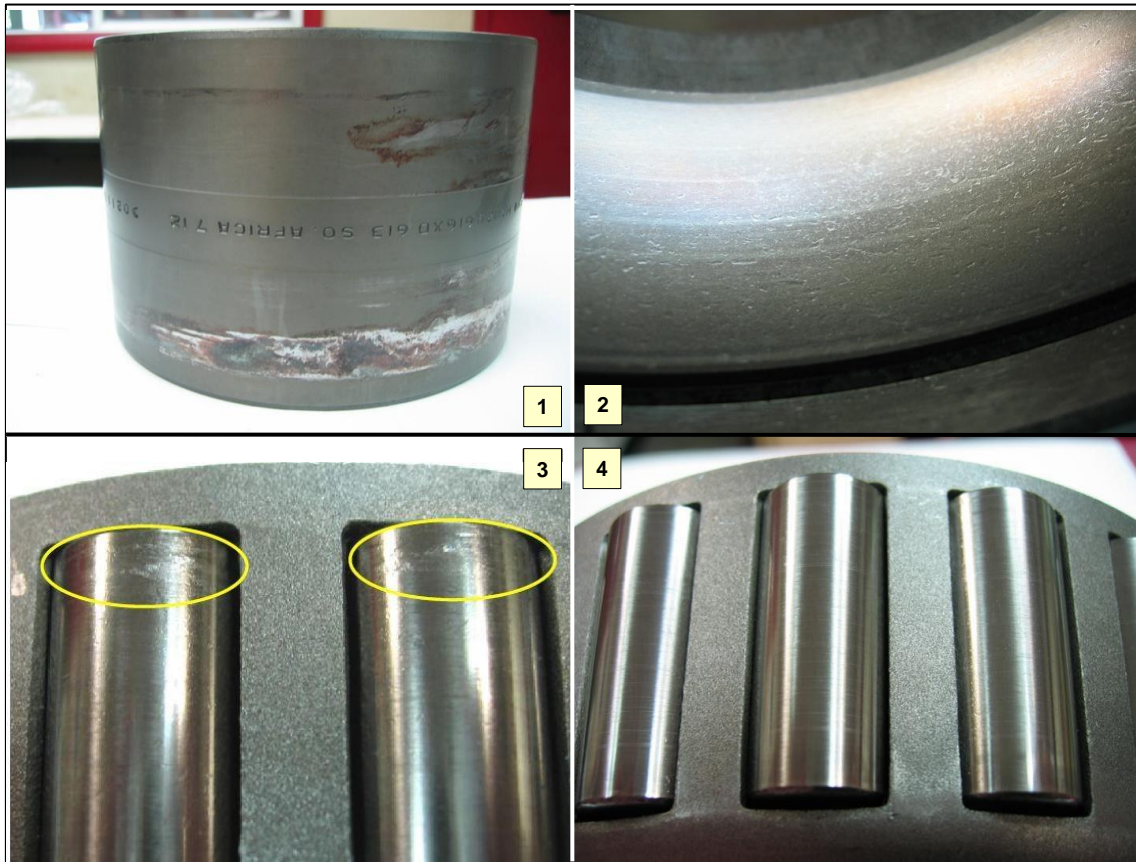
**Figure 8: Partner bearing**

The bearing was weighed and grease samples from the inner, outer and spacer (centre) of the bearing was taken and sent for analysis. The BES examination found that the bearing showed uneven adaptor fretting<sup>14</sup> marks on the cup exterior (Figure 8-1). There was also wear and damage to the inboard raceway (Figure 8-2) and outside edges of the inboard cone rolling elements (Figure 8-3). Conversely, the raceway and rolling elements of the outboard cone (Figure 8-4) were in good condition.

Image 1: Uneven fretting marks on the exterior of bearing cup indicating uneven contact pressure between the bearing cup and the swing-arm bearing housing.

Image 2: Indentation damage to the inboard raceway.

Image 3: Peeling damage to the rolling elements of the inboard cone, predominately on the outside edges due to uneven loading.

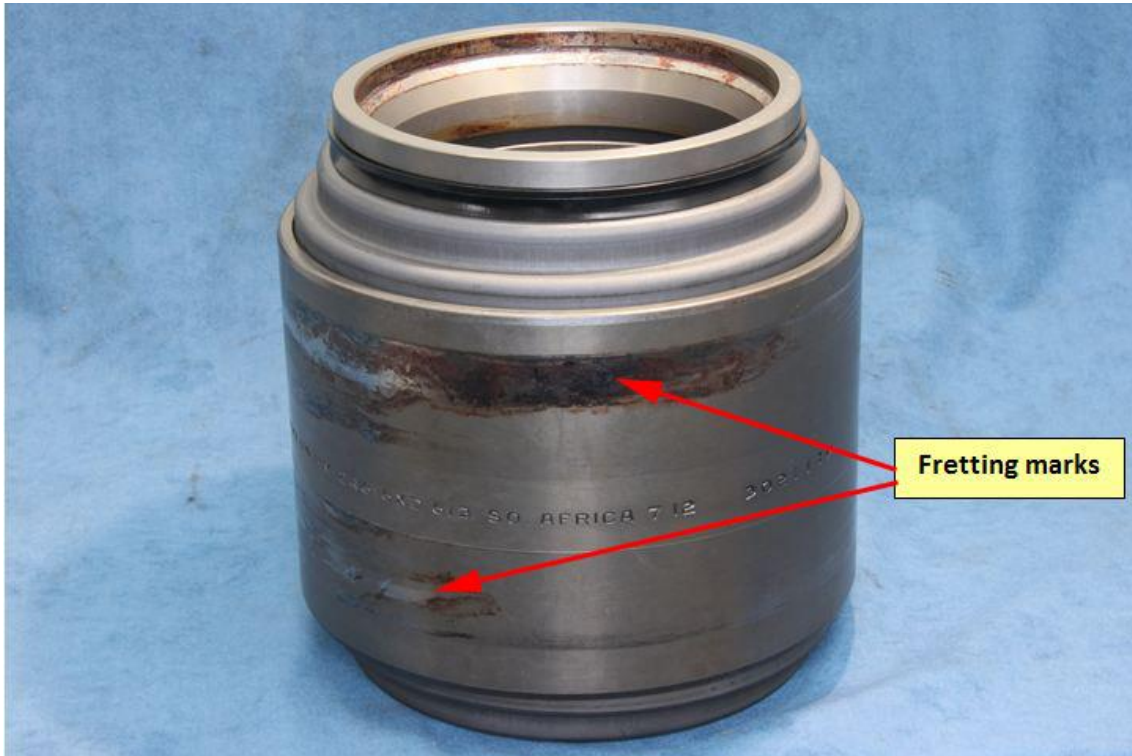
**Figure 9: Partner bearing (position 4) serial number 302111**

The swing-arm bearing housing showed heavy fretting wear that corresponded with asymmetric fretting wear on the bearing cup (Figure 9). Also observed, was the crack in the upper half of the bearing housing (Figure 10).

The corresponding fretting marks found on the partner-bearing cup was also evident on the partner swing arm.  
Source: ATSB

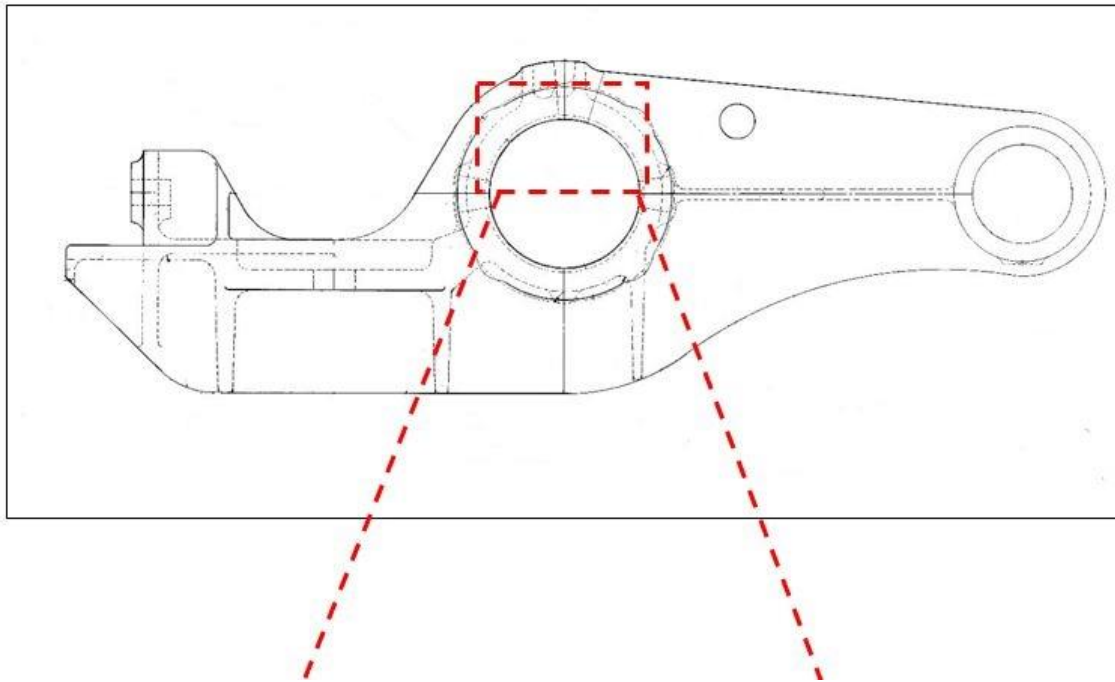
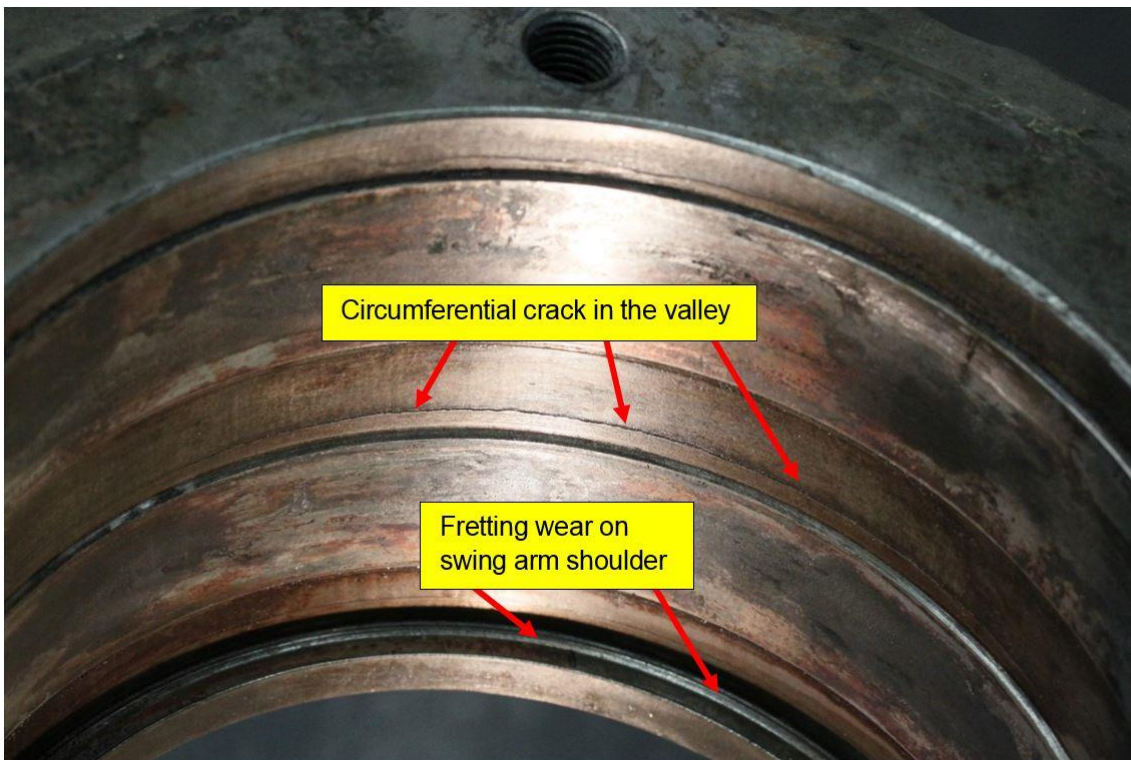
Figure 10: Swing arm assembly with exploded view of the bearing housing bore below

Figure 10 is of the partner swing arm (from the same axle). The exploded view shows the fretting wear on the swing arm shoulder evident by the shiny marks as annotated. As illustrated, there is also a crack in the valley of the housing. Source: ATSB

These wear patterns provided further evidence of uneven loading, possibly due to the axle misaligning when the axle journal failed and the opposite end of the axle became unsupported.

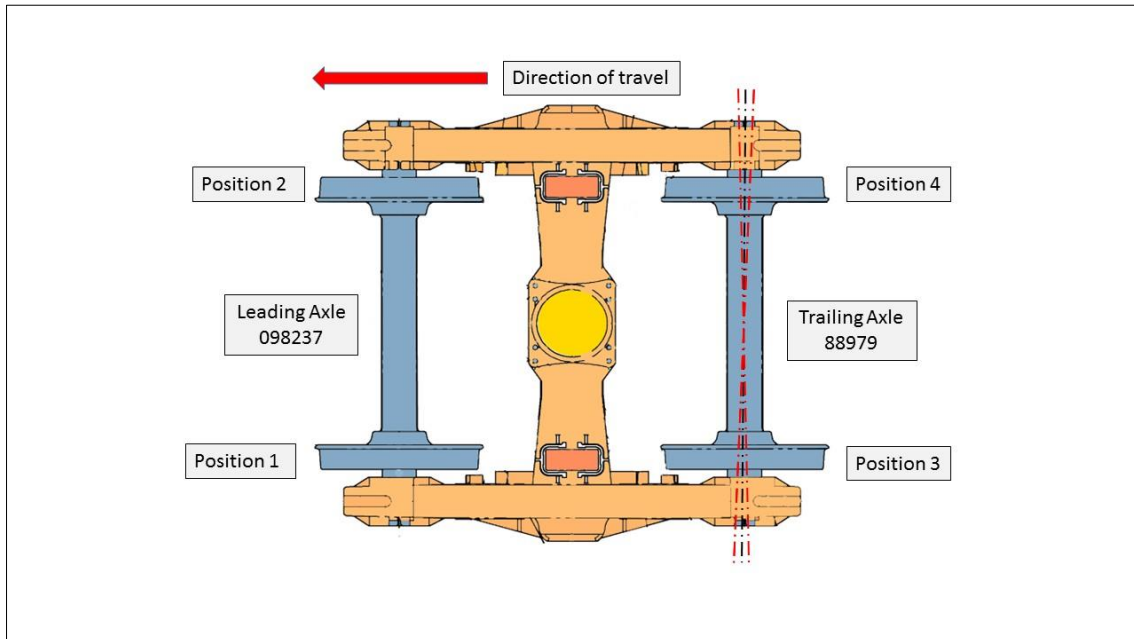
**Figure 11: Bearing position on bogie NHA-8B**

When matching the bearing cup witness marks to those in the swing-arm bearing housing, the marks ranged from a 9-3 o'clock position and were asymmetric in nature. This indicated that there might have also been some misalignment in the horizontal plane (Figure 11).

Figure 11 is for illustrative purposes and not a direct representation of an XPT bogie. The black dotted line on the trailing axle represents the centreline of the axle when running true. The red line illustrates a misalignment of the trailing axle, in the horizontal plane. Source: ATSB

The ATSB concluded that there was evidence of uneven loading. However, there was insufficient evidence to determine if the misalignment was predominantly in the horizontal or vertical planes.
