Shifted load collision with bridge

Great Western, Victoria, 9 December 2014

ATSB Transport Safety Report

RO-2014-022

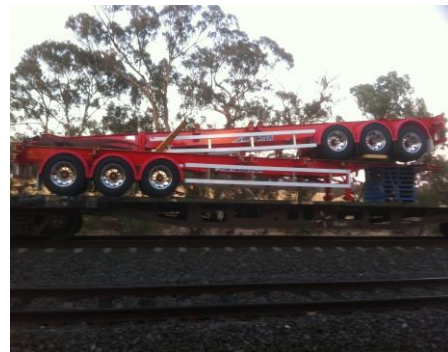
Shifted load on rail wagon

The ATSB found that, based on recorded data from wayside monitoring systems and the condition of the wagon's side bearers, it is likely that the wagon carrying the shifted load (PQMY4346V) was hunting. The hunting motion would be expected to increase the lateral forces on the load restraints. Compounding this, SCT's freight loading procedures did not specifically provide for the effective restraint and securement of commercial road transport vehicles for transportation on rail vehicles. Terminal staff responsible for securing and checking the load were not fully aware of the load securement requirements documented in the Rail Industry Safety and Standards Board (RISSB) *Code of Practice for the Loading of Rail Freight*.

SCT Logistics have issued a safety alert to all SCT managers and supervisors, reminding them of the freight loading Code of Practice requirements and instructing that only qualified and/or experienced staff are to perform the loading task.

SCT also addressed the mandatory replacement of wagon side bearers in accordance with the manufacturer's service bulletin.

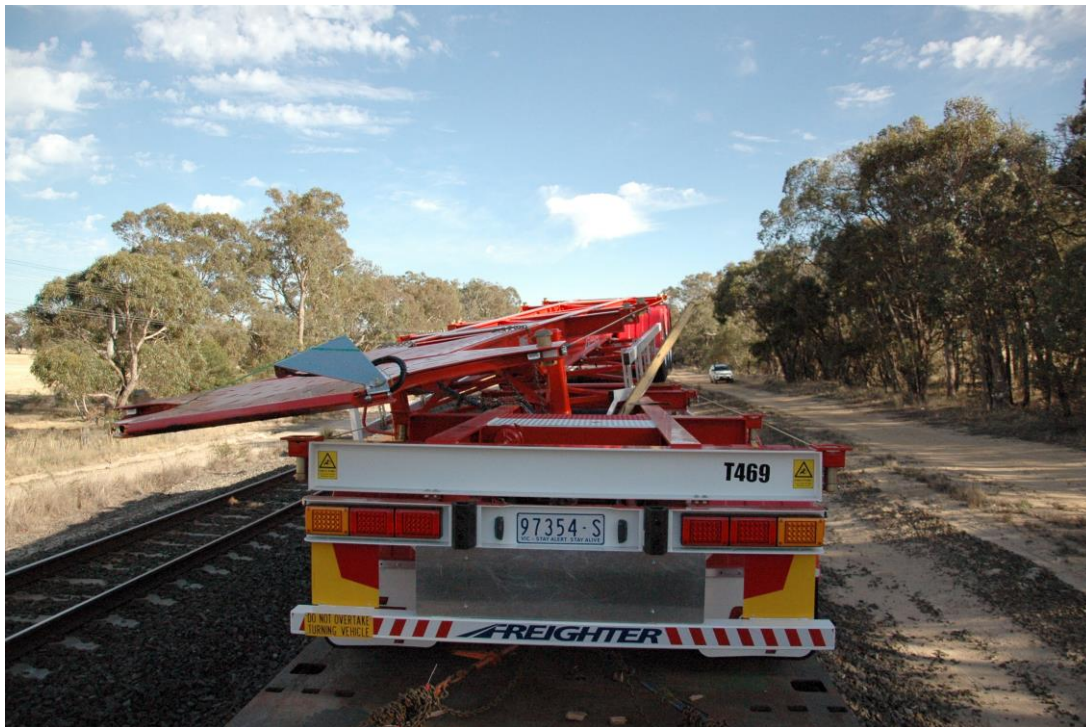
Figure 1: The shifted load

At some point in the journey, one of the skeletal road trailers moved, leading to the load protruding almost 2 m beyond the edges of the rail wagon (out-of-gauge) (Figure 1). An out-of-gauge load is a load that does not conform to a predefined loading outline.

The top road trailer had shifted to the left-hand-side in direction of travel. The movement was enough to strike the bridge infrastructure. Source: SCT Logistics

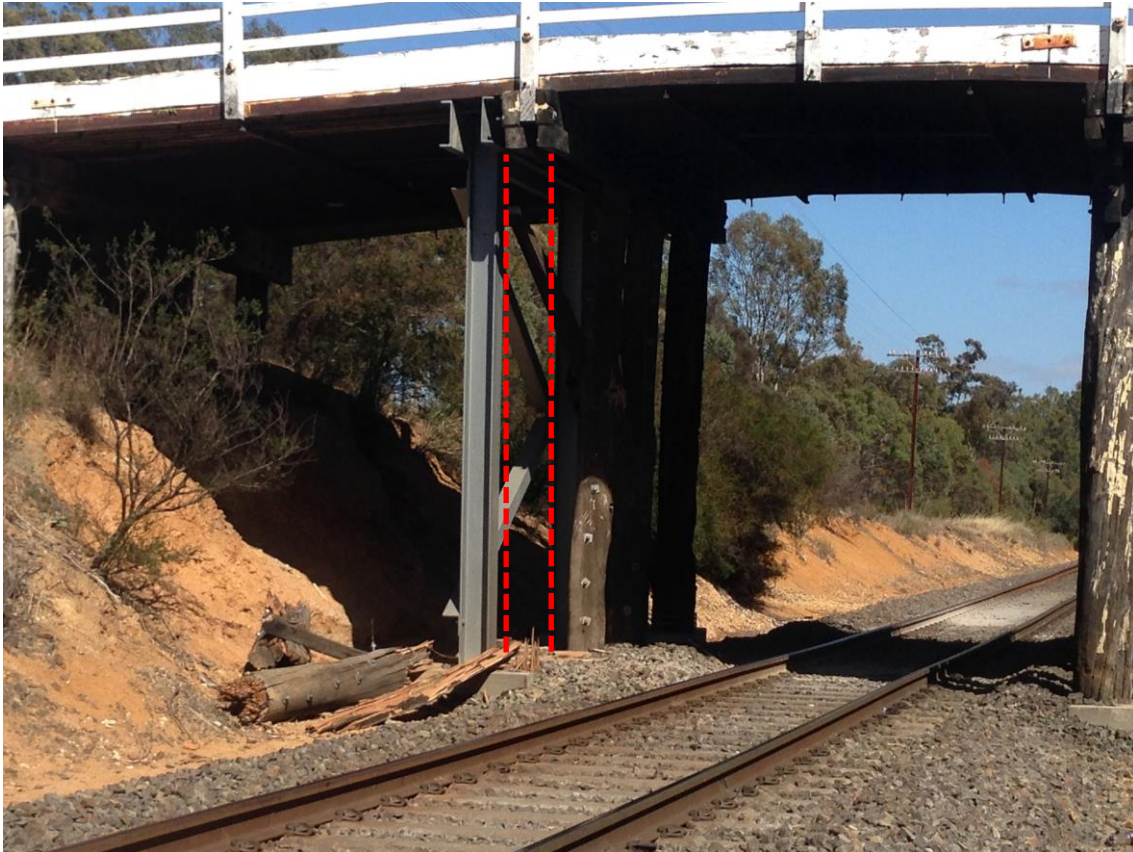
Figure 2: Paxton Street bridge damage

An examination of the over-rail bridge established that a timber pylon had been struck and destroyed (Figure 2). Accordingly, the bridge was cleared for rail traffic but remained closed to road traffic pending a subsequent structural engineering examination.

The shifted road trailer struck and destroyed the wooden pylon as indicated. Note however, the pylon was redundant due to an additional steel support structure installed at an earlier time. Source: SCT

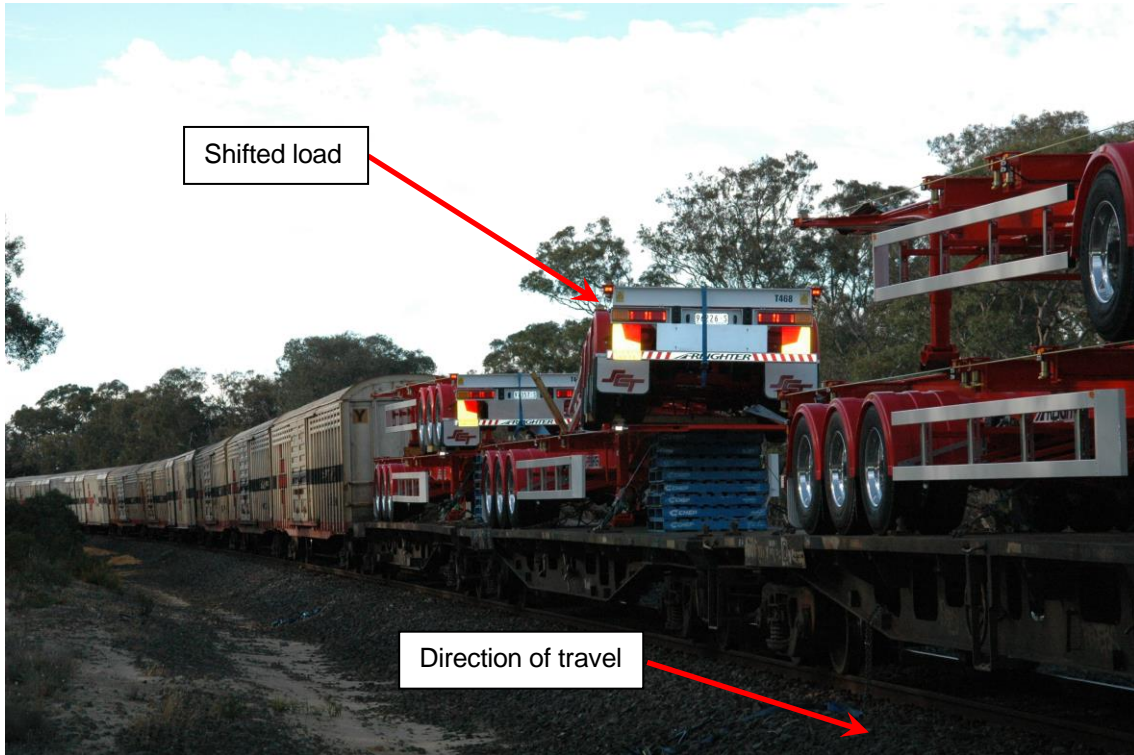
Figure 4: Trailer loading on train 2MP9

The shifted trailer (indicated) compared with similar loads on adjacent wagons. Source: SCT Logistics

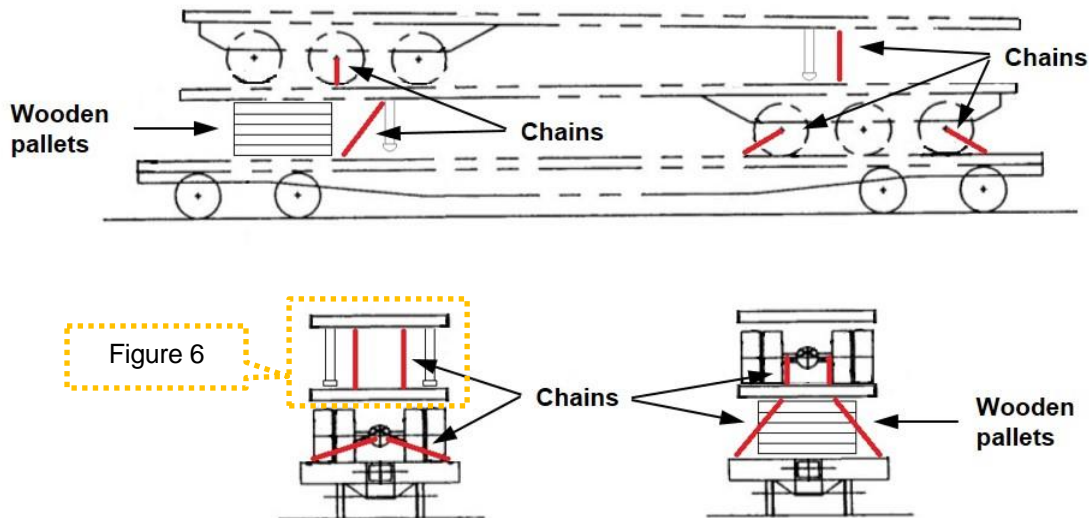
Figure 5: Securing of trailers on wagon PQMY4346V

Figure 5 illustrates the load and securing configuration for the double stacked road vehicles on the rail wagon. The red lines represent securing of the trailers to the wagon at the time of the incident. Source: ATSB

In this occurrence, the methods used to secure the lower trailer to the wagon (Figure 5) had provided limited restraint against longitudinal, lateral, and vertical forces. Most significantly, the upper trailer had only been restrained on the vertical axis, relying on the downward clamping (frictional) forces provided by the two forward hold-down chains to restrain the load against lateral or longitudinal movement.

- Road vehicles are (to be) secured as described in the Australian Code of Practice – Loading of Rail Freight (Appendix F – Road Vehicles).
- A copy of the Code of Practice MUST be available to all staff who are required to secure loading.
- Loading should only be undertaken by trained and / or experienced staff.

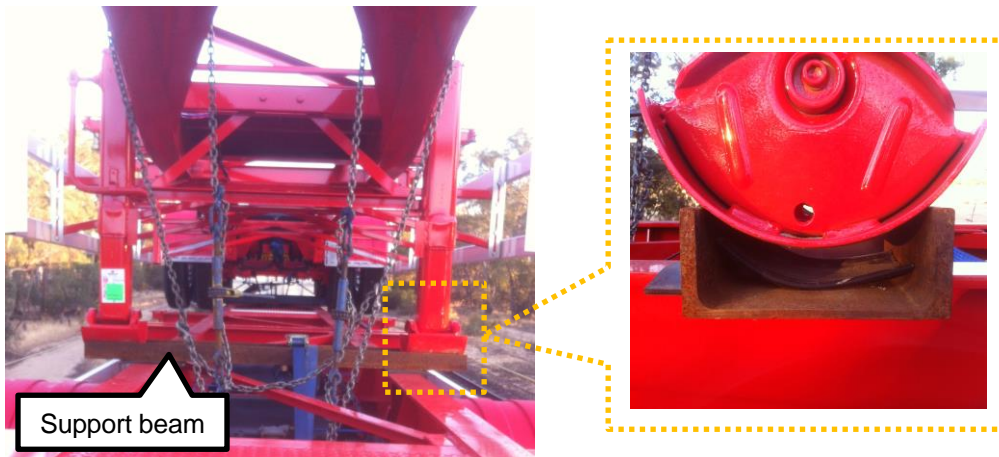
Figure 6: Securing of trailers

Figure 6 shows the securing chain unitising the two trailers together. Note the steel beam on which the trailer support stands sit. A similar beam was used as a wheel guide for the rear wheels. Source: SCT Logistics

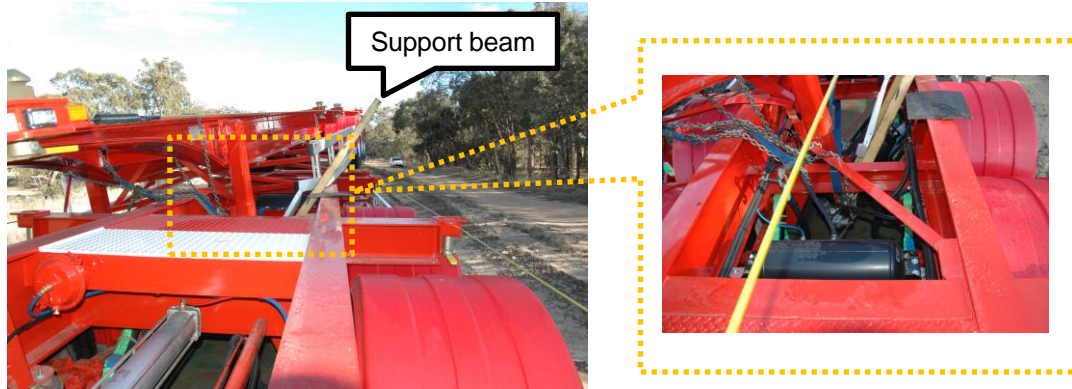
Figure 7: Collapsed trailer

Neither trailer had been secured sufficiently to prevent movement relative to the rail vehicle, as required by the RISSB CoP. This allowed the upper trailer stands and/or support beams to move laterally and subsequently collapse downward (Figure 7). When the upper trailer collapsed, the restraint chains became ineffective at restraining lateral movement, allowing the trailer to move further out-of-gauge.

Figure 7 shows the collapsed upper trailer and support beam. Note the securing point of the two forward hold-down chains on a lateral beam of the lower trailer. In this configuration, the potential existed for the chains to move laterally along the beam, contributing further to the lack of lateral restraint. Source: SCT Logistics
