Signals Passed at Danger by Train 1240

Marshall near Geelong, Victoria | 29 May 2015

ATSB Transport Safety Report
Rail Occurrence Investigation
RO-2015-009
Final – 12 December 2016

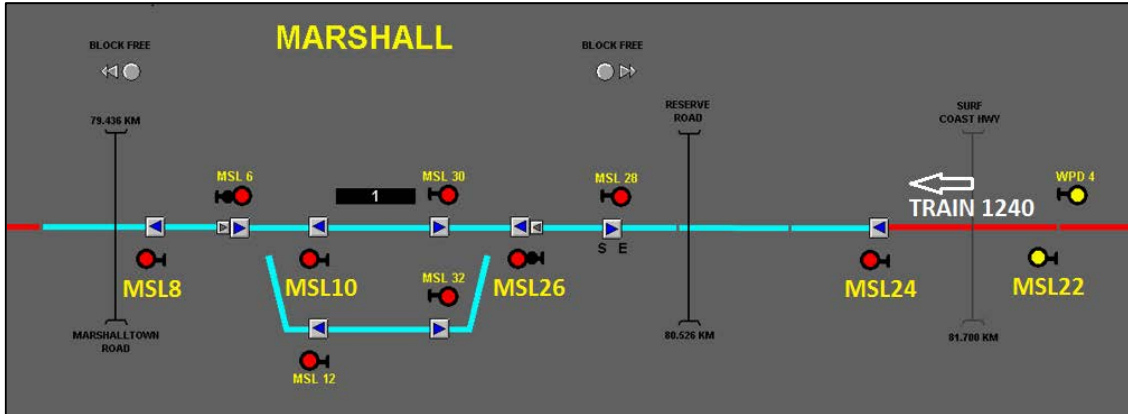
Distant signal MSL22 was at Caution when the train passed, and the signals ahead were at Stop (Figure 3). In response to the Caution indication of MSL22, the driver reduced the speed of the train from 83 km/h to 67 km/h.

Figure 3: Signal status when Train 1240 passed Distant Signal MSL22. MSL22 was at Caution (yellow), and other signals ahead were at Stop (Red). The red highlight on the line adjacent to MSL22 is indicating that Train 1240 is detected in the section.

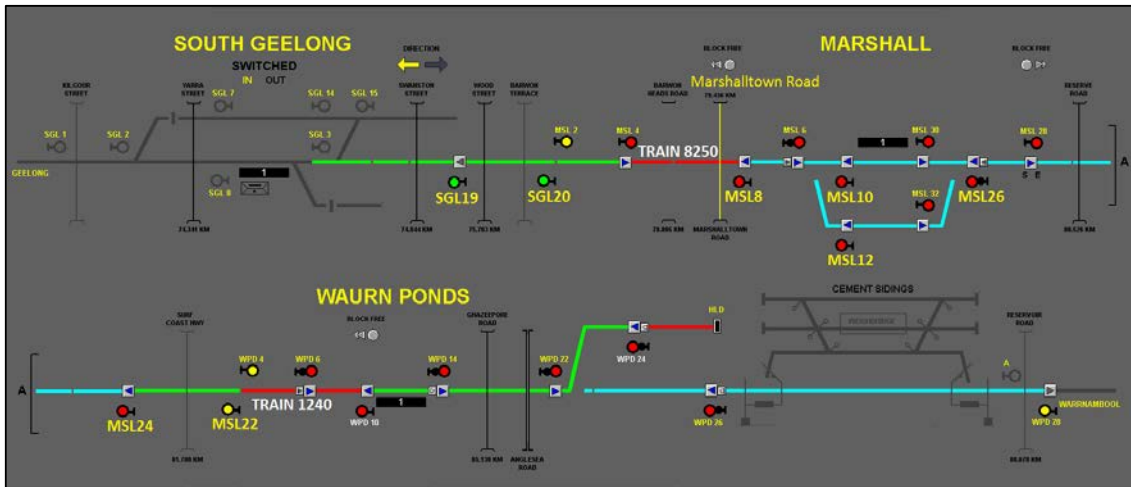
At about 1922 after departing the siding, Train 1240 was travelling between Waurn Ponds and Marshall (Figure 5). At this time Train 8250 (the train ahead) had passed through Marshall Station and the Marshalltown Road level crossing had activated (road shown highlighted yellow). Another train was in the Waurn Ponds siding waiting to follow 1240.

Figure 5: Extract of VDU screen at 19:22:07 showing train 1240 travelling between Waurn Ponds and Marshall, approaching Distant signal MSL22 at Caution. The signals through Marshall are at Stop. The train ahead (8250) has passed through Marshall Station.

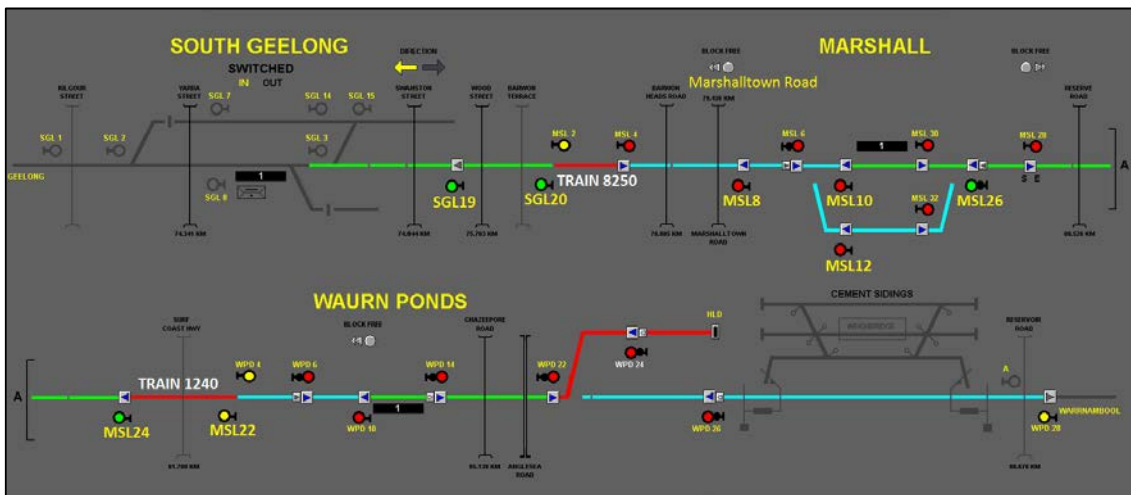
Before Train 1240 passed MSL24, Home signal MSL26 also went to Proceed (Figure 6). At this point, the train ahead was approaching the Distant signal for South Geelong (SGL20), that was at Proceed (Green). Because this train was still occupying the section between MSL8 and SGL20, signals MSL10 and 8 were not yet cleared to Proceed.

Figure 6: Extract of VDU screen at 19:23:05 showing MSL26 now at Proceed. MSL10 and MSL8 are at Stop.

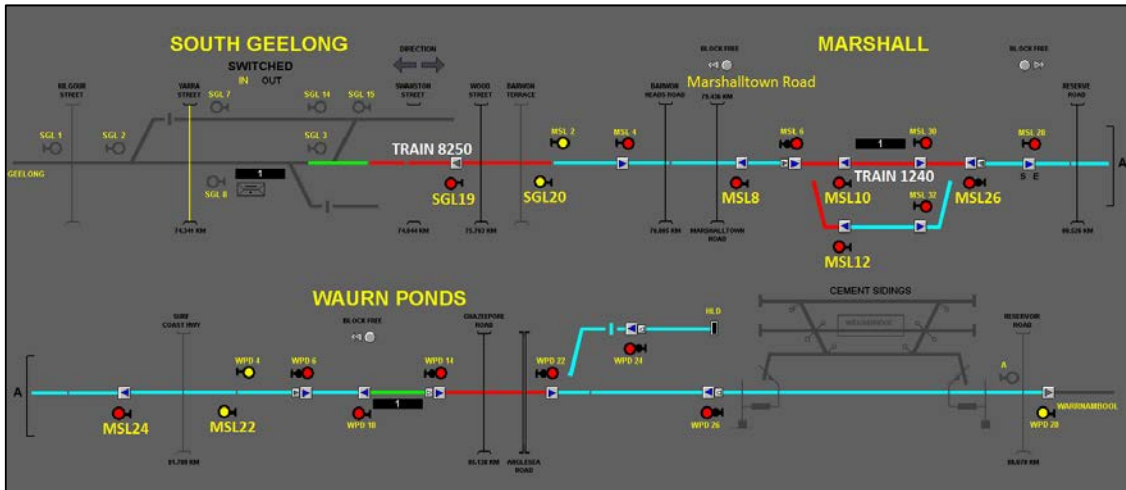
A few seconds later, Train 1240 had passed MSL10 at Stop (Figure 7) and was soon to pass MSL8 at Stop. Train 8250 was still progressing past SGL19. The headway between the two trains was such that Train 1240 needed to stop at Marshall to wait for Train 8250 to clear the section ahead.

Figure 7: Extract of VDU screen at 19:25:29 showing Train 1240 had now passed signal MSL10 at Stop.

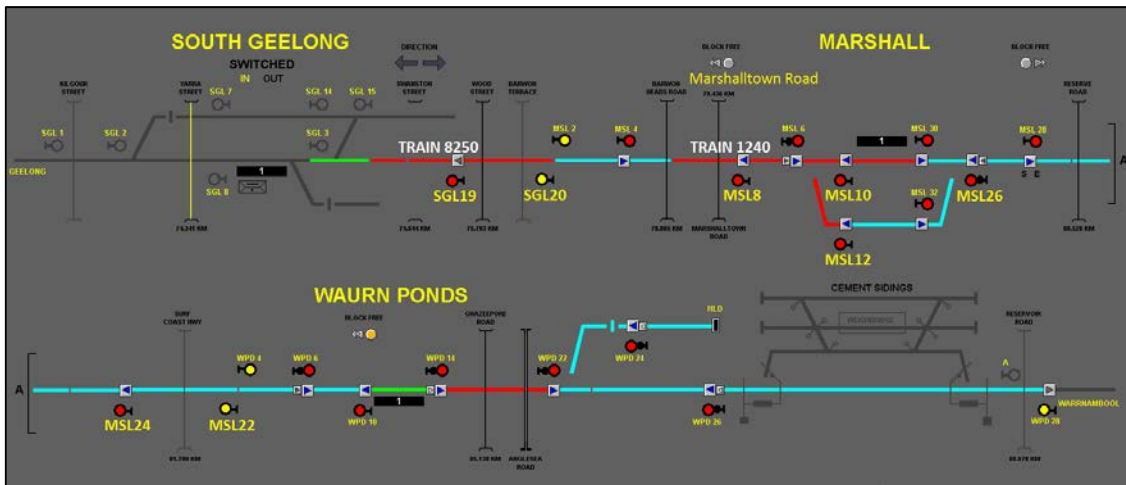
A short time later, MSL8 had also been passed at Stop (Figure 8). The Marshalltown level crossing protection was not yet active.⁶

Figure 8: Extract of VDU screen at 19:25:34 showing that Train 1240 has now passed signal MSL8 at Stop. The Marshalltown Road level crossing warning protection has not yet activated. Train 8250 has not completely cleared SGL19.

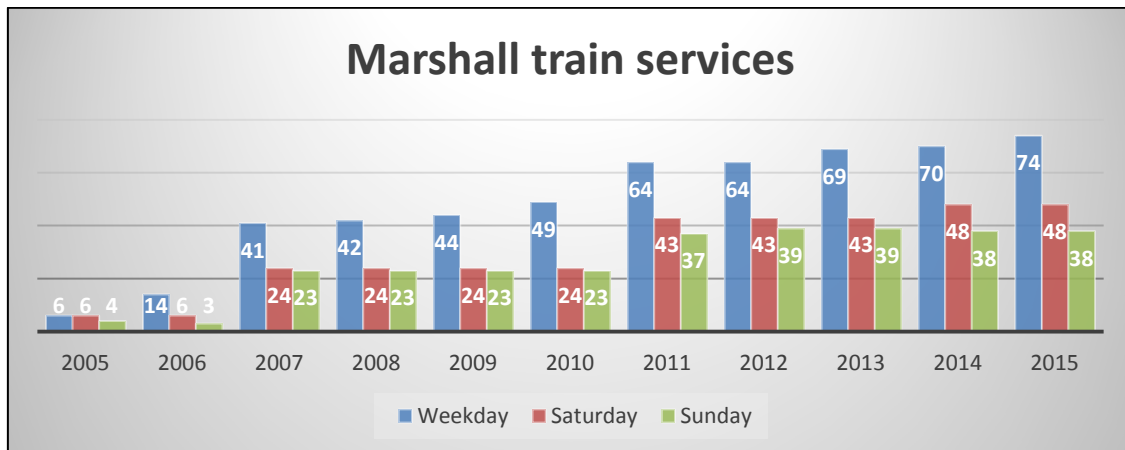
Figure 13: Passenger train services per day to or through Marshall (total)

When re-opened, the only passenger services through Marshall were the Melbourne-Warrnambool services. Commuter demand led to services through Marshall steadily increasing (Figure 13).

Marshall was re-established with infrastructure that catered for the relatively small number of passenger services. However, over a ten year period, rail traffic increased significantly (16 in 2005 to 160 services per week in 2015), altering both the operating environment and the risk profile of the location.
