Over-speed of V/Line passenger train 8625 over points at Wallan loop

Wallan, Victoria | 11 July 2015

ATSB Transport Safety Report
Rail Occurrence Investigation
RO-2015-011
Final – 11 July 2017

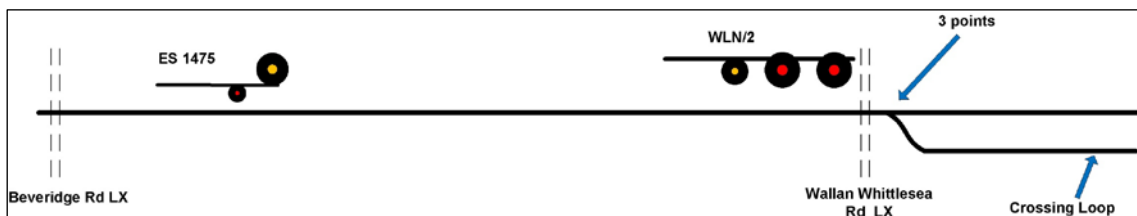
Figure 2: Signalling approaching Wallan

The above schematic shows the position of the signals, level crossings, and points. The signals show the aspects at the time of the train approaching ES1475 and WLN/2. Not to scale. Source: ATSB

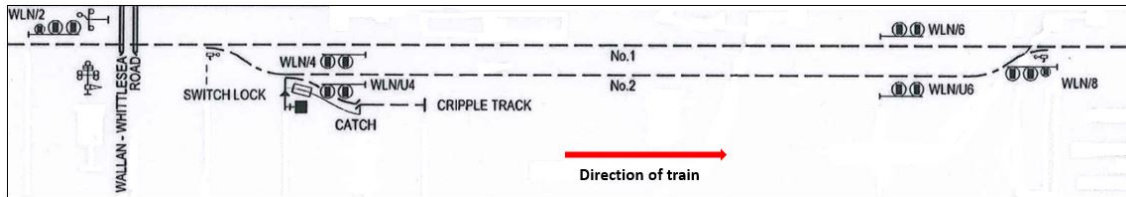
Figure 3: Layout of signalling at Wallan loop Standard Gauge.

Figure 3 shows the location of the signalling. Train 8625 arrived at Wallan from Melbourne (from left of figure 3) Once 8625 traversed the number 3 points the train came to a stand at WLN/U6 signal on the loop track (No.2 road) waiting for train 6WP2 to approach from the Seymour (right side of Figure 3) on the main line (No.1 road). Source ARTC

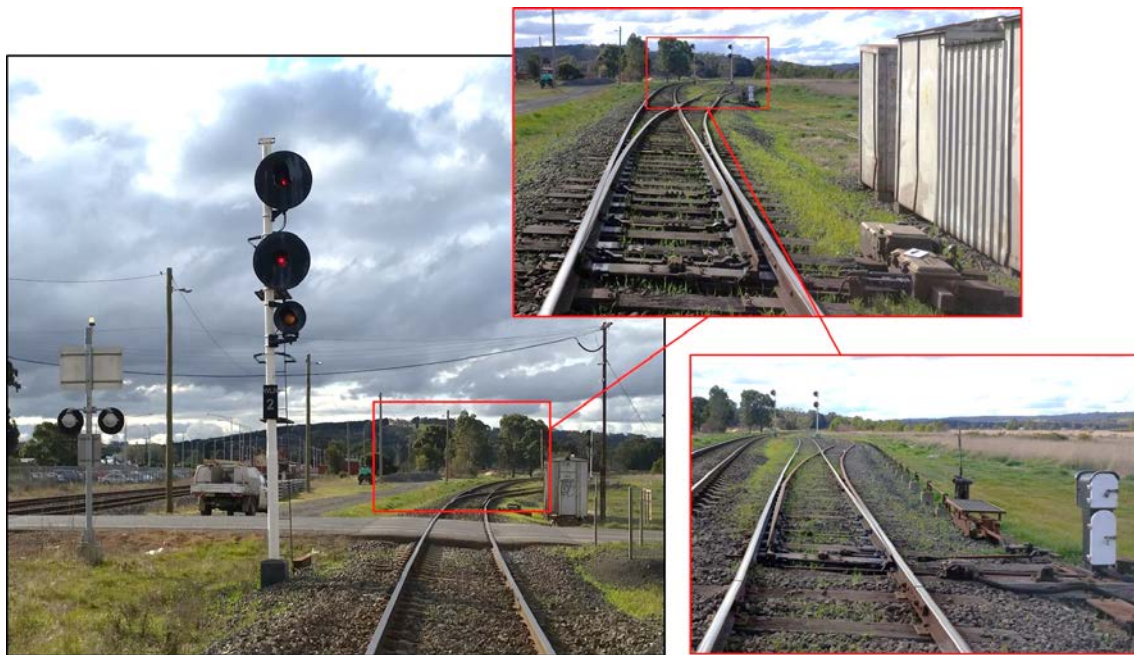
Figure 4: Approaching WLN 2 signal and 3 points into Wallan Loop road.

Figure 4 shows the location at and beyond WLN/2 signal over Wallan Whittlesea Rd and approaching 3 points with the signal and points set for the loop road. Note the low speed aspect (yellow) on the 'C' arm. At the time, 8625 was travelling over 90 km/h.

The top right call out box shows number 3 points in the reverse position and the loop road diverging to the right hand side.

The lower right hand call out box show the track layout beyond 3 points through the cripple road points (right hand side). Train 8625 was traversing the middle road (Figure 3 No.2 road) after traversing 3 points in reverse. Source: ATSB

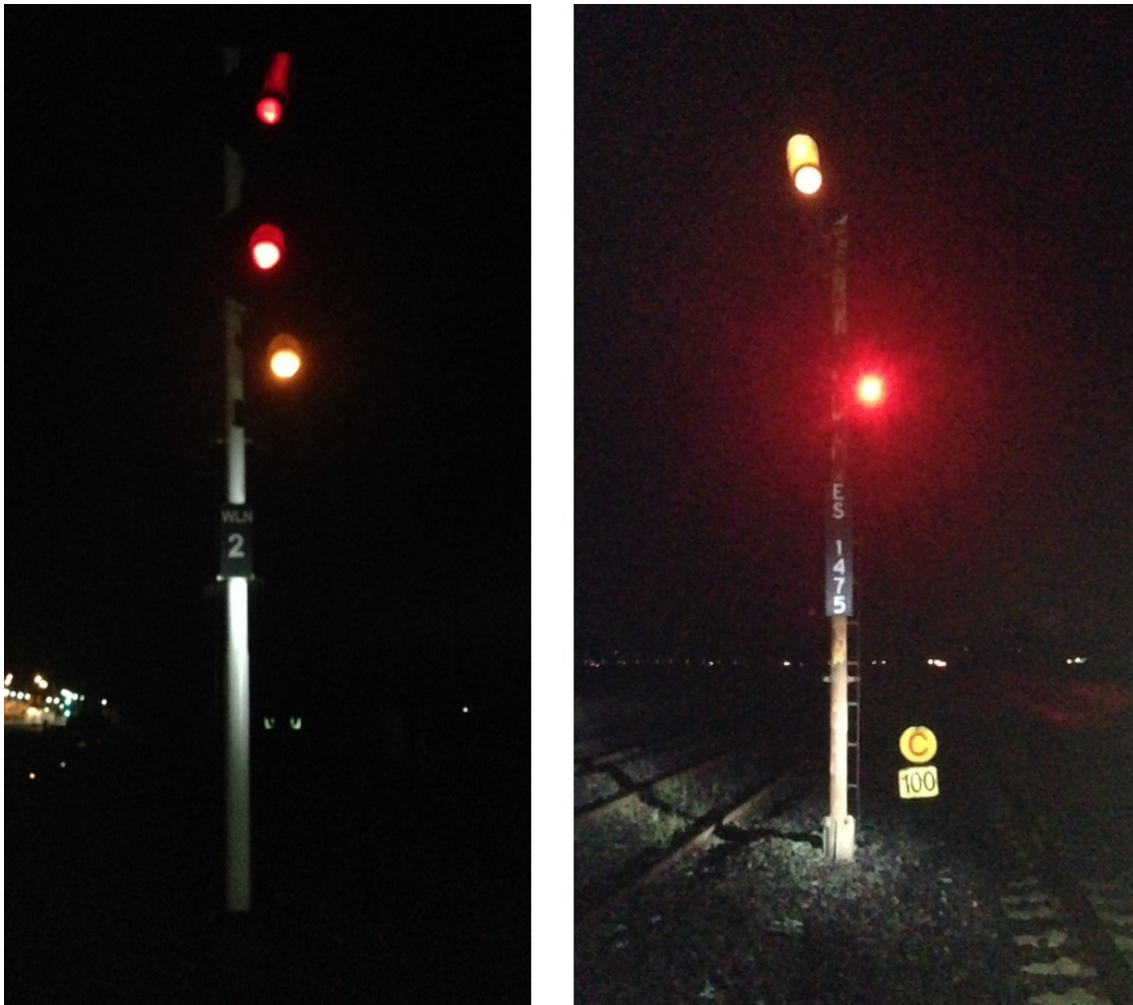
Figure 5: Signal WLN2 and ES 1475

Signals WLN/2 and ES1475 taken on the 7 July after the incident during testing of the signals. Signal WLN/2 is displaying a red over red over yellow aspect (Low speed). Signal ES1475 is displaying a yellow over red aspect (Normal speed warning). Both signals are displaying the aspects that the driver would have seen approaching Wallan. The 'A' arms on both signals are K3 (long-range) Searchlight signals. Source: ARTC.

The ARTC examined the operation of signal ES1475 and WLN/2 and number 3 points at Wallan Standard Gauge Loop. The tests concluded that the signalling and points equipment were working as per design at the time of the incident.

The ARTC conducted an inspection on the sighting distance of the signals. Both ES1475 and WLN/2 was found to be in good working order with no issue of sighting over the designed viewing distance.

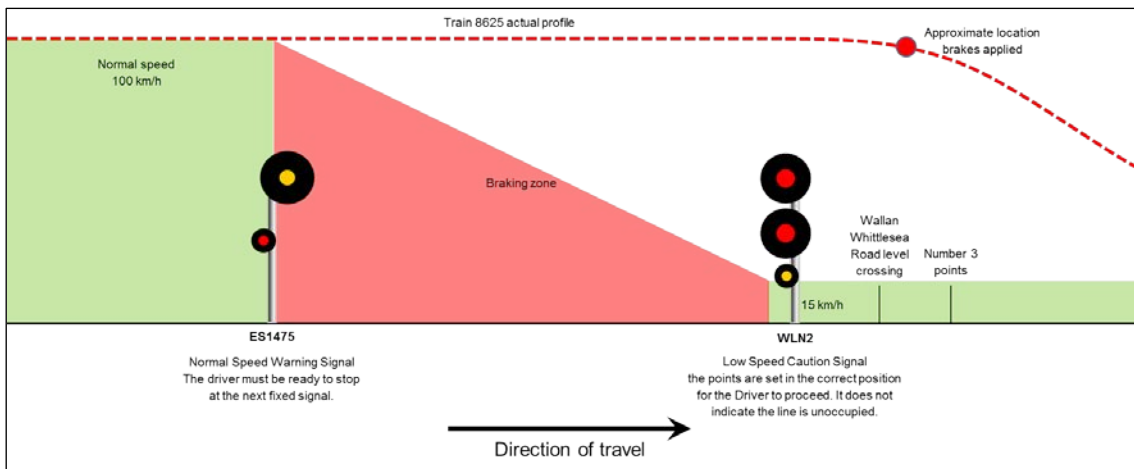
Figure 6: Typical speed profile versus actual speed

On approach to signal WLN/2 (about 200 m prior the signal), a low speed aspect would have been visible, indicating that a route had been set for the loop road (Figure 6). The driver must be prepared to stop clear of any obstruction and not exceed a speed of 15km/h.

Figure 5 illustrates the typical speed profile for a train being signalled into the loop compared to the speed data taken from the locomotive data logger. Not to scale. Source: ATSB.
