Derailment of freight train 532

Near Nala, Tasmania, 6 August 2015

ATSB Transport Safety Report

RO-2015-014

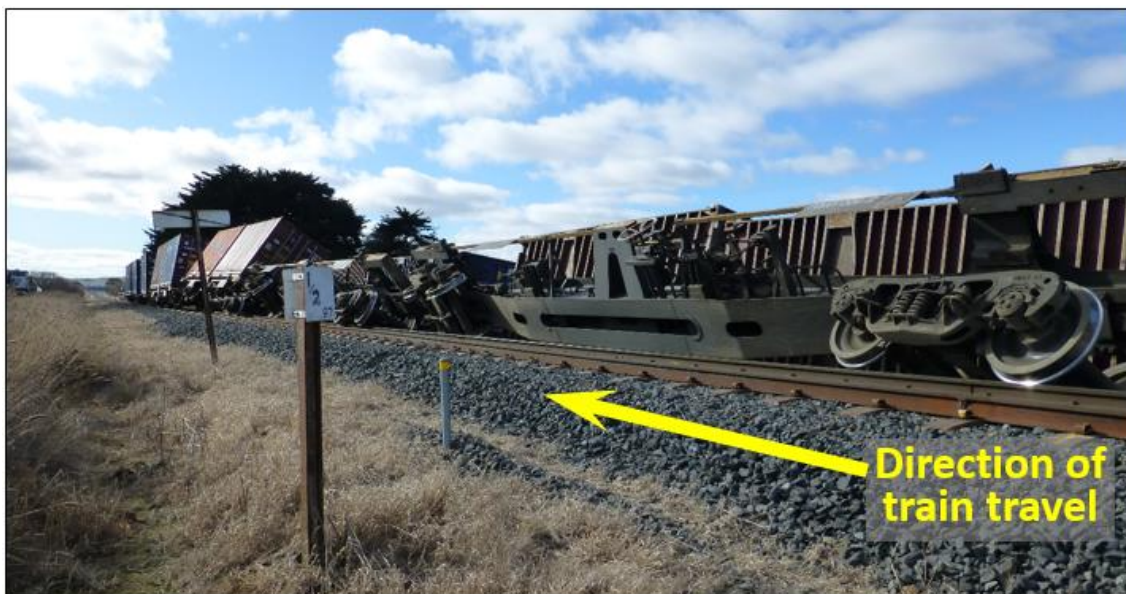
Figure 3: Rear part of train 532 adjacent 97.5 km post

The driver contacted train control to advise that the train had come to a stand just past the Nala Road railway crossing and had probably derailed. After speaking to train control and activating his personal alarm monitor, he detrained and walked the length of the train to inspect for damage. On completing the inspection, he returned to the cab and communicated with train control, advising that a number of wagons had derailed and that there was extensive track damage (Figure 3).

This most likely caused the wagons ahead to roll over, and wagons behind to derail, resulting in the multi-wagon pile-up shown at Figure 3. Wagon TQMF03G had travelled about 2.3 km beyond the initial PoD before coming to rest.

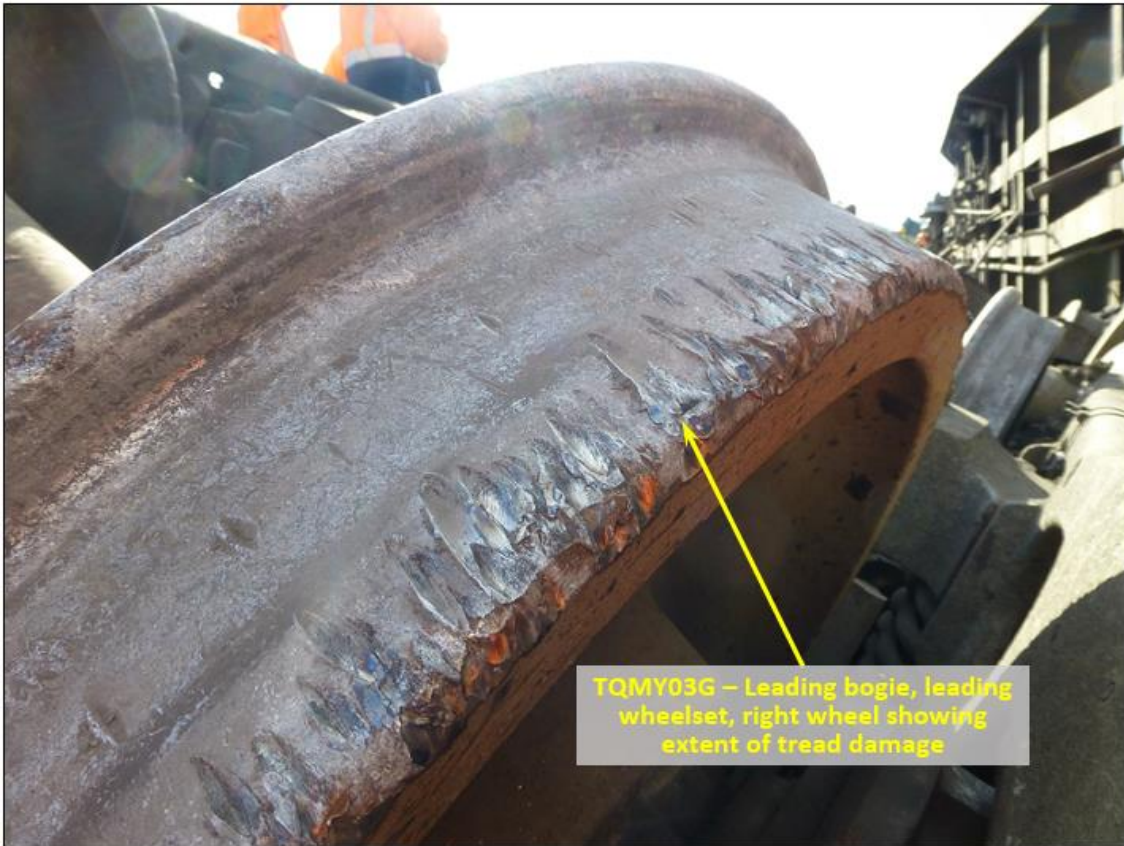
The first wheelset to show significant tread damage (Figure 5 and Figure 6), consistent with a wheelset riding on ballast over an extended distance, was wagon TQMF03G. It was concluded that wagon TQMF03G, located at position 21, was likely to have derailed first. The wagons ahead of TQMF03G (positions 14 to 20) had probably derailed later in the sequence, as train 532 negotiated a number of tight curves.

Figure 5: TQMY03G – Leading bogie, leading wheelset, right wheel (direction of train travel) showing evidence of extensive of tread damage

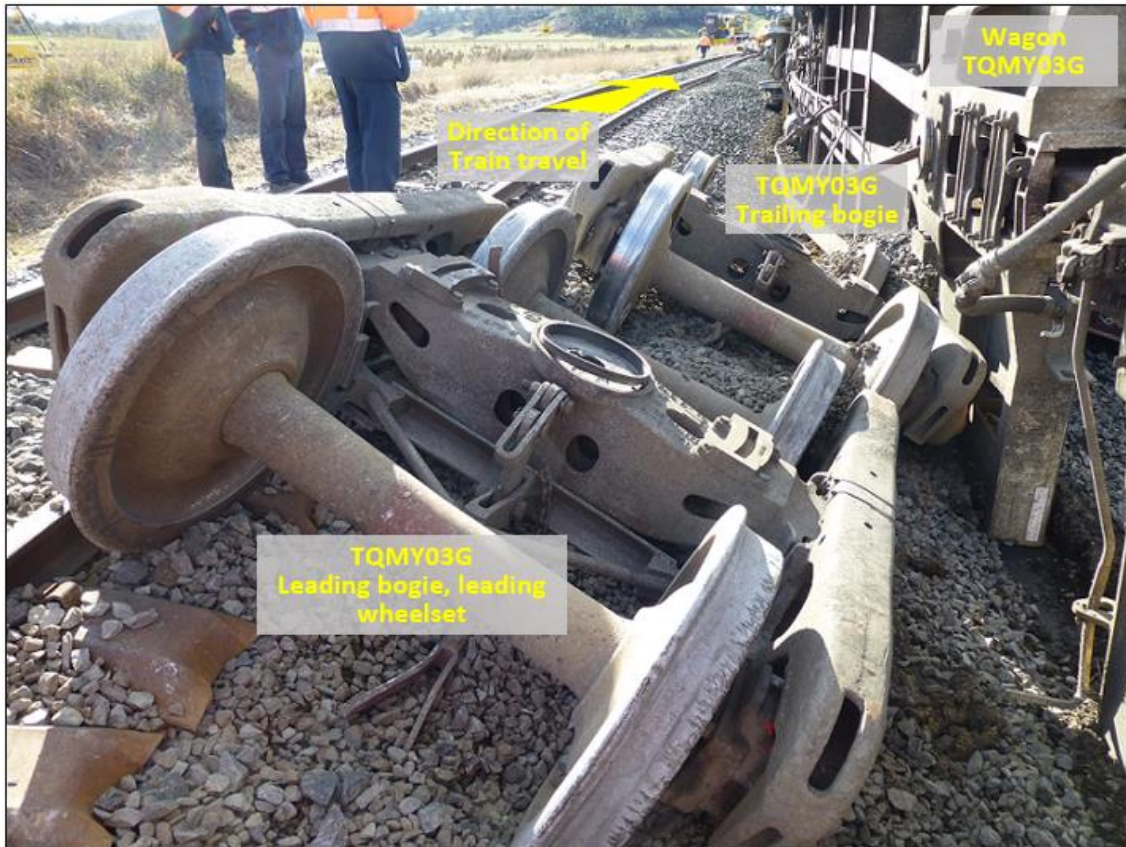
Figure 6: Derailed wagon TQMY03G (looking north) showing final positioning of bogies

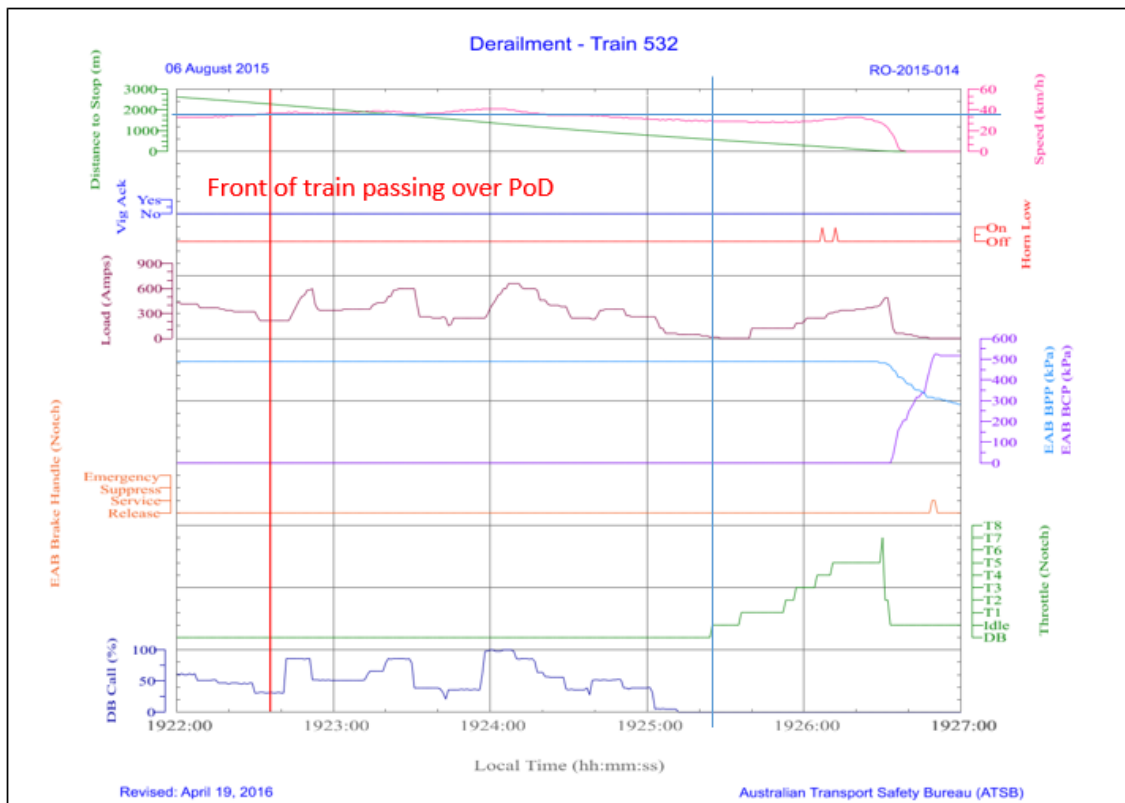
Figure 7: Graph derived from Wabtec loco-log data, lead locomotive TR15

A review of the loco-log data corroborates the driver’s recollection of events, and strongly indicates that train handling and driver performance were unlikely to have been factors that contributed to the derailment.

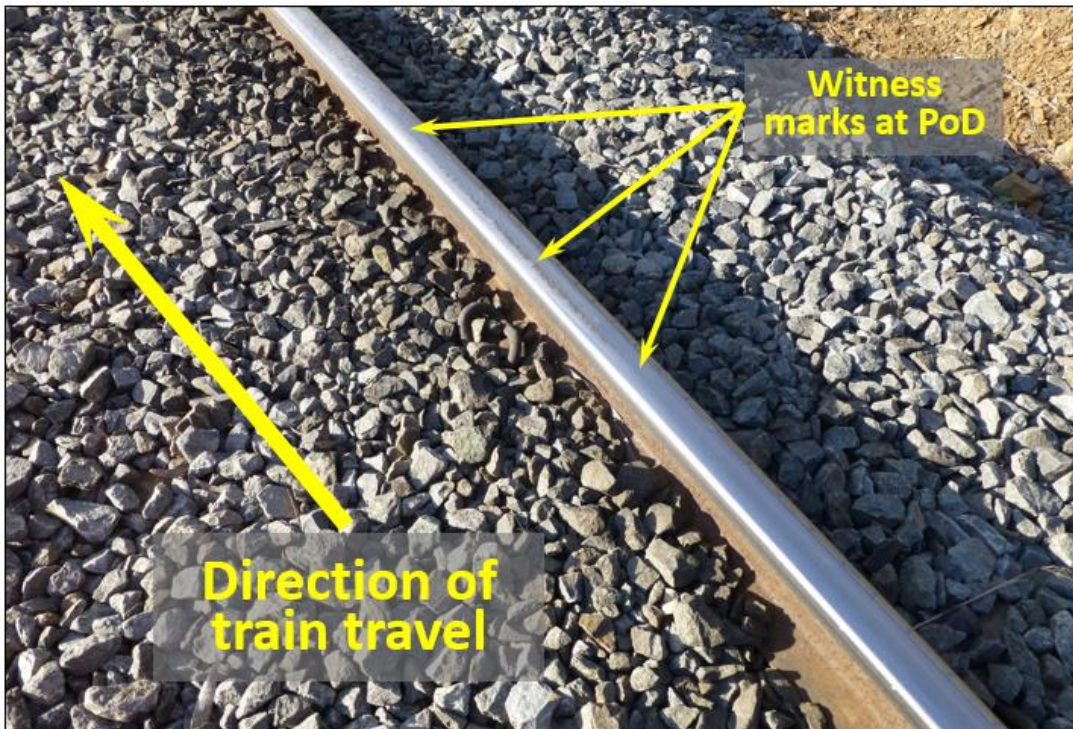
At the PoD there was evidence of flange climb,⁴ (direction of train travel) on the right side running rail, (high rail) followed by witness marks, over a distance of about 5 m, which is consistent with a wheel flange crossing over the railhead (Figure 8).

Figure 8: Witness marks at PoD (95.185 km) shown by line of arrows on railhead

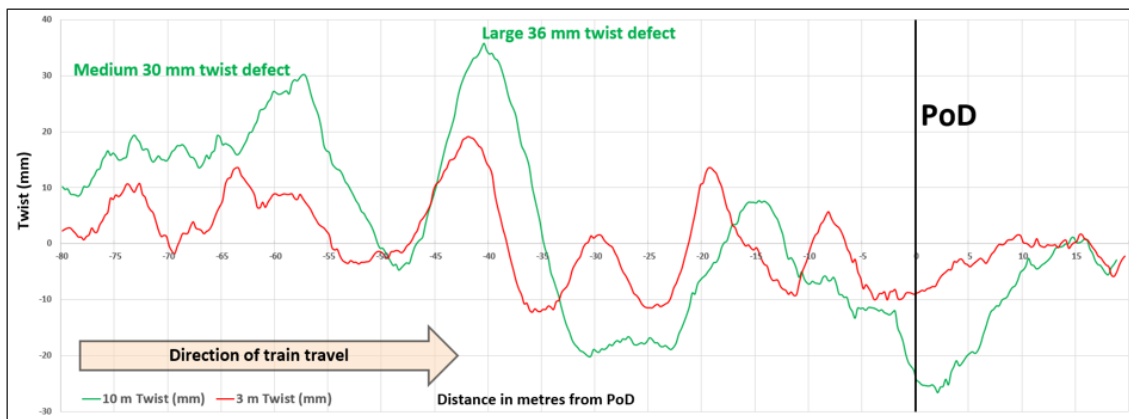
The post-derailment survey, undertaken by TasRail, measured a range of track parameters including track gauge, alignment, superelevation, twist and top. Figure 9 illustrates the geometry in terms of track twist⁷ – green line at 10 m intervals and the red line at 3 m intervals. The survey confirmed on-site visual observations that a series of geometry irregularities existed leading up to the point of derailment.

Figure 9: Twist measurements taken at derailment site (95.185 kps)

Post-derailment analysis suggests that the geometry defects observed following the derailment of train 532 were probably consistent with the defects identified on 3 August 2015. Twist measurements taken post-derailment (Figure 9) showed the existence of a (10 m) twist defect 30 mm (medium) in size, followed by a (large) 36 mm defect, located 60 m and 40 m, respectively, before the PoD. Closer towards the POD were a series of smaller yet significant defects, with a 26 mm (medium) defect at the PoD. The magnitude and cyclic nature of these defects, in advance of the PoD, would have initiated significant body roll in wagons as they travelled through the derailment site.

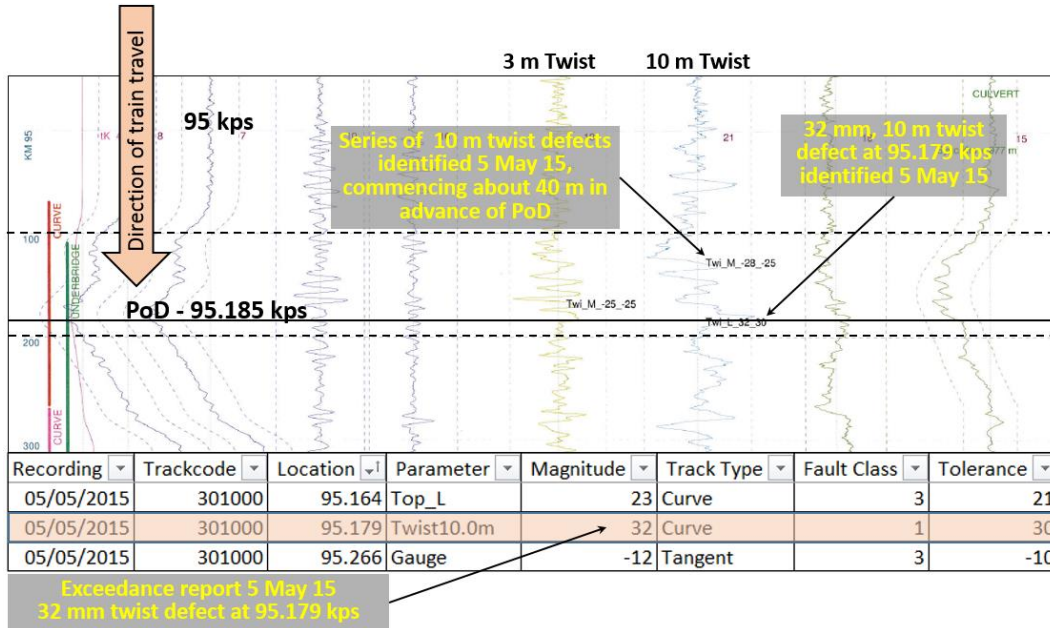
Figure 15 (top portion) is a graphical extract of that track geometry car report of 5 May 2015. It shows a series of twist irregularities before the 95.185 kps location. The largest was a 32 mm twist defect at the 95.179 kps, close to the POD. The twist defect was categorised as a priority 1 defect and recorded in an exceedance report (Figure 15 – bottom portion). TasRail’s maintenance records show no evidence of any corrective action in response to this priority 1 defect.

Figure 15: Extract of track geometry car, report of 5 May 2015 near PoD (95.185 kps)
