# Derailment of freight train MB520

Pangela, NSW, 28 August 2015

**ATSB Transport Safety Report**  
Rail Occurrence Investigation  
RO-2015-015  
Final – 30 June 2016

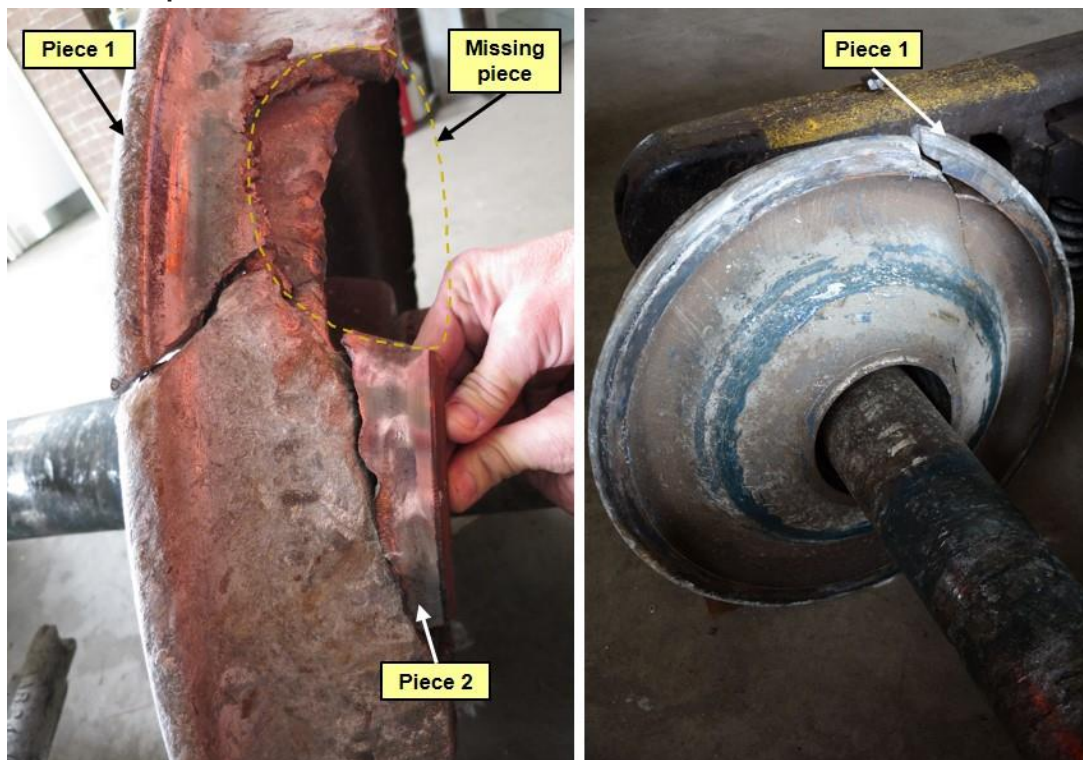
**Figure 2: Wheel pieces from failed wheel found in ballast**

The derailed bogie continued causing damage to over 590 metres of track including 963 sleepers. Pieces of the wheel detached and were later found on the track (Figure 2).

One significant piece of the failed wheel was not found. This piece was likely the first piece to break away and the reason it was not found may be that it occurred sometime in the days leading up to the derailment. It is possible this missing piece might have been the cause of the increase in impact readings in the lead-up to the derailment.

During the site inspection, pieces of the failed wheel were found in the ballast. One piece was found 7 m forward of the point of derailment on the Down side of the track. Another piece from the wheel, brake blocks and brake block keys were found inside the four foot. An unsuccessful search was conducted for another large piece from the failed wheel.

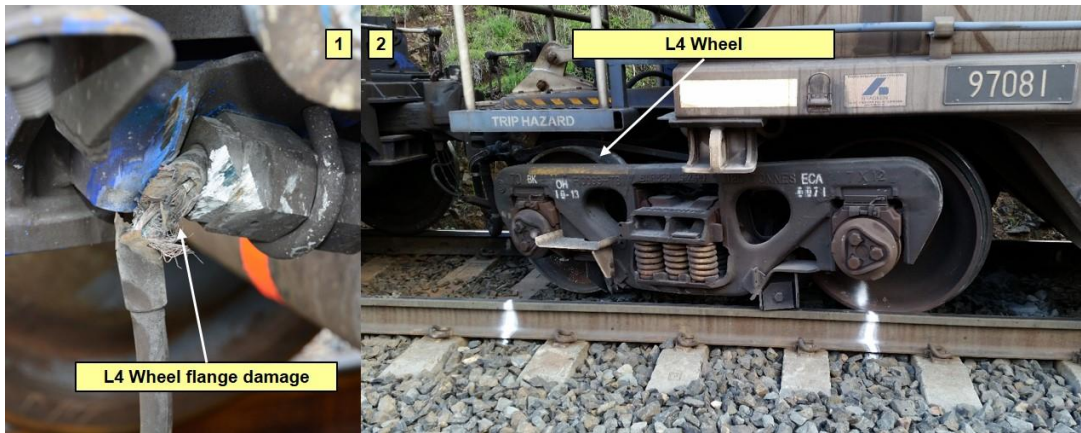
**Figure 3: Damaged Electronically Controlled Pneumatic train line brake cable**

*During the derailment the L4 wheel rubbed against, and damaged, the ECP cable causing the train to come to a stop.*

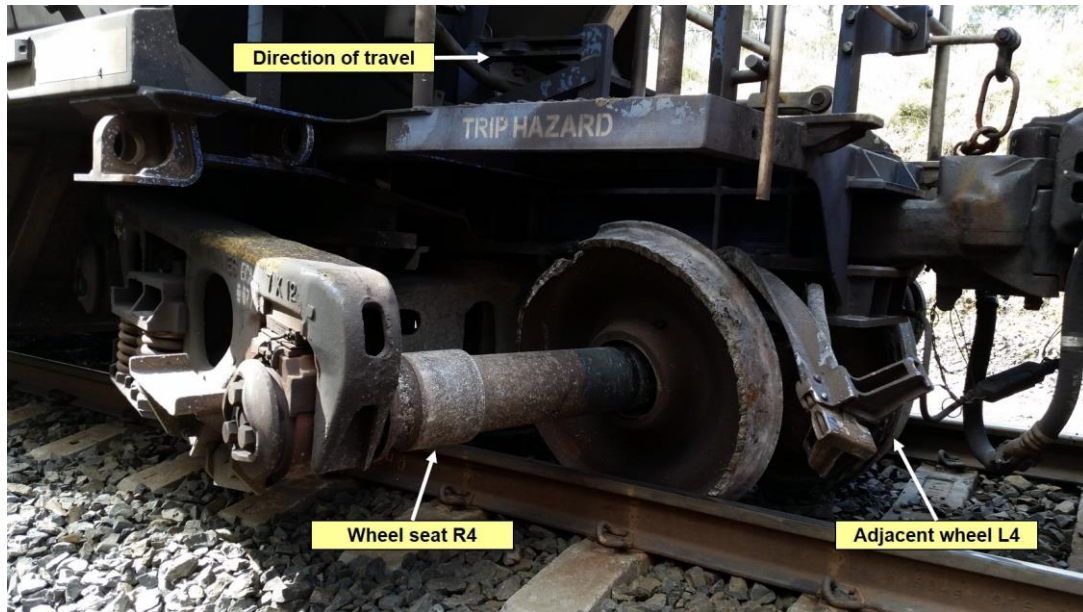
**Figure 4: Derailed bogie viewed from Down side of track**

As the train was descending towards Pangela at 24 km/h, the front right wheel (R4) failed on the 19<sup>th</sup> wagon (NHIH97081). This resulted in a loss of the interference fit<sup>3</sup> between the wheel and the axle, which allowed the wheel to move inwards along the axle. The point of derailment was at 360.829 km. The derailment of the R4 wheel caused the bogie to rotate and derail the other three wheels. The other paired wheel on the front wheelset (L4), rotated to the extent that it started rubbing against the electronically controlled pneumatic (ECP)<sup>4</sup> train line brake cable. The abrasion of the cable caused the three locomotives to lose power and return the locomotives to idle.

*This shows the derailed bogie and the failed wheel that moved off the wheel seat towards the centre of the axle.*

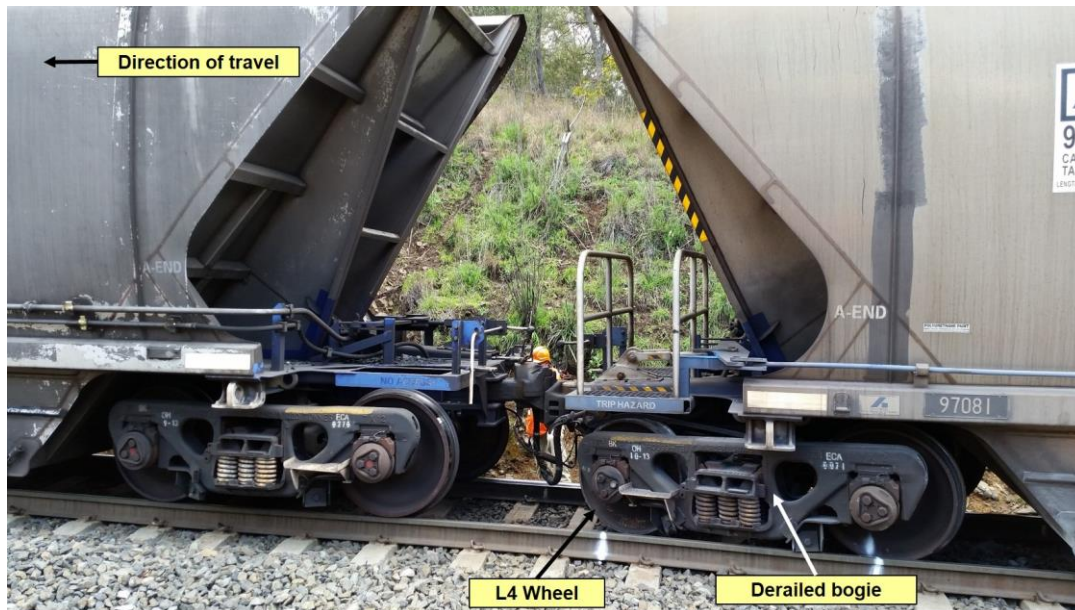
**Figure 5: Derailed bogie viewed from Up side of track**

*This shows the derailed bogie at the point the train came to a stand.*

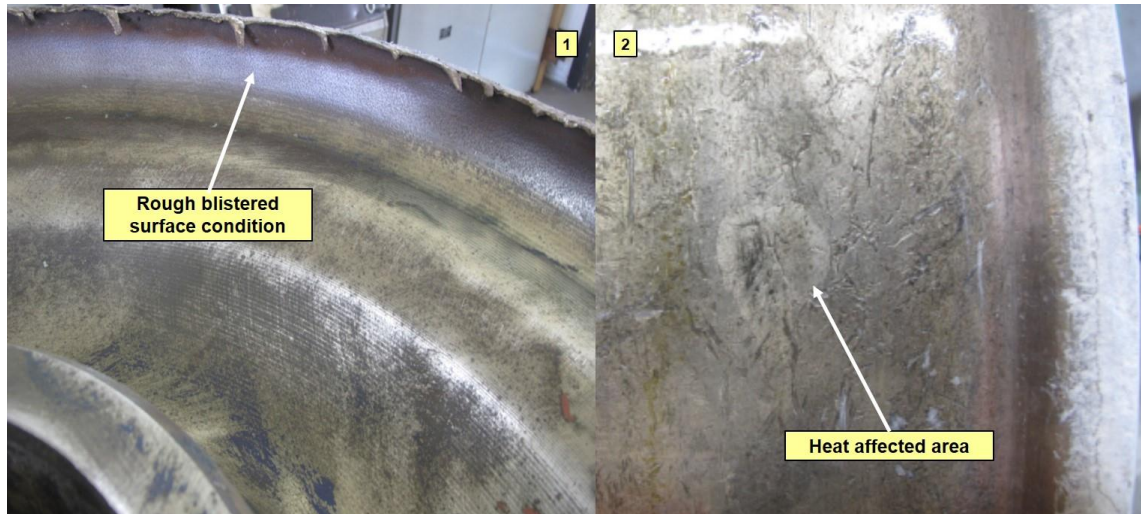
**Figure 9: Heat indications on wheels**

The paired wheel on the wheelset was also examined but no thermal cracks were detected on its wheel tread. This suggested that, at some time prior to the crack formation, there was uneven distribution of braking energy between the two wheels on the wheelset. The appearance of the rough/ blistered /corroded surface on the inner rim of the failed wheel supports the likelihood that

there was thermal loading on the wheel rim (Figure 9-1). There were indications on the paired wheel of a white etching layer (Figure 9-2), this is usually indicative of a heat-affected area possibly also caused by a braking event. It appears further away from the rim edge than those classified as near rim edge and has no crack indications. No heat-affected areas of this type were found on the failed wheel, but this evidence would likely have been removed due to the gouging of the wheel after the derailment when it was dragging in the four foot.

*Image 1 shows the surface condition that may indicate overheating of the wheel rim of R4. Image 2 shows an area of white etching layer on the paired wheel L4, which was indicative of a heat affected area.*

There was no evidence of any problem with the brake mechanism or brake blocks on bogie NECA71. In addition, there was no record of wayside alarms for high wheel temperature for the wagon. This increases the likelihood that any thermal loading event would have occurred under service brake conditions.

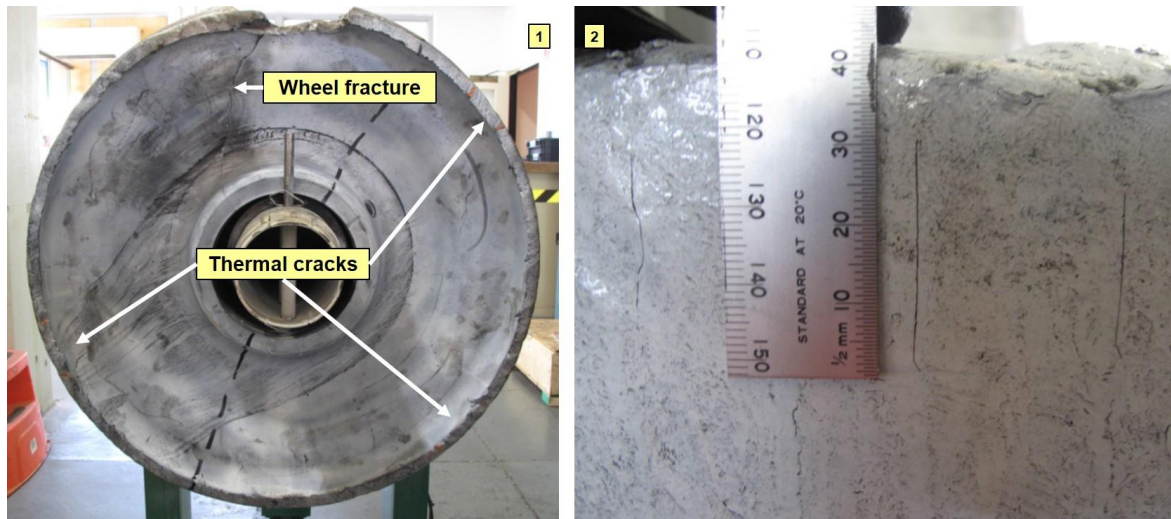
**Figure 10: Thermal cracks identified during metallurgical analysis**

The metallurgical report concluded that multiple thermal cracks had initiated in the wheel rim. A magnetic particle inspection revealed six thermal cracks at a number of locations around the circumference of the wheel tread. It also found two cracks in the wheel rim. One of the thermal cracks progressed by fatigue until it extended from the rim to the boss of the wheel and was responsible for the loss of the interference fit between the wheel and the axle, which allowed the wheel to move inwards along the axle and initiate the derailment. The other crack extended 90 mm from the rim into the rim.

The report stated: 'It is highly suggestive that the fracture was initiated by a transverse thermal crack in the wheel tread. This type of transverse thermal cracking is typically cause by excessive localised thermal load into a vulnerable region of the wheel tread and is generally associated with abnormal braking load.'

The metallurgical report found that the failed wheel was approaching the end of its service life with a rim section 25 mm thick. This thin rim section leads to lower rim rigidity and, hence, higher propensity to unusual thermal distortion and would be a significant contributing factor into the thermal crack formation and propagation. Examples of thermal cracks identified by Comsteel during the metallurgical analysis are shown in Figure 10.

Image 1 shows the location of the thermal cracks in relation to the fracture. Image 2 identifies thermal cracks located on the front face of the wheel tread.

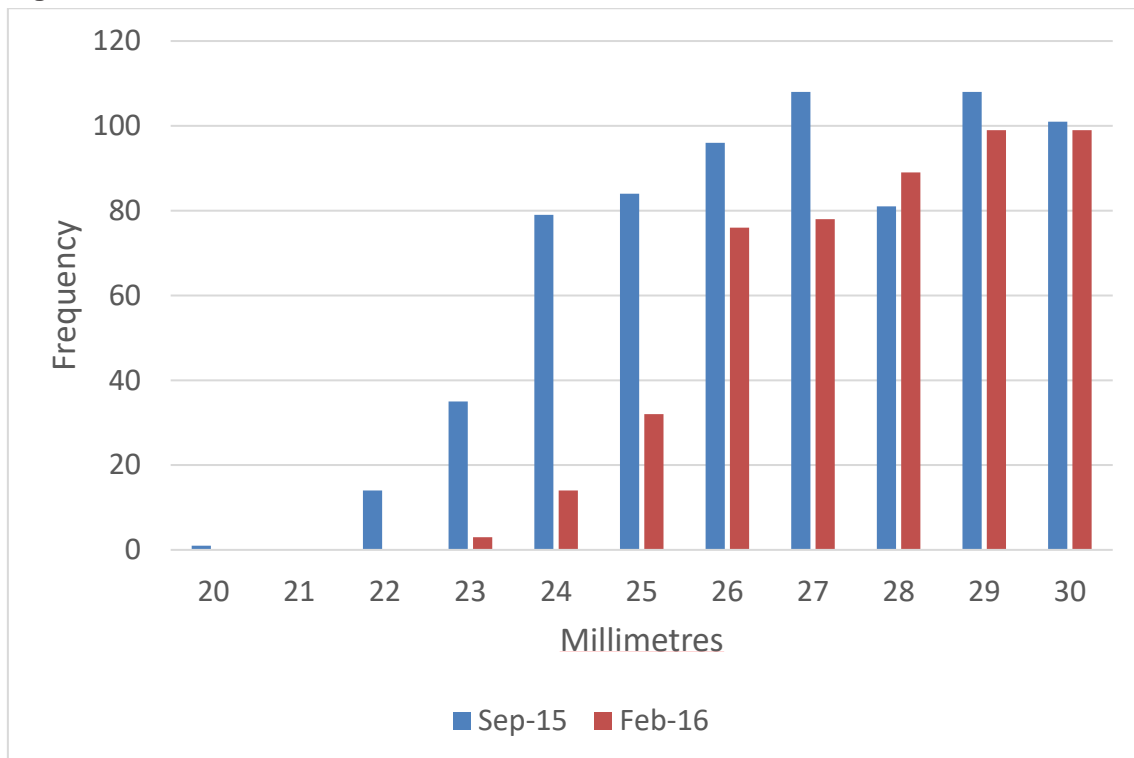
**Figure 13: Wheelset rim thickness 30 tonne axle load coal fleet**

The change in the Pacific National wheelset rim thickness in the 30 tonne axle load coal fleet from just prior to the derailment in September 2015 to February 2016 is shown in Figure 13. The lower range of rim thickness from 20 mm to 30 mm was selected to be shown as it is the area of most concern, the upper range from 31 mm to 57 mm is not shown. The graph shows the progress of the removal of the bottom range of wheel rim thickness.

Pacific National acknowledge that increasing the minimum rim thickness would assist with reducing stresses in the wheel and may act to prevent further failures. Pacific National did not review the application of this value until after the derailment. Pacific National advised that they had implemented various strategies to reduce the incidence of wheel failure. These strategies include:
