# Collision involving road-train truck and train 8834N

near Narromine, New South Wales, 23 September 2015

**ATSB Transport Safety Report**

RO-2015-016

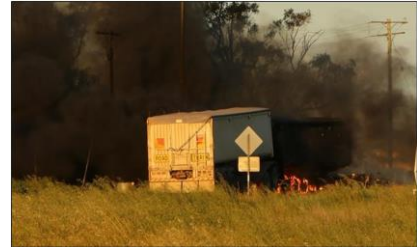
The collision and a post-impact fire destroyed the prime mover and one of the two trailers; the truck driver was fatally injured. The crew of the train were physically unhurt. As a result of the impact two wagons, were damaged, one of which derailed. Some of the railway crossing infrastructure (flashing lights) was destroyed and required replacement.

Road-train truck at collision site

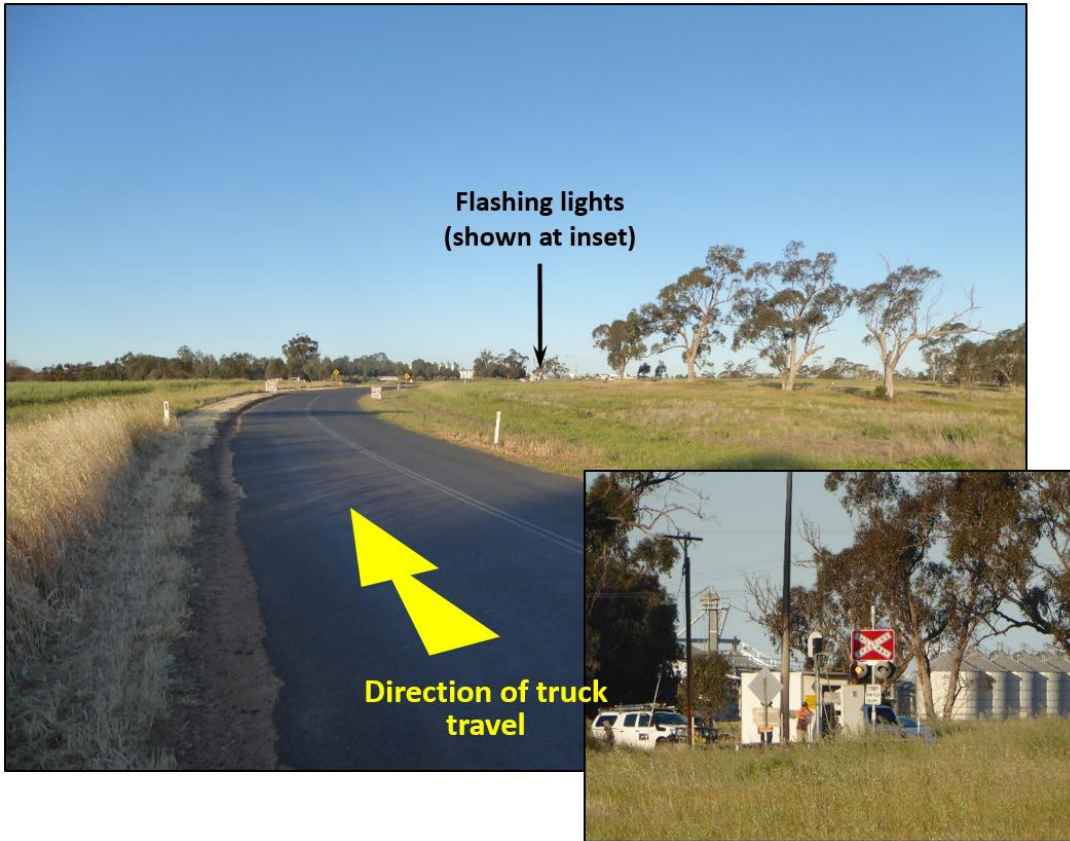
**Figure 4: View approaching railway crossing at 300 m (Inset 30 x zoom)**

As 8834N approached the Tullamore - Narromine Road level crossing, the train driver observed the 'Main Line Indicator' displaying a pulsating white light, signifying that the level crossing equipment was set for the passage of the train. At 1714:53, with the train heading in a south-westerly direction, (610 m from the railway crossing) the flashing lights began to operate. The truck was now about 950 m from the crossing. The truck continued to approach the crossing with the witness vehicle close behind. At a distance of about 300 m from the railway crossing, (Figure 3 and Figure 4) the truck entered a sweeping right hand curve (85 km/h advisory speed limit); the flashing lights continued to operate. The train driver sounded the locomotive horn when the train was about 200 m from the railway crossing. As the truck continued to progress through the right hand curve, the witness behind noted that the truck was travelling 'really quickly', and not slowing for the railway crossing.

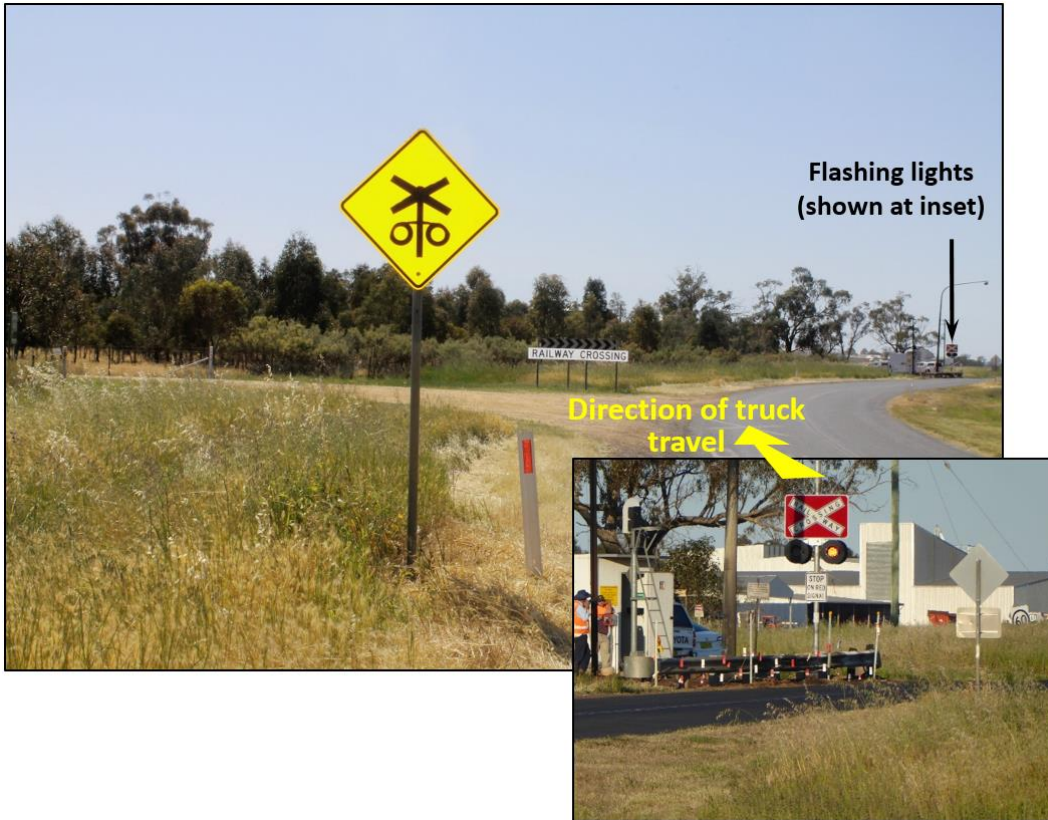
Figure 6: View approaching railway crossing at 180 m (Inset 30 x zoom)

At a distance of about 180 m from the railway crossing, (Figure 5 and Figure 6) it is likely the truck driver perceived the operation of the flashing lights, and made an emergency brake application. The witness behind saw the road-train truck brake heavily; smoke billowed from the tyres. Skid marks from the truck were evident about 84 m before the railway crossing (Figure 7).

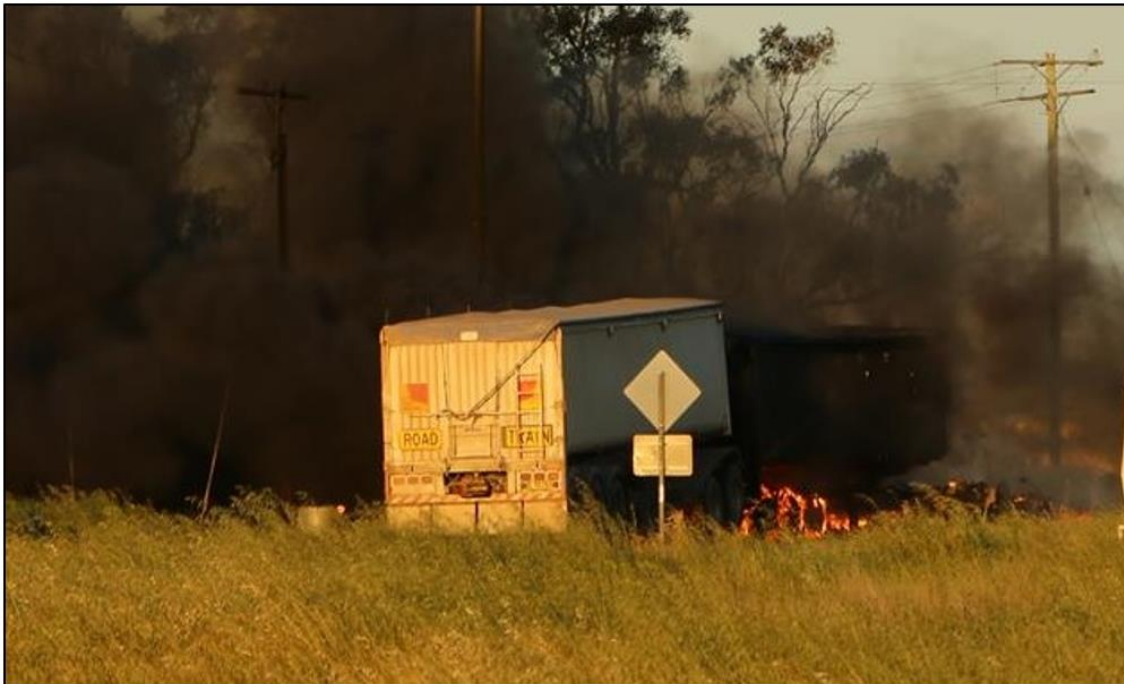
**Figure 8: Post-collision fire, road-train truck (trailers) at Tullamore – Narromine Road railway crossing**

The truck rapidly approached the railway crossing before colliding with train 8834N (1715:31) between the second and third wagons. At the time of collision, the train was travelling at 60 km/h. Truck parts scattered in all directions, but generally along the line of train travel. The force of the collision crushed the prime mover's bodywork and ruptured its fuel tanks, which subsequently caught fire. The motorist (witness) directly behind the truck, pulled over and ran towards the prime mover cabin. The truck driver was not moving, and appeared fatally injured. The witness tried to extract the truck driver from the crushed cabin, but retreated when flames engulfed the cabin (Figure 8).

The impact and post-collision fire destroyed the prime mover and damaged the road-train trailers. There was no damage to the locomotive (8144) and the first wagon, but the second and third wagons were damaged by the collision and subsequent derailment. Damage to track infrastructure was mainly confined to the northwest approach flashing lights, which were destroyed by the fire.

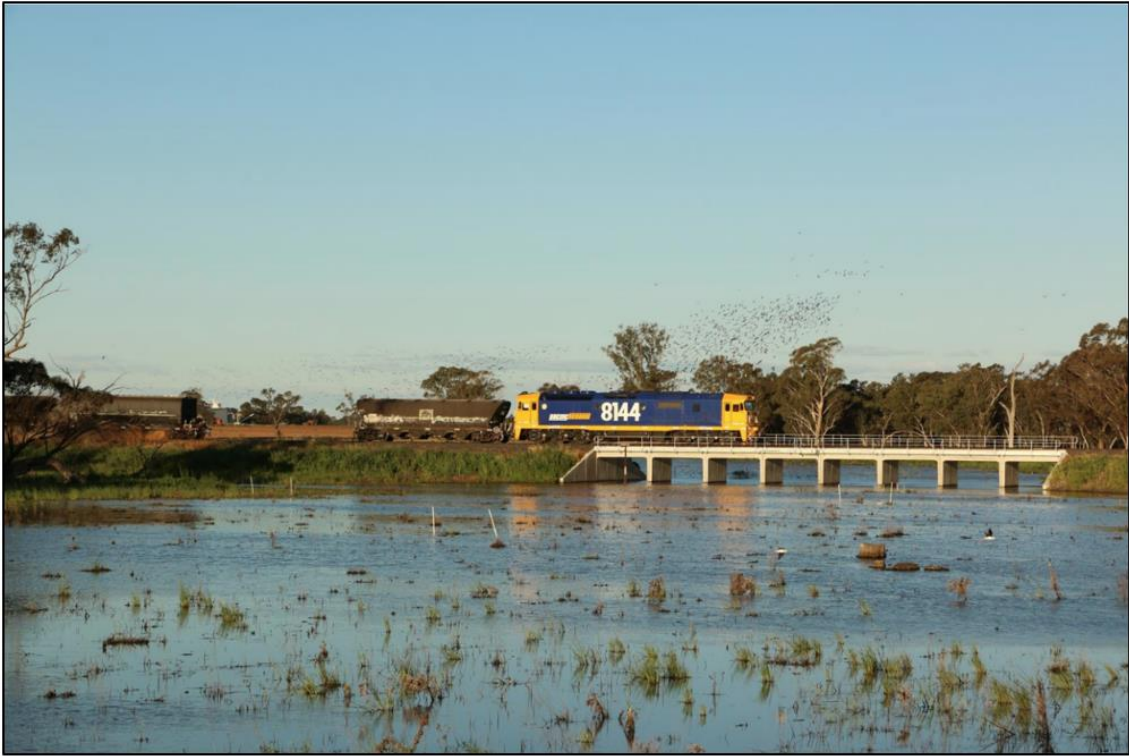
**Figure 9: Photo of train 8834N while split between first and second wagon was occurring**

During this time, train 8834N continued under emergency brake application, the train split behind the first wagon (**Error! Reference source not found.**). The locomotive came to a stand 777 m beyond the crossing. The second wagon was derailed by the collision, it continued upright along the track, coming to a stand about 551 m beyond the crossing. The train's second driver made an emergency call to the Australian Rail Track Corporation (ARTC) network control centre – advising the network control officer (NCO) of the collision and requesting attendance by the emergency services.

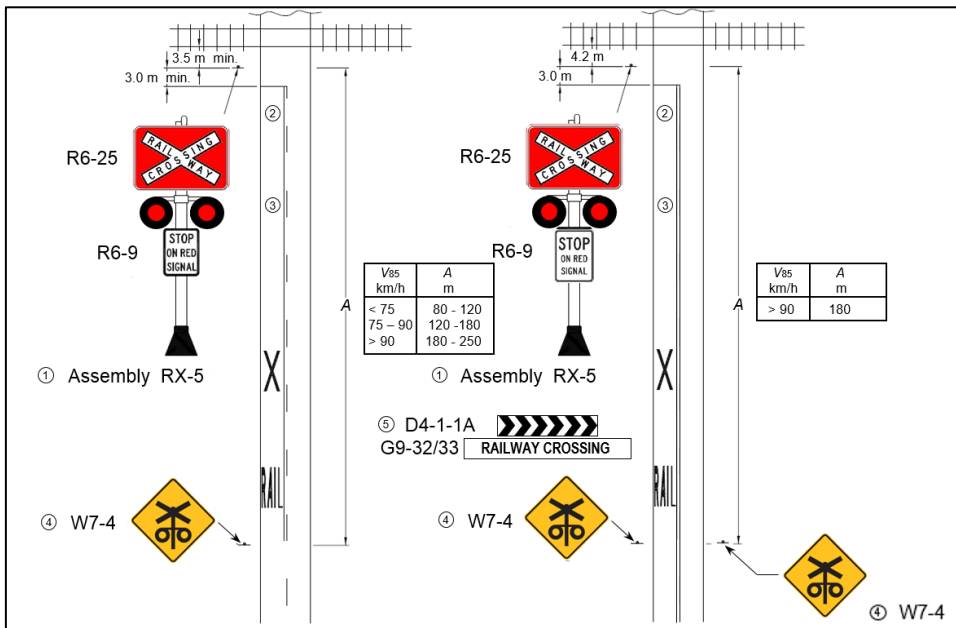
**Figure 11: Signage as required (minimum) by AS 1742.7-2007 (left). Signage as installed at the Tullamore – Narromine Road railway crossing, on 23 Sept. 2015 (right)**

A review of the site against the standard established no non-compliances; the following observations are nevertheless provided for completeness:

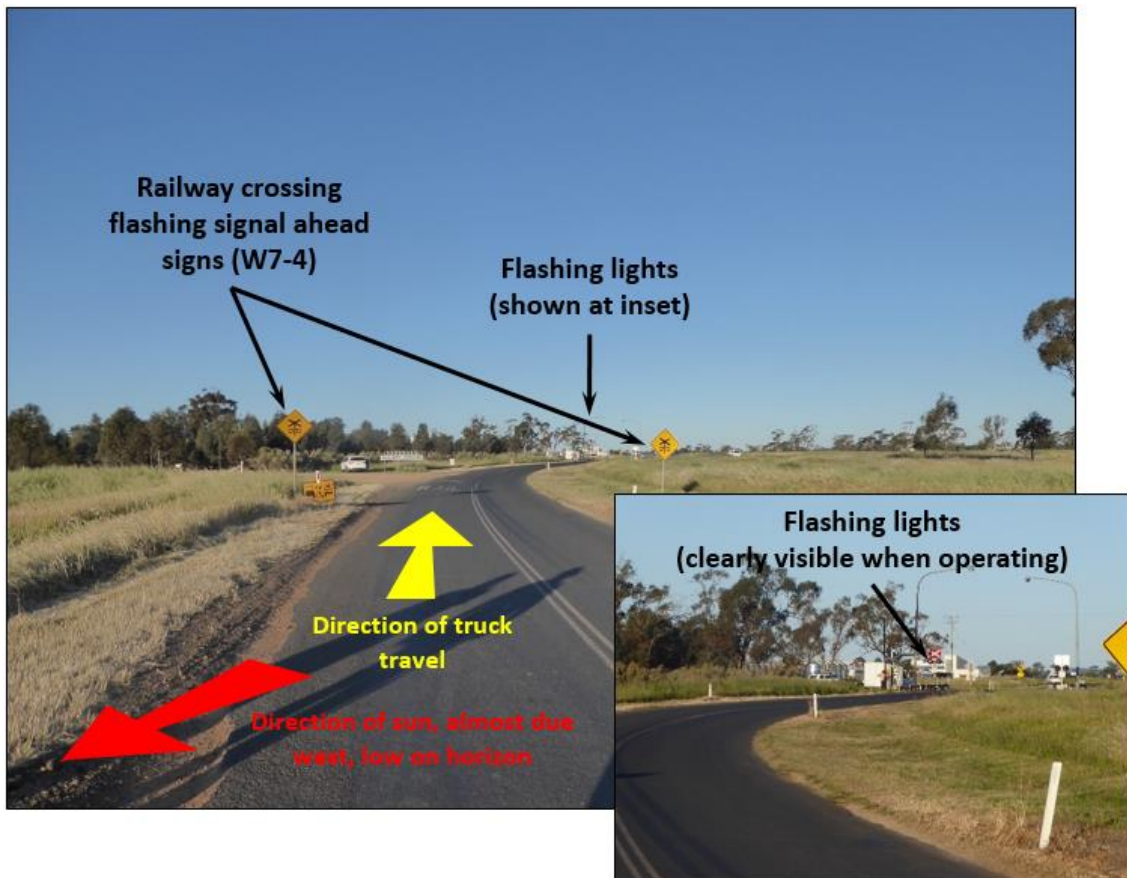
**Figure 13:** Photo taken at 1715 (4 days after the collision), about 200 m (Inset 30 x zoom) from railway crossing. Sun almost directly behind road-train truck, its position (azimuth and altitude) was similar to that just before collision

With respect to this collision, with the sun being almost directly behind the truck, sun-glare had the potential to reduce the truck driver's ability to see the flashing lights by shining on them. It was therefore important to inspect the crossing under similar environmental conditions, and at about the same time as the collision, to determine the possible influence of sun-glare.

It was concluded that had the driver been specifically looking for the flashing lights, he would almost certainly have seen them operating. However, the 'A pillar' and air snorkel, (prime mover, driver near side, Figure 10) probably restricted the view<sup>20</sup> of the flashing lights (intermittently), as the truck approached the railway crossing (Figure 14).
