# Safe working irregularity

near Jumperkine, Western Australia | 29 September 2015

**ATSB Transport Safety Report**  
Rail Occurrence Investigation  
RO-2015-018  
Final – 15 June 2017

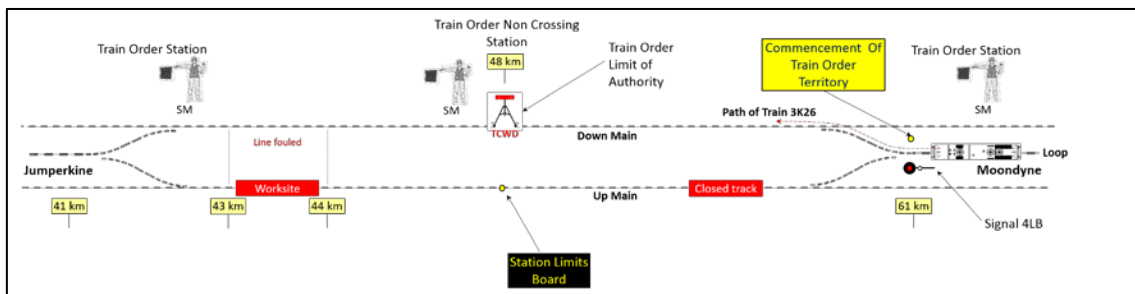
**Figure 2: Map showing positions of the Stationmasters and authority limits**

The network control officer advised the crew of train 3K26 that train order working was in place from Moondyne to Jumperkine. At 1149, train 3K26 arrived at Moondyne and after a brief stop the train entered the bypass loop and stopped at signal 4LB (Figure 2).

The network control officer acknowledged that the read-back of the authority was correct, but made no mention about the additional instructions not contained in the train order. The network control officer then advised the crew that the points were set and locked, and authorised the crew to pass signal 4LB at stop and depart Moondyne (Figure 2).
