Derailment of freight train 6DA2

Near Marla, South Australia | 31 October 2015

ATSB Transport Safety Report
Rail Occurrence Investigation
RO-2015-020
Final – 13 July 2017

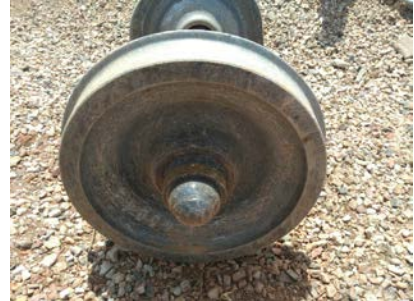
Screwed journal

The ATSB found that the journal and bearing on wagon FQWY 12-F had seized and lost interference fit. The loss of interference fit generated high levels of frictional heating between the bearing and the axle journal, and the subsequent torsional shearing failure of the axle (commonly referred to as a 'screwed journal'). The axle failure caused the axle and wheels to stop rotating, resulting in one wheel skidding along the railhead for approximately 50 km, before derailing.

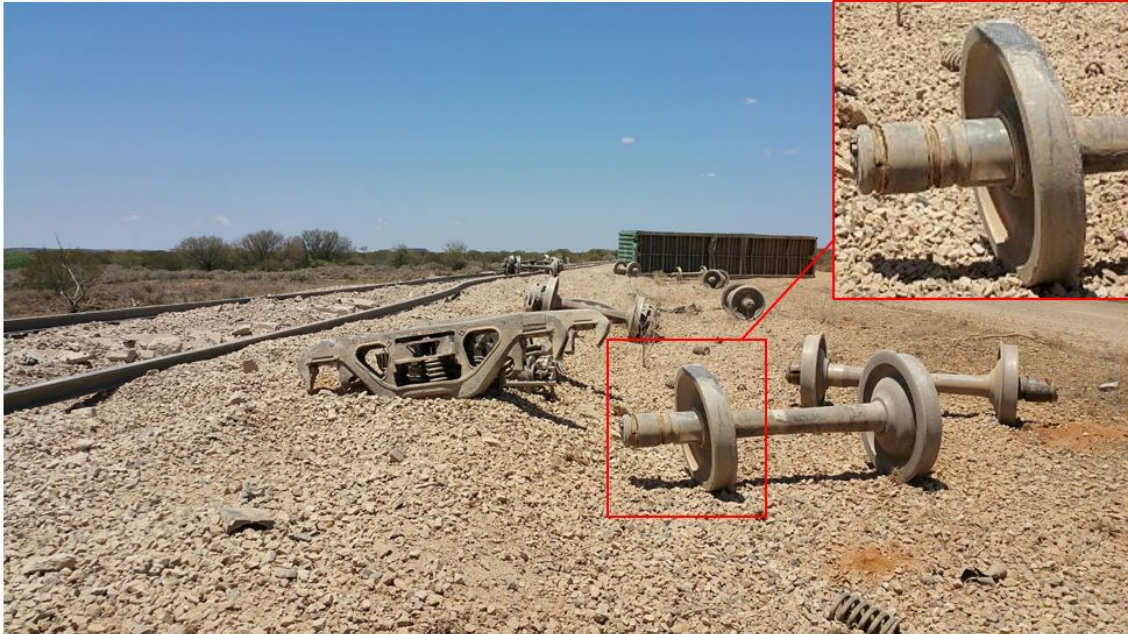
Figure 3: Photo of derailment site with the screwed journal axle in the foreground

The observer was tasked to go and inspect the rear of the train. As he walked towards the rear of the train, he found that the rear bogie on wagon FQWY 12-F (fourth-to-last wagon) had dislodged from the platform and was located alongside the track approximately 500m from the rear of the train (Figure 3). The remaining three 2-pack wagons remained upright with all bogies derailed, with some completely removed from their associated platforms. Several containers from the derailed wagons had broken away from the train and landed in the rail corridor. The derailment had also caused significant damage to 12 km of track resulting in mostly cracked sleepers and damage to rail fasteners. There was no spillage of any dangerous goods.

Figure 3 shows the derailment site. The axle in the foreground is the lead axle from the trailing bogie (refer to figure 2) of wagon FQWY12-F which was found to have the screwed journal. The callout box depicts the flat wheel due to the wheel jamming as a result of the screwed journal. Also pictured is the mated bearing on the journal. Obscured from view on the axle is the screwed journal. Source GWA

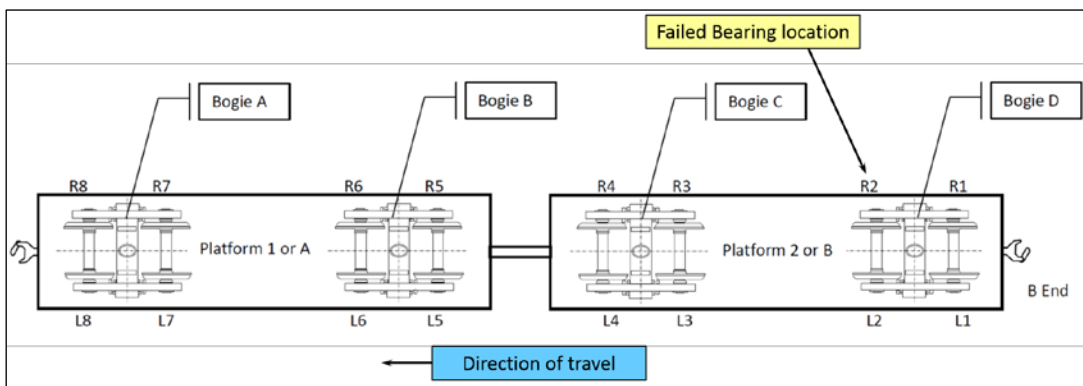
Figure 4: Schematic of FQWY 12-F

The R2 axle bearing on platform two bogie D failed. The wheelset was the leading axle on bogie D in the direction of travel. Source: Genesee Wyoming Australia Pty Ltd and annotated by ATSB

The failed axle was the lead axle on the rear bogie (Bogie D). At the time of the derailment the train was traveling at approximately 82 km/h. A 6.45 t container was loaded on platform A and an 11.8 t container loaded on platform B.

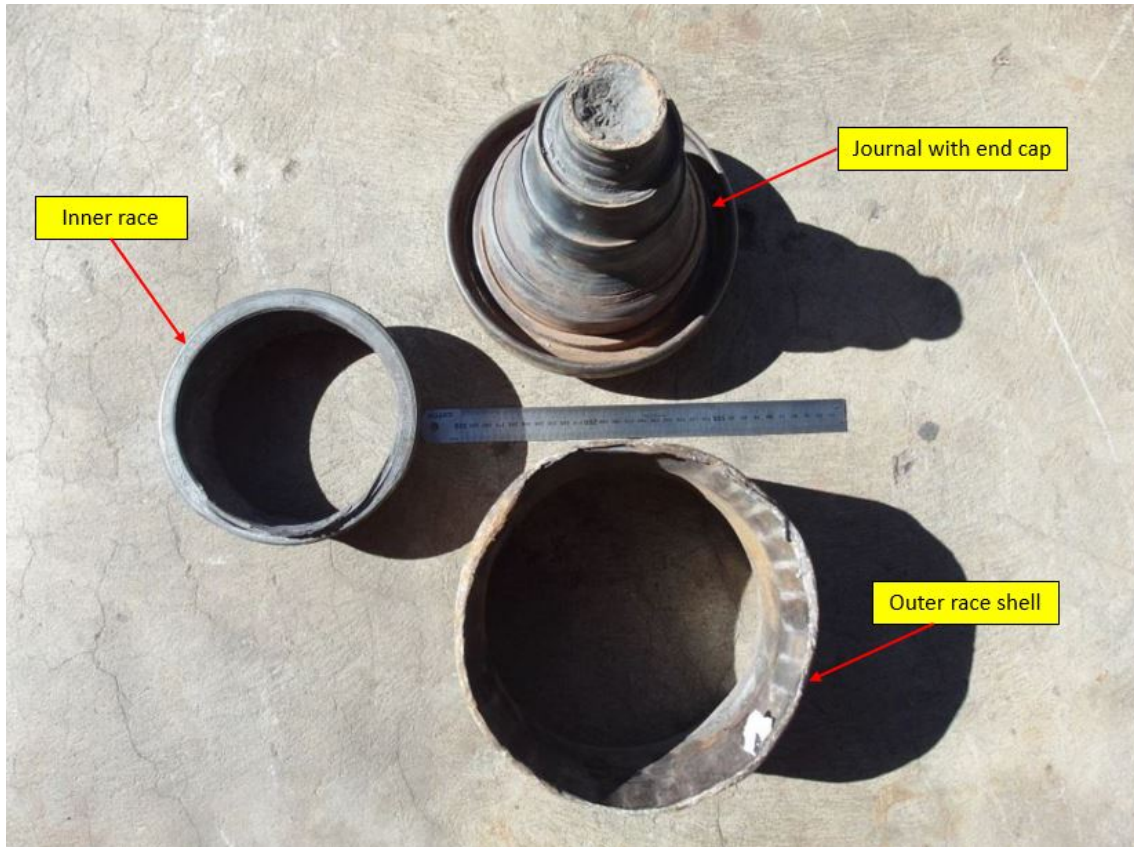
Figure 6: Recovered components of failed bearing

The remaining components of the failed bearing above were retrieved from site and was inspected and analysed by the Bureau Veritas Source: Genesee & Wyoming Australia and annotated by ATSB.

Examination of the inner race of the failed bearing found stamping from SKF (Sweden). There was evidence of significant heat damage and significant amount of mill scale (flaky surface, often found on hot rolled steel), suggesting a long period of exposure to high temperatures.

Examination of the outer race was unable to identify any stamping. There was significant mechanical and thermal damage to the surfaces, as well as a build-up of mill scale. Marks found around the race suggested post incident false brinelling⁷. An area of spalling was also noted on the rolling surface of the outer race, though this was partially obscured by post failure surface damage.

The Bureau Veritas concluded that the most likely contributor to the bearing failure was a lubrication supply issue. This may have been due to either seal failure or inadequate lubrication at the time of assembly of the bearing package. The seal was not recovered so could not be examined to determine its condition and the possibility that it may have failed prior to the derailment.

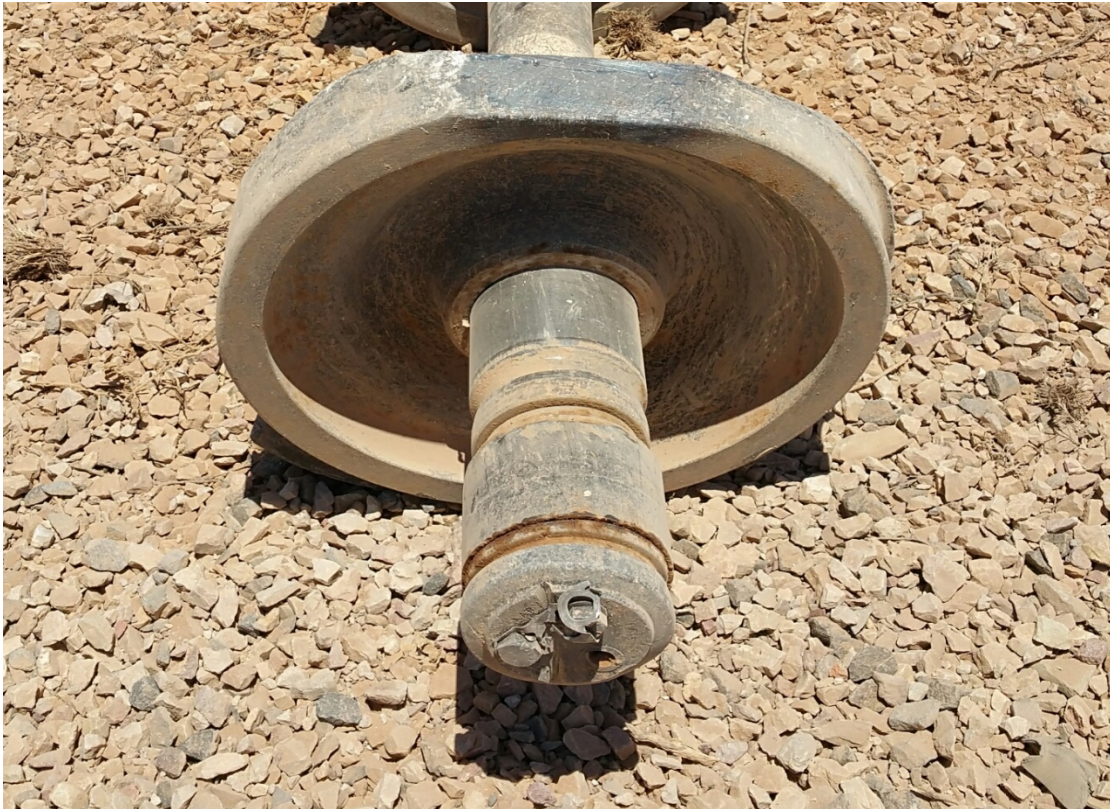
Figure 7: Mated bearing with signs of grease leaking from end caps

The examination also included the partner bearing from the opposite end of the axle, and found it to be in good order. The amount of grease in the mated bearing was only a light application and contained small amounts of sand. The Bureau Veritas estimated conservatively that there was less than 200 grams of grease in the bearing as supplied (approximately 50% when compared to

Both grease seals were present and intact, though post derailment observations show the end seals of the bearing appearing to be ‘wet’ which indicates that some grease may have been liberated during the derailment. It could not be determined how much grease was installed in the bearing. However, it is likely that some grease from the mated bearing was lost as a result of the derailment.

Figure 7 shows that the end seals of the bearing appearing to be ‘wet’ which indicates that some grease may have been liberated during the derailment. This also indicates that there may have been a failure in the bearing seal. Source: Genesee & Wyoming Australia
