Derailment of intermodal freight train 5PM9

near Rawlinna, Western Australia on 4 December 2015

ATSB Transport Safety Report

RO-2015-024

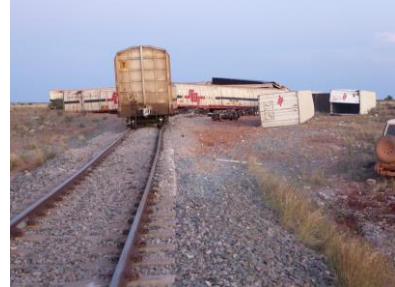
At about 1450, near Rawlinna, WA freight train 5PM9 operated by SCT Logistics derailed during a severe storm. There was a combination of 59 vehicles located immediately behind the locomotives. The train broke into two sections, where 39 vehicles had either derailed or overturned, generally to the south side of the track. A fire started within one refrigerated food van about 500 m from the front of the train and later burned itself out. There were no dangerous goods involved in the accident and no fuel spillage. The derailment damaged approximately 550 m of track. There were no physical injuries to the train drivers, but the two relief drivers were badly shaken when the crew van rolled on its side.

Derailed vehicles looking east

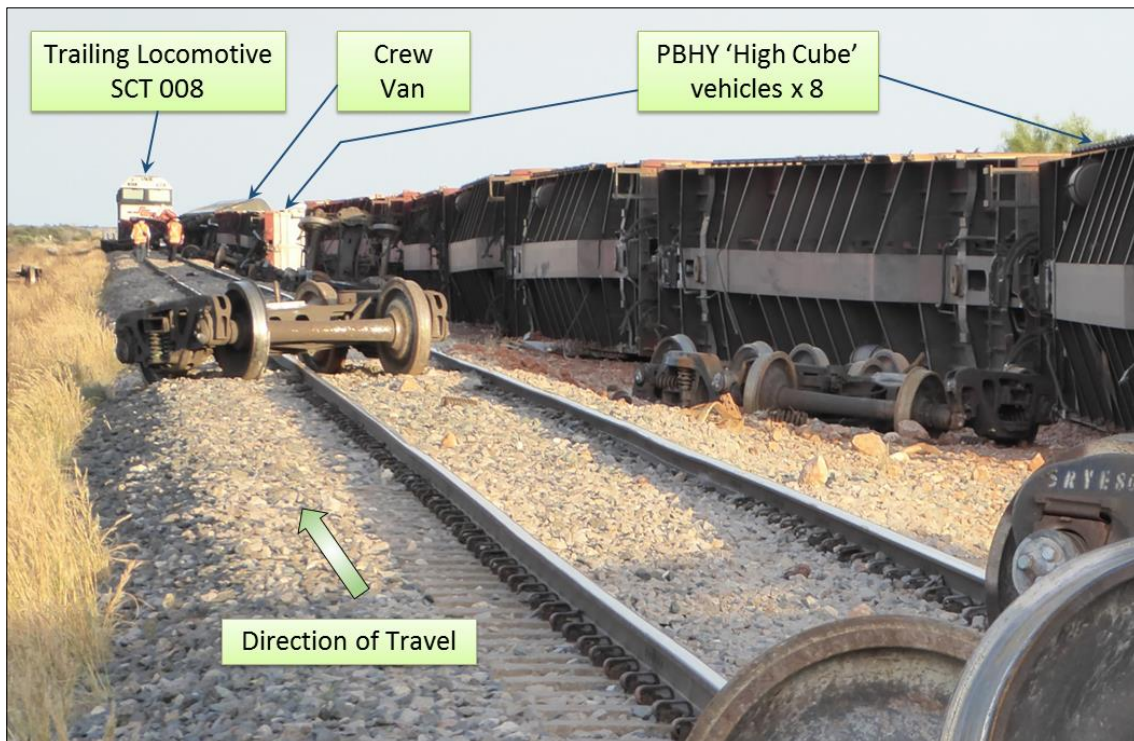
Figure 2: Leading end of train showing overturned crew van and trailing vehicles.

The second driver looked in the rear view mirror, and saw rail vehicles derailling and rolling onto their sides. The first vehicles to derail appeared to be about 10 vehicles behind the locomotives, with subsequent vehicles progressively derailling towards the front of the train. As the train slowed, it jerked backwards and forwards. All the vehicles derailed to the south of the track, including the crew van and in-line fuel tanker coupled immediately behind locomotive SCT 008 (Figure 2).

Looking in the direction of travel, this photo shows how the vehicles progressively derailed towards the front of the train while rolling onto their sides south of the track. Source: ATSB:

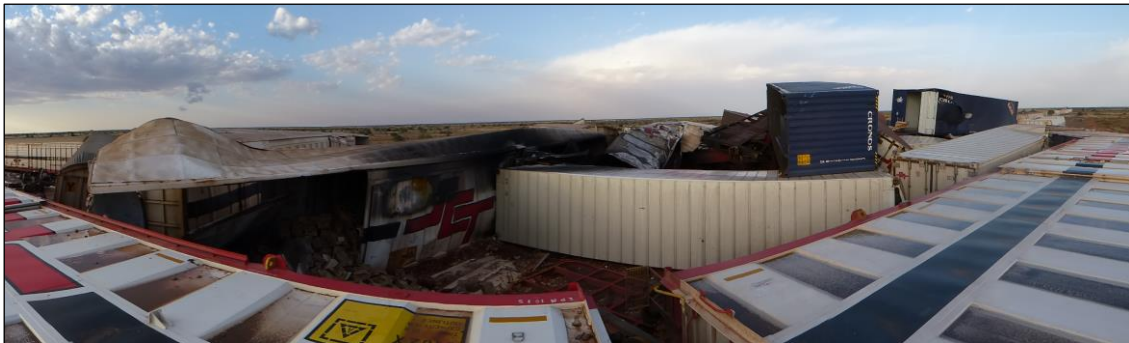
Figure 3: Panoramic view of derailed vehicles and containers

the crew van and in-line fuel tanker had rolled onto their sides and there was a fire in the pileup of vehicles (Figure 3) about 500 m behind the crew van.

Source: ATSB: Viewed from above train 5PM9 shows where collision damage and a fire has severely damaged some derailed and overturned vehicles. The train was travelling east (right of photo) where all vehicles overturned to the southern side of the track towards trailing locomotive SCT008.

It was evident that the fire had started in a refrigerated wagon containing food products, probably initiating at the refrigeration unit. The fire was inaccessible for the crew to safely extinguish. The fire subsequently extinguished naturally without spreading to other freight.

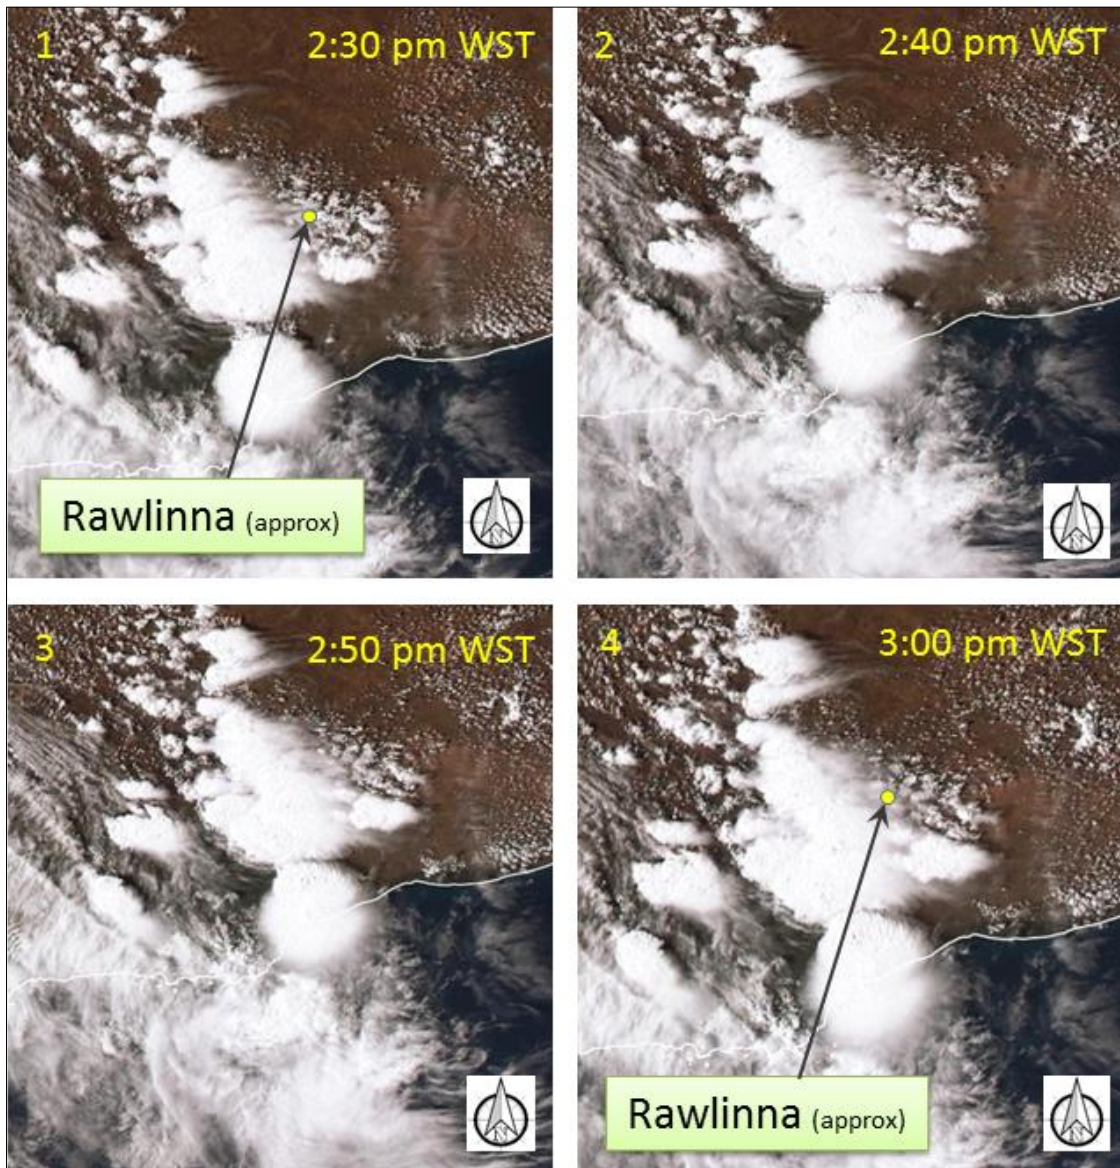
Figure 4: Satellite images

Commencing at about 1230, thunderstorms progressively developed across the forecast area. Radar images had identified strong cells mainly south and southeast of Kalgoorlie. At about 1400, a thunderstorm developed east of the main activity area peaking between 1440 and 1450. The timing of this thunderstorm corresponds with the time that 5PM9 derailed (Figure 4).

Satellite images showing the cloud masses travelling generally in a south-easterly direction near Rawlinna, WA between 2:30 pm and 3:00 pm (WST) Image Source: Satellite images from Himawari-8 operated by the Japan Meteorological Agency (JMA) and sourced from the Bureau of Meteorology. Annotated by ATSB

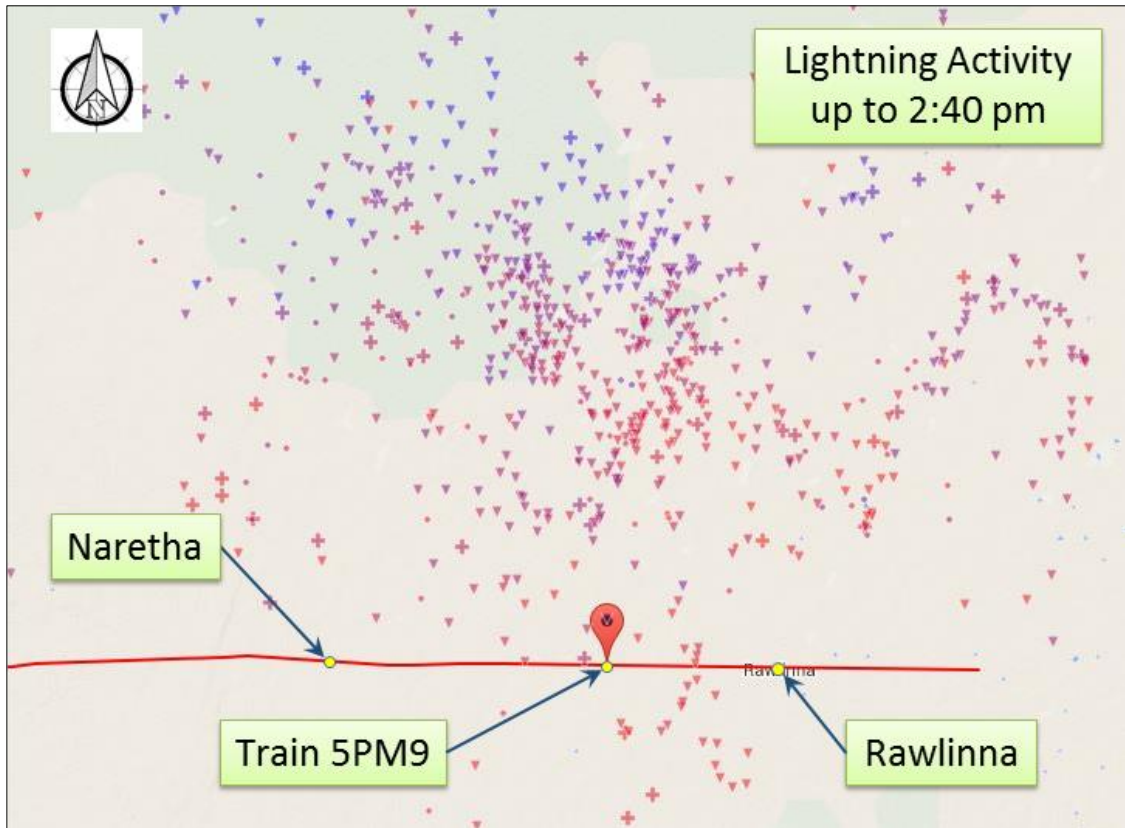
Figure 5: Thunderstorm lightning lifecycle recorded north of Rawlinna, WA – 4 Dec 2015.

At about 1400, the EWN also recorded widespread lightning activity starting at about 40-50 km north of the railway line. The lightning moved slowly in a southerly direction. At about 1440, there was increased intensity near the railway line (Figure 5).

Lightning strikes are displayed as crosses (ground events) or triangles (cloud events). The strikes are colour coded to indicate changes in the time of strike. Blue indicates 60 minutes prior to the image capture and transition to red indicating 30 minutes prior to the image capture. The image illustrates that lightning strikes had moved slowly in a southerly direction towards the railway line.
Image Source: Map data 2015 Google Imagery 2015 TerraMetrics

The EWN reported ‘lightning tends to occur near the transition between the downdraught and updraught indicating the downdraught would have been close to the railway line. At this time, the likely effect would have been a strong out flow of winds and heavy rainfall that could have caused flash flooding.

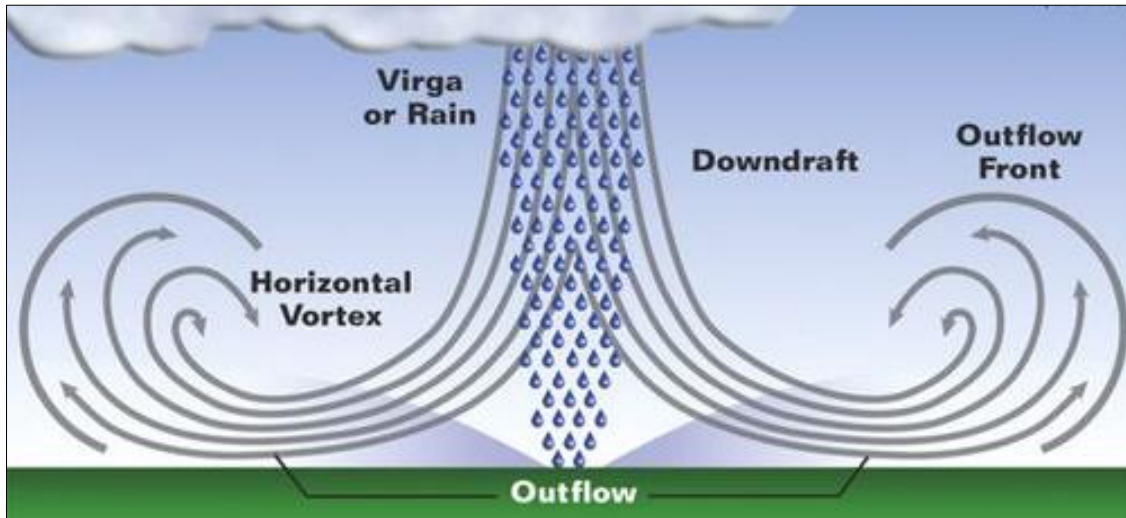
Figure 6: Diagram of thunderstorm downdraught/microburst.

Microbursts often have wind gusts in the 90-100 km/h range – but briefly in small geographic areas. The descending air is forced to spread out laterally near the earth's surface, often creating severe wind squalls with associated dust.
Source: WDRB Meteorologist Jeremy Kappell.

In this instance the EWN reported that: 'Severe weather produced was most likely microburst winds. Microbursts often have wind gusts in the 90-100 km/h range – but briefly in small geographic areas'.

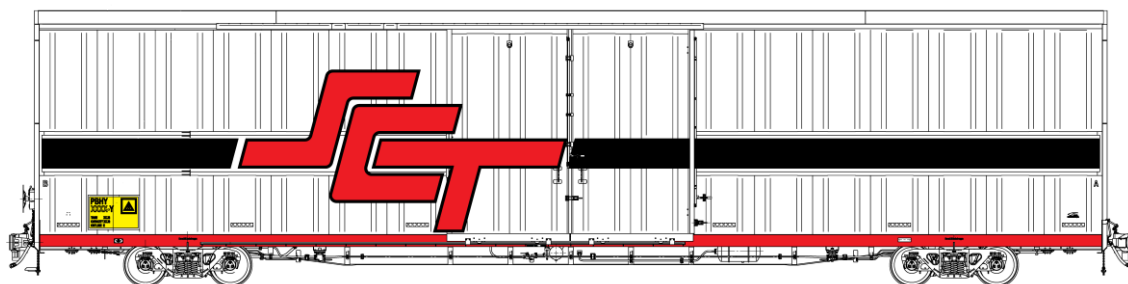
Figure 7: Diagram of SCT Logistics PBHY 'High Cube' class vehicle.

The ATSB found that the configuration of multiple PBHY 'High Cube' vehicles provided a large side surface area that was susceptible to high wind forces. A localised downdraught of cold air in the form of a microburst on the north side (driver side) of the train produced severe winds that were sufficient to initiate the overturning of eight coupled lightly loaded PBHY vehicles. Other laden vehicles, including another eight PBHY vehicles, the crew van and in-line fuel tanker, had progressively derailed and overturned towards the front of the train. These vehicles had derailed through the transference of the rotating force through the couplers, due to rollover of adjacent vehicles.

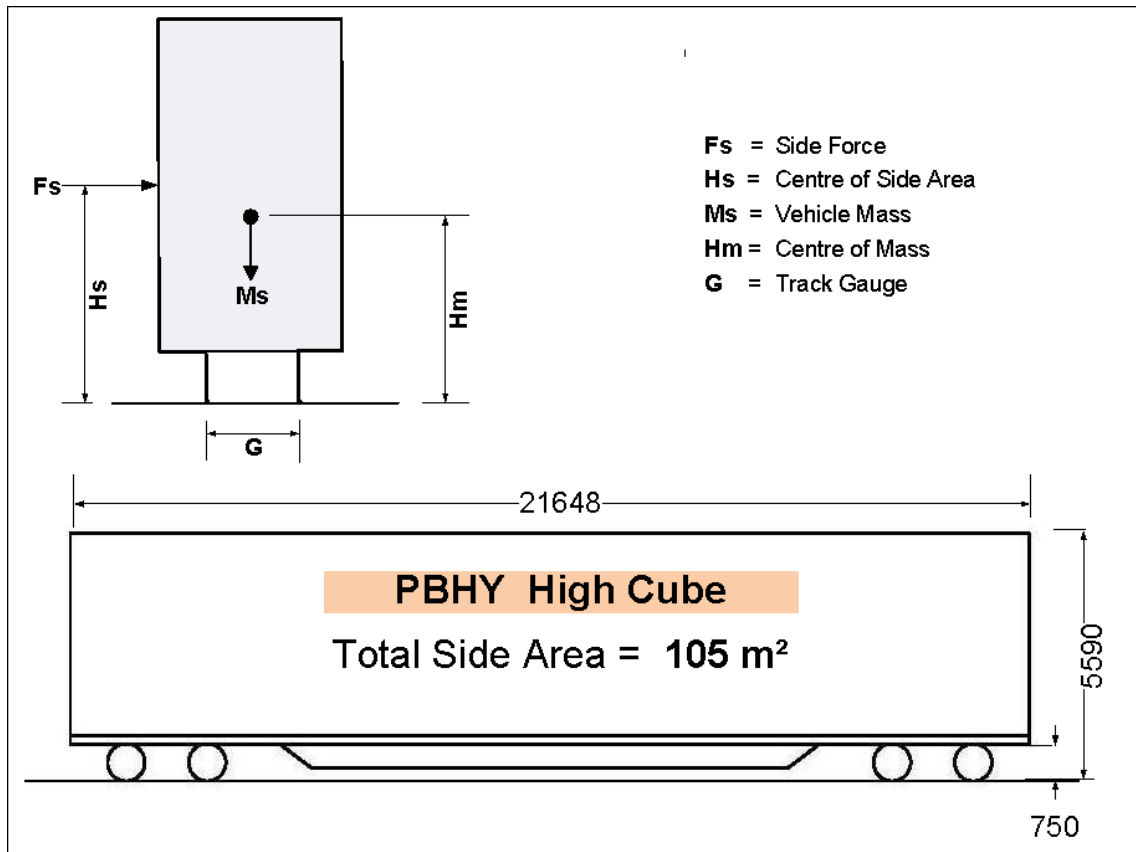
Figure 8: Vehicle profile and side area showing elements used in the estimation of forces acting on a PBHY vehicle.

In calculating the percentage of wheel unloading, a simplified method assumes that the vehicle's centre of mass acts continuously at the centre point between the two rails (that is, the vehicle suspension is rigid and does not permit body roll). For a train travelling at 90 km/h, 100% wheel unloading on a PBHY class of vehicle was calculated to occur when the effective wind speed⁹ is about 80 km/h and acting at an angle of between 60 degrees and 80 degrees relative to the direction of travel.
