Derailment of grain train 9156

Ouyen, Victoria | 29 December 2015

ATSB Transport Safety Report
Rail Occurrence Investigation
RO-2015-029
Final – 12 July 2017

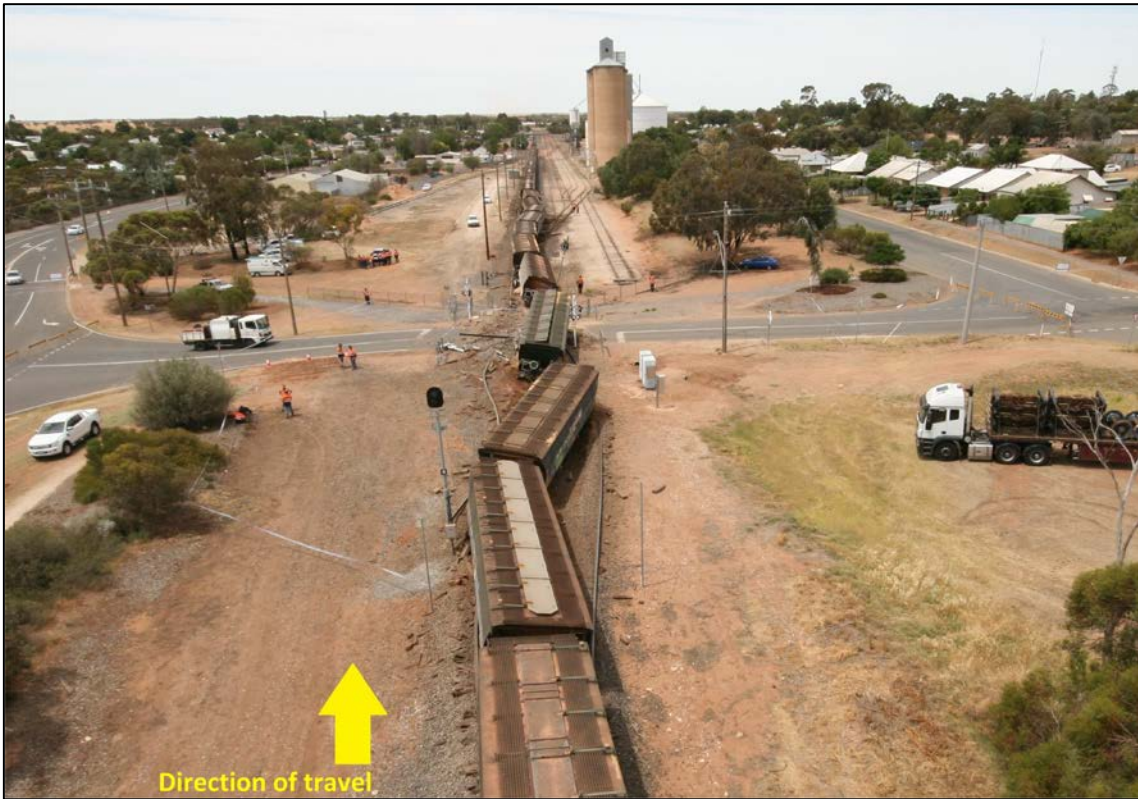
As a result of the loss of brake pipe air, the train quickly came to a stop. It was identified that twelve wagons (the 25th to 36th) had derailed at the William Street level crossing (Figure 2).

Figure 2: View of derailed train at the William Street level crossing.

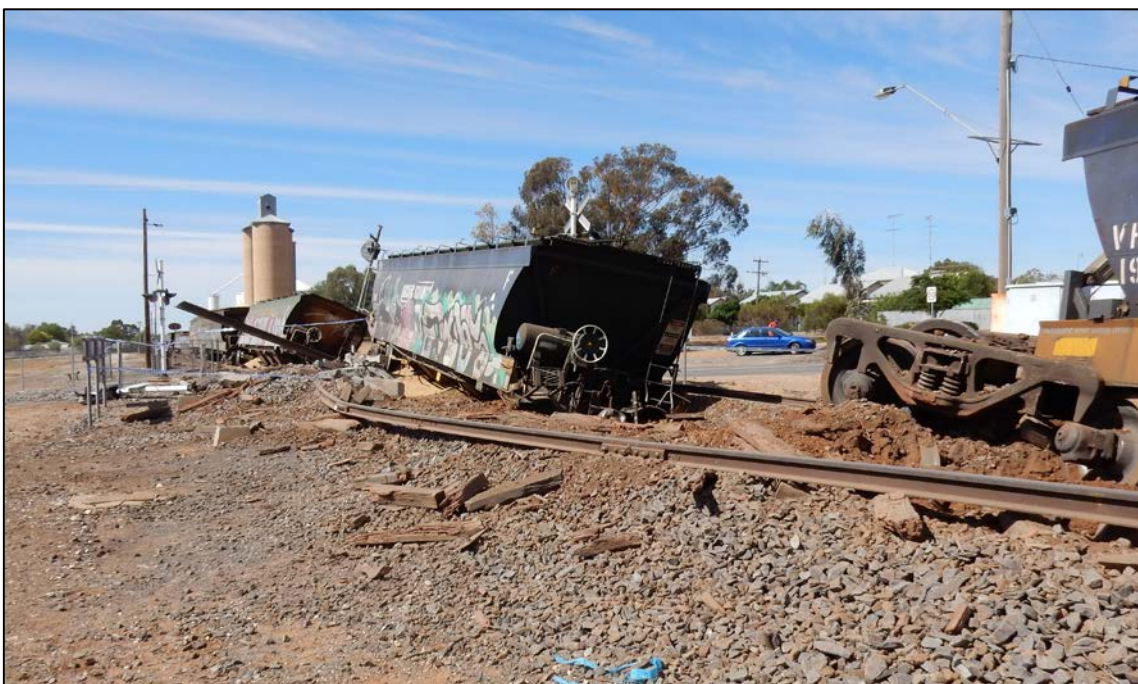
There were no injuries as a result of the derailment and a car that was stopped on the east side of crossing and a motorbike stopped on the west side were not impacted. There was severe infrastructure damage ahead of, and at, the level crossing (Figure 3).

Figure 3: Track damage on the approach side of the William Street level crossing

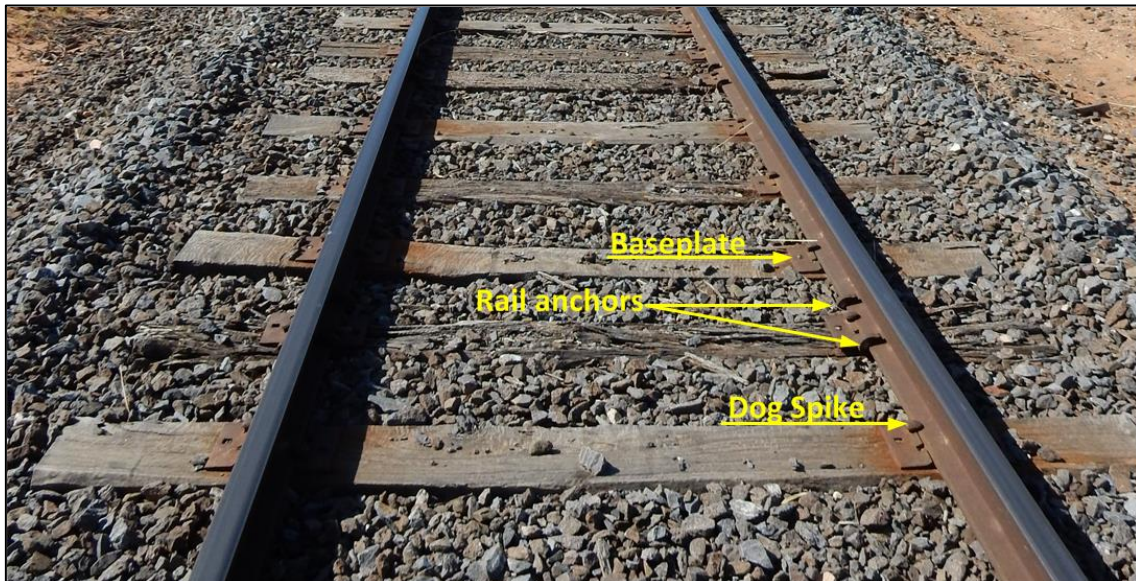
The track condition was fair with a good ballast profile (Figure 6). The condition of sleepers varied, with intermittent higher quality sleepers used to supplement sleepers that were nearing end-of-life.

Figure 6: Undisturbed track on the Carwarp side of the derailment site, showing intermittent higher quality sleepers and typical ballast condition. Rail was affixed with dog-spikes with intermittent use of box anchoring to reduce rail creep.

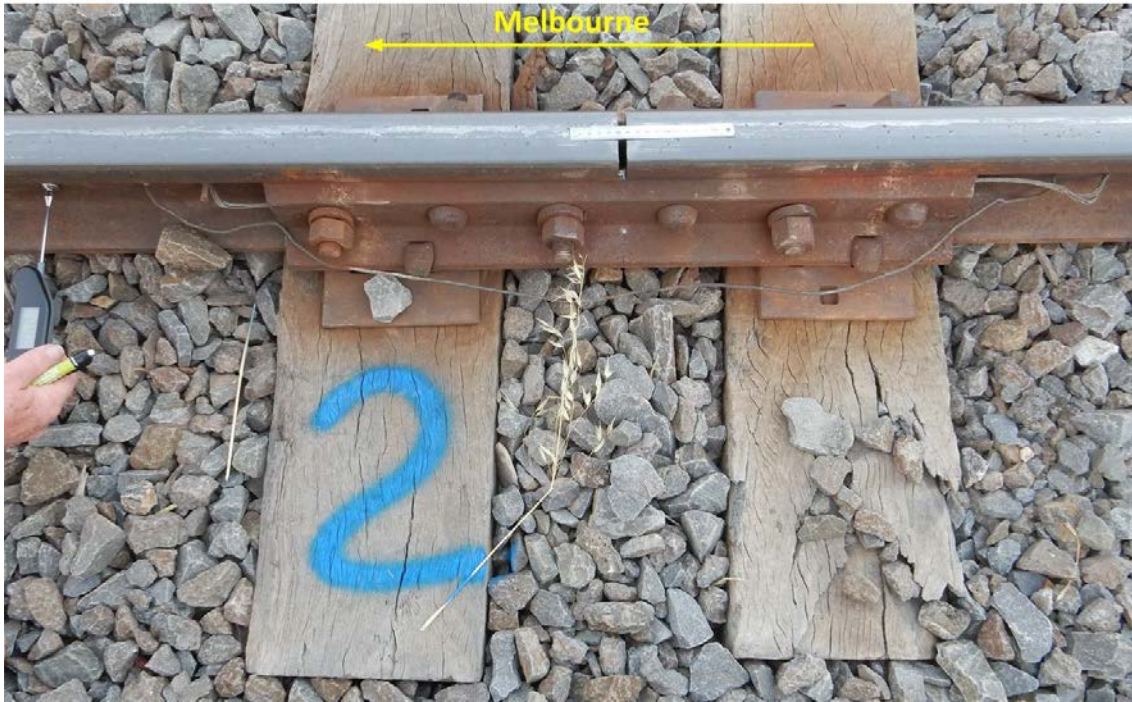
Rail joints behind the derailed train (on the Carwarp side) were inspected following the derailment. Through 30 December all joints remained closed in the continuing hot weather. The joints were reassessed in the early morning on 31 December and all joints had opened by varying amounts. Measurements were taken between 0630 and 0700 with a stable mean rail temperature of 21.6 °C (Figure 8).

Figure 8: Measurement of the gap at the second joint to the north of the derailed train on the left (Up) rail.

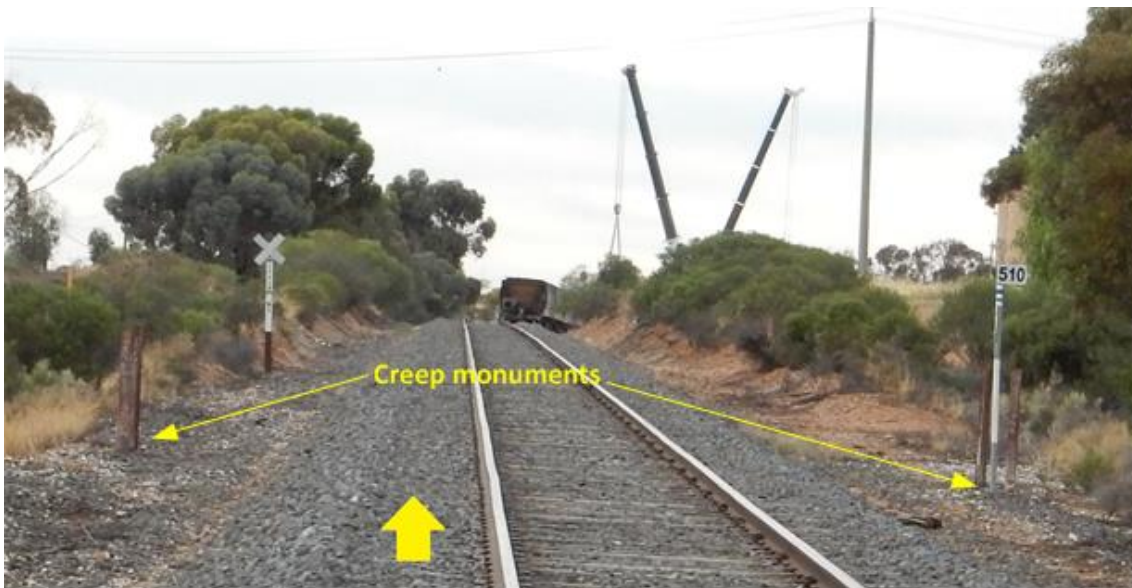
Figure 9: The 510 km post and creep monuments on uphill grade approaching Ouyen.

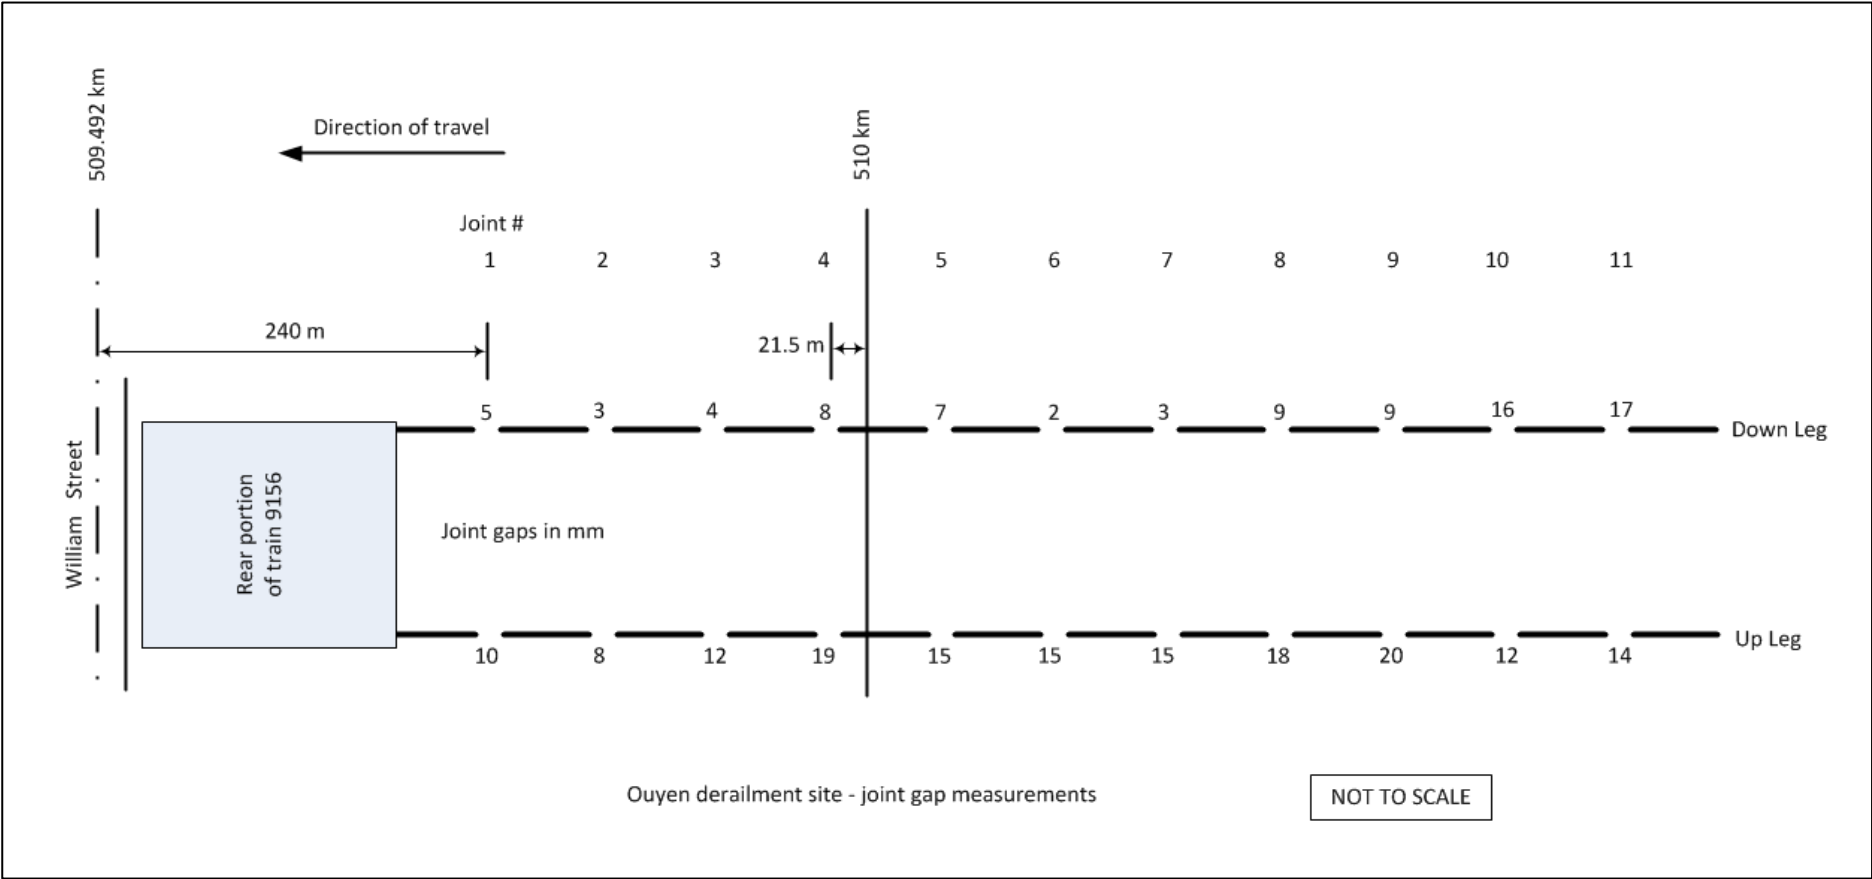
Figure 10: Joint gap measurements taken on the morning of 31 December 2015 at a mean rail temperature of 21.6 °C

Rail gaps were found to progressively increase the further the distance from the rear of the train. Gaps as high as 20 mm were measured even though the nominal maximum gap in rail joints is 11 mm. This was probably the result of variations and wear in bolts and holes and it is probable that all joints in this track could extend to a gap of at least 15 mm.

Considering the data for the three rail joints to the north of the derailment site, the mean rail temperatures at which these joints would close was estimated to be about 26 °C for the Down leg and 32 °C for the Up leg.

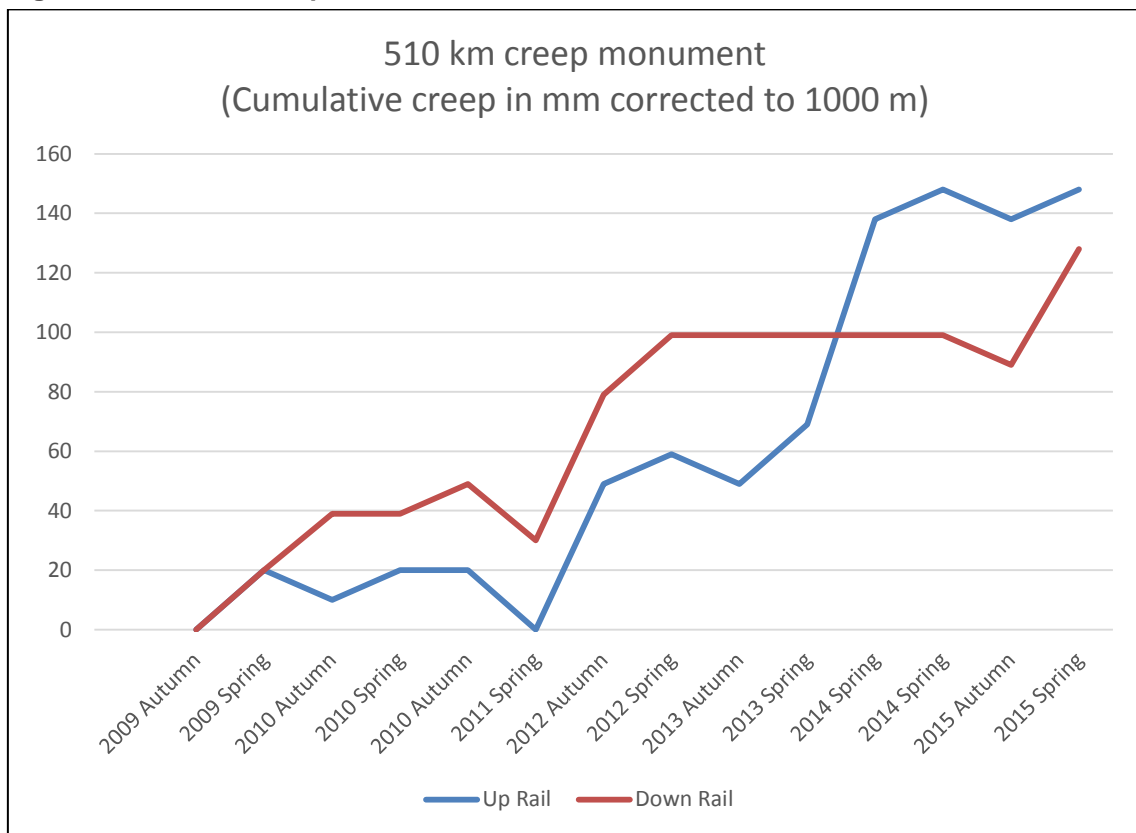
V/Line network standards identified that creep could occur over a short period or may accumulate over time. Since the resetting of the creep in 2009, there had been regular southward creep in both rails at the 510 km measurement point (Figure 15).

Figure 15: Trend in creep measurements at the 510 km monument

By 2014, cumulative creep had exceeded defect criteria. However, the asset management system did not flag this exceedance. Neither the previous nor the new systems included algorithms to identify and assess creep that had accumulated since the last creep reset. The asset management systems only compared creep measurements with the previous two readings. As a result, the slow but regular rail creep southward towards the William Street level crossing was not identified for remedial action.
