# Collision between a road vehicle and V/Line passenger train 8309

Pogue Road level crossing, Toolamba, Victoria, on 27 July 2016

**ATSB Transport Safety Report**  
Rail Occurrence Investigation  
RO-2016-010  
Final – 19 October 2016

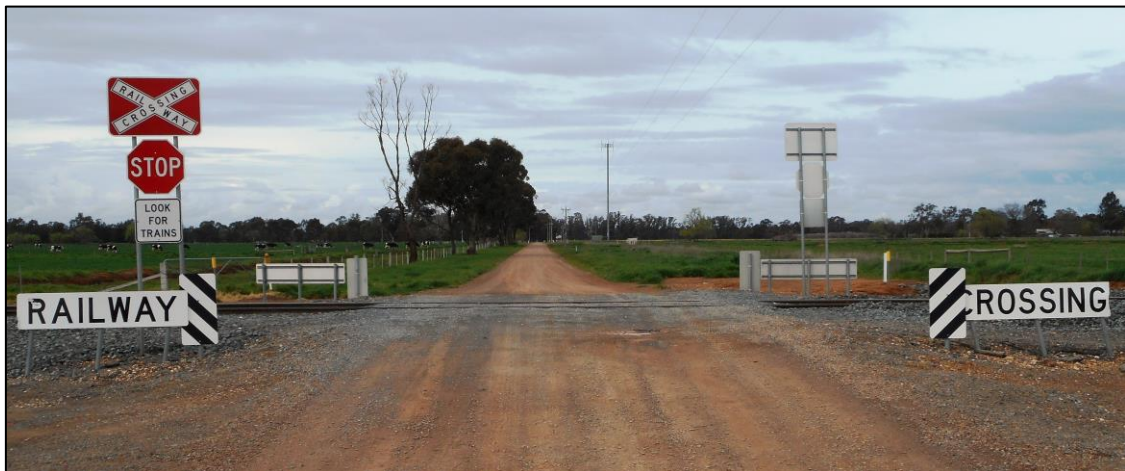
At about 1147 the train had passed Toolamba, and approached the Pogue Road level crossing travelling north at about 100 km/h. At about the same time, a utility vehicle was travelling east along Pogue Road and was approaching the level crossing. The crossing was controlled by a Stop sign (Figure 1) that required road users to stop near the crossing and look for trains.

**Figure 1: Pogue Road level crossing viewed from the direction of the car’s approach**

Pogue Road is a single-lane gravel road with a speed limit of 100 km/h. It intersected the 100 km/h train line to Shepparton at near right angles. The crossing was controlled by Stop signs (passive control) that required road users to come to a stop and check for trains before proceeding. The signage at the crossing and the advanced warning signage on the approach was in good condition and generally consistent with the Australian Standard for railway crossing signage<sup>1</sup>, with minor variations not material to this incident. There have been no previous near-miss or collision incidents reported at this level crossing.

The road-side vegetation and orchard meant that the view to the track was obscured on the approach to the crossing. The provision of Stop sign traffic control measures is consistent with this configuration, as this required road users to stop in a position that would allow them to sight trains.

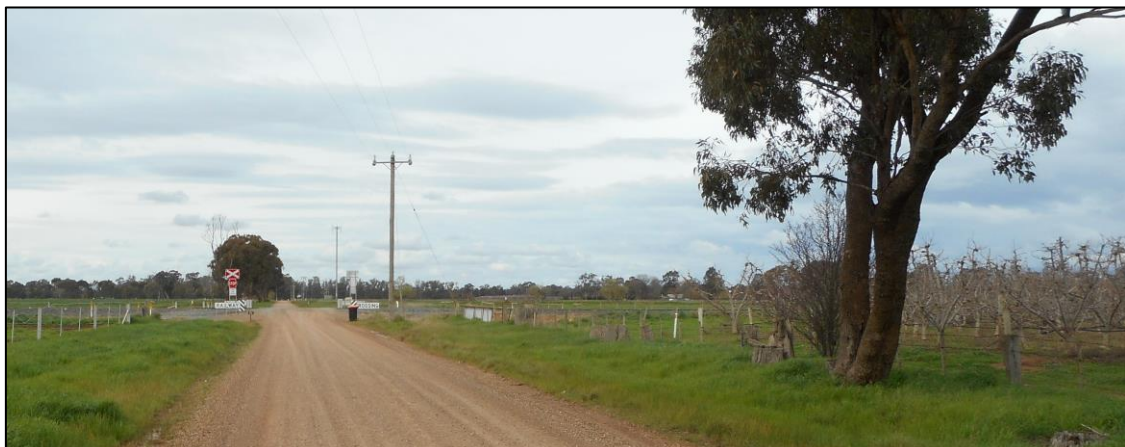
The driver of the car travelled this route almost daily and was familiar with the crossing. On this day, he had driven into town earlier that morning and was returning home. On the approach to the crossing, the driver’s view towards the train was obscured by an orchard and road side trees to the south-west of the crossing (Figure 2).

**Figure 2: Pogue Road approach to the level crossing. The view to a train approaching from the right was obscured by road-side vegetation and an orchard.**

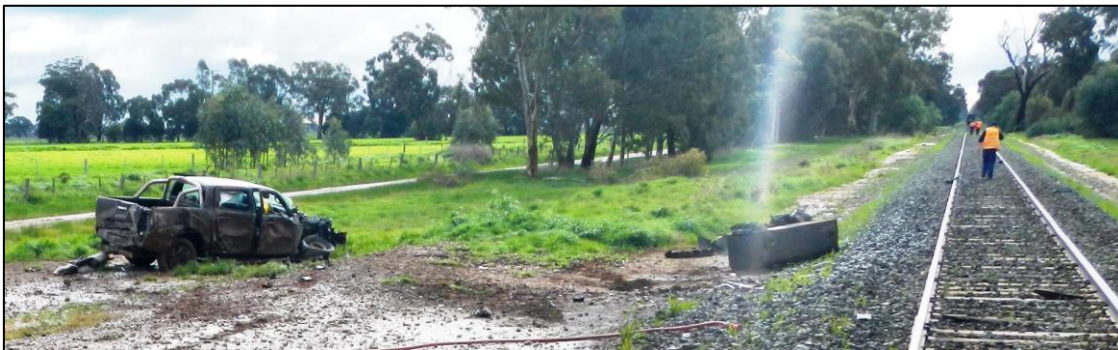
When the train came into view, the driver applied the vehicle's brakes, leaving skid marks on the gravel road about 40 m in length. However, the vehicle could not be stopped before the crossing and collided with the first passenger carriage behind the locomotive. The impact was to the underframe area of the carriage and dislodged a diesel fuel tank from the train. The passenger compartment remained intact and there were no reported passenger injuries. The road vehicle was severely damaged (Figure 3) and its driver suffered bruising injuries.

**Figure 3: Damaged road vehicle and the fuel tank from the impacted rail car.**
