VFR into smoke on a dark night and collision with terrain involving Robinson R22, VH-DLD

112 km south-south-east of Tindal Aerodrome, Northern Territory on
7 December 2023

ATSB Transport Safety Report

AO-2023-058

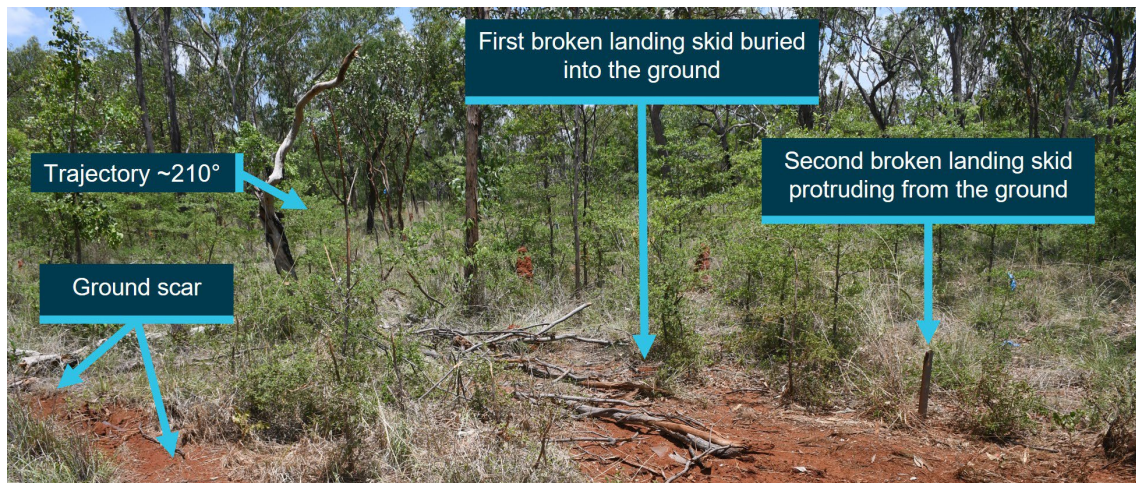
The helicopter initially struck a tall tree, breaking tree branches and the cabin perspex, before impacting the ground. The direction of travel was about 210° (True). There was a prominent ground scar on the right side of the main wreckage trail, which exhibited a pattern of multiple ground strikes and was the start of the ground impact sequence. Two broken sections of the landing skids were found buried in the ground on the left side at the start of the main wreckage trail, one after the other with the second one protruding. They were estimated by the police to be about 8 ft apart (Figure 3).¹⁰ The fronts of the landing skids were otherwise not identified among the images of landing skid debris in the wreckage.

Figure 3: Location of broken landing skids

The ground scar to the right of the main wreckage path and discovery of the broken landing skids buried in the ground on the left side of the main wreckage trail followed by the lower instrument panel indicated that the helicopter was likely in a nose down, right roll attitude when it collided with terrain. The discovery of the helicopter battery about 20 m beyond the main wreckage, and an outboard section of one of the main rotor blades about 75 m beyond the main wreckage, indicated a high energy collision in terms of both the helicopter airspeed and rotor speed. The evidence from the witnesses, forecast conditions and the impact and wreckage trail indicated the pilot likely

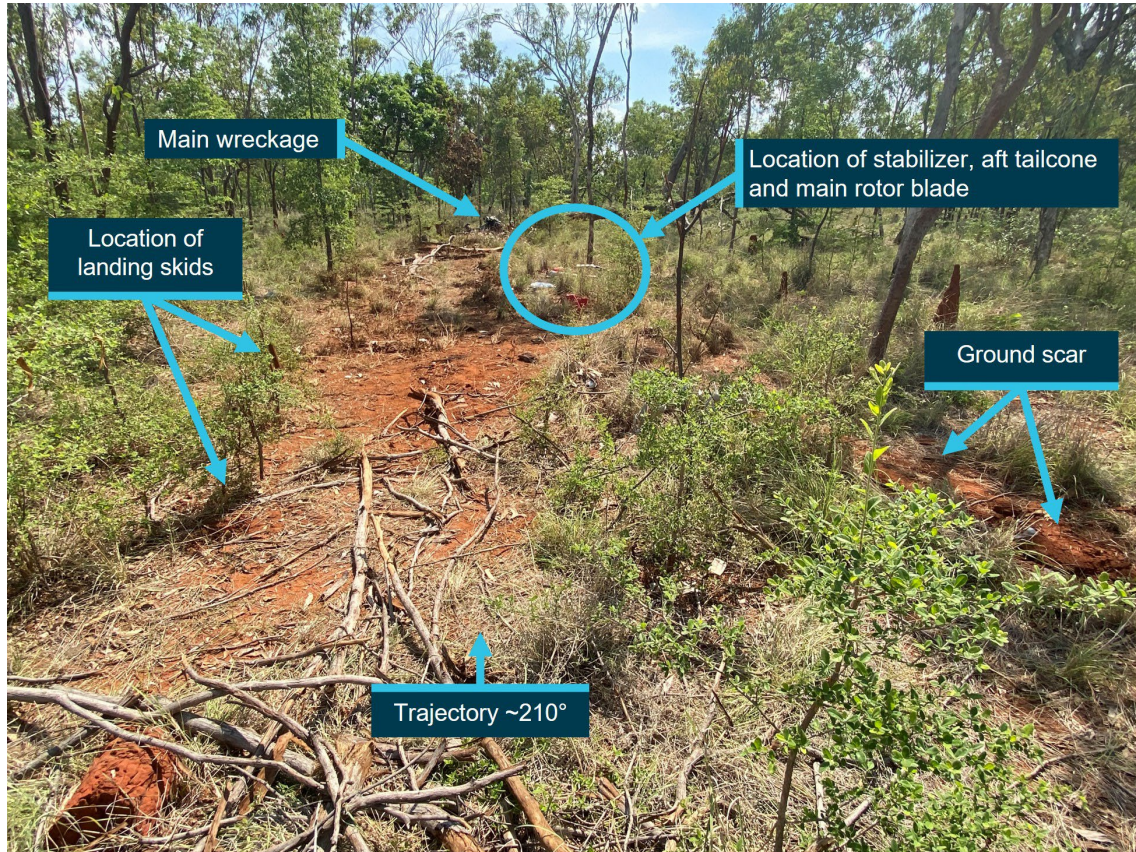
tailcone with the tail rotor and driveshaft, followed by one of the main rotor blades. The entire cabin forward of the vertical firewall was destroyed. The trail from the initial tree strike to the main wreckage was estimated by the ATSB to be about 46 m in length (Figure 4).¹¹

Figure 4: View of the wreckage trail

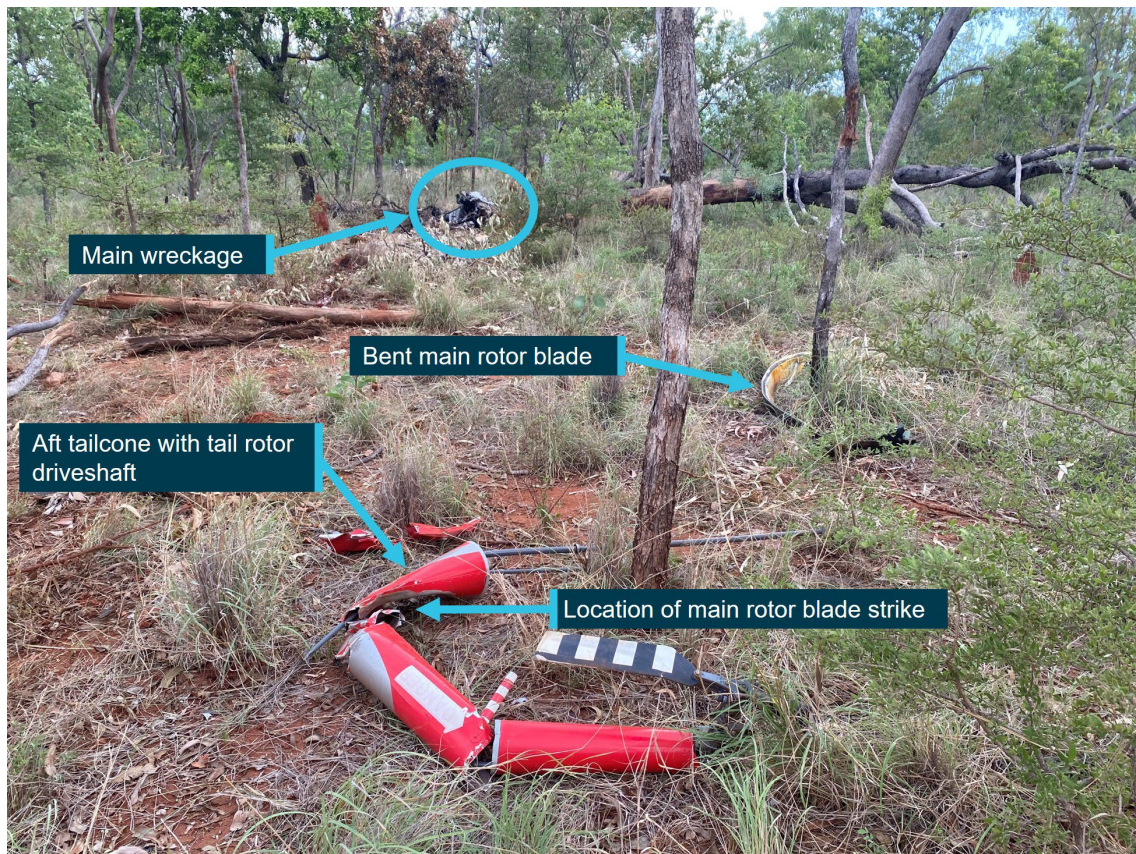
One of the main rotor blades separated in the accident sequence while the other remained attached to the rotor head. The detached blade showed evidence of upward and aft bending that presented as a significant upward bend at the blade root and buckling of the trailing edge (Figure 5). The detached blade also lost a small portion of the trailing edge section; however, the blade tip was present and attached. The opposite (attached) main rotor blade exhibited trailing edge buckling and had lost a section of the outer portion including the tip (found about 75 m beyond the main wreckage), which was consistent with the blade striking an object. A strike mark in the shape of a main rotor blade profile was present on the left side of the tailcone and the intermediate flex coupling exhibited significant tension, which indicated the tailcone was probably separated by a main rotor blade strike after the initial ground impact.

Figure 5: Aft tailcone and bent main rotor blade
