Collision with terrain involving Cessna 172S, VH-CPQ

1.9 NM west of Camden Airport, NSW on 24 January 2024

ATSB Transport Safety Report
Aviation Occurrence Investigation
AO-2024-002
Preliminary – 13 March 2024

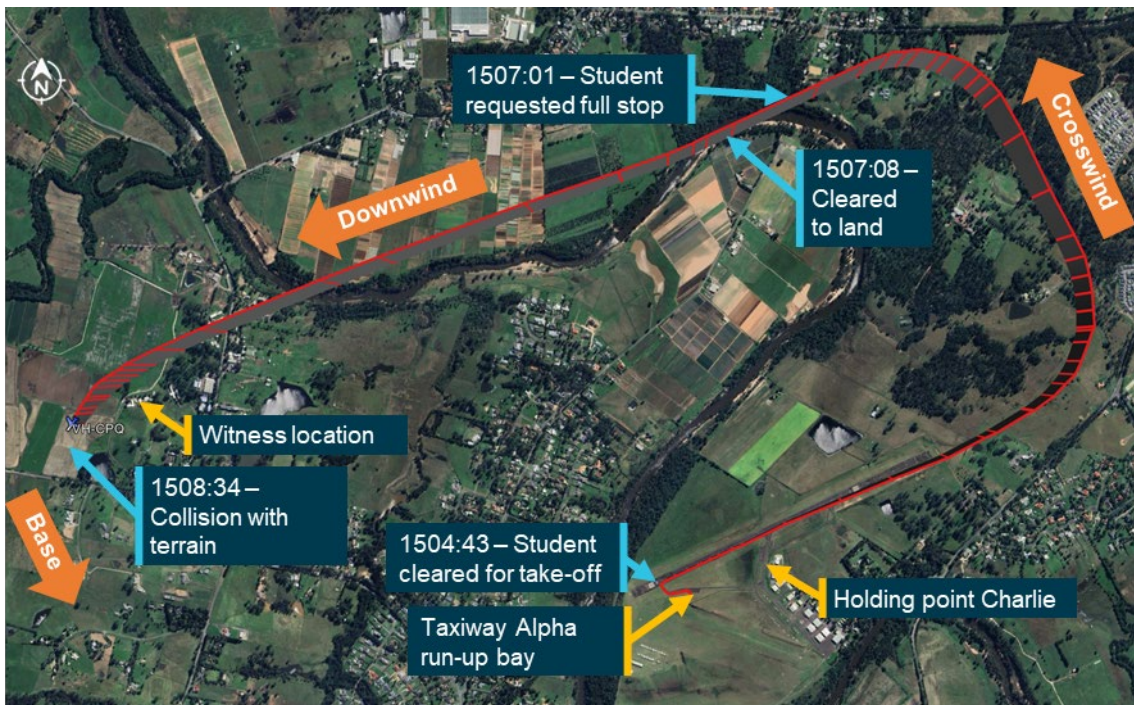
Figure 1: Flight path overview

The instructor recalled watching the student take off, turn onto the crosswind leg of the circuit and then onto the downwind leg (Figure 1). The instructor walked towards holding point Charlie which was the preferred viewpoint for the entire circuit. The student made a radio call stating ‘Charlie Papa Quebec downwind full stop’ and the instructor recalled hearing this before losing sight of the aircraft behind an obstruction. The controller issued the student pilot clearance to land 7 seconds later.

Upon reaching holding point Charlie, the instructor expected to see the aircraft turning onto the base leg or on base. However, they were unable to see it.

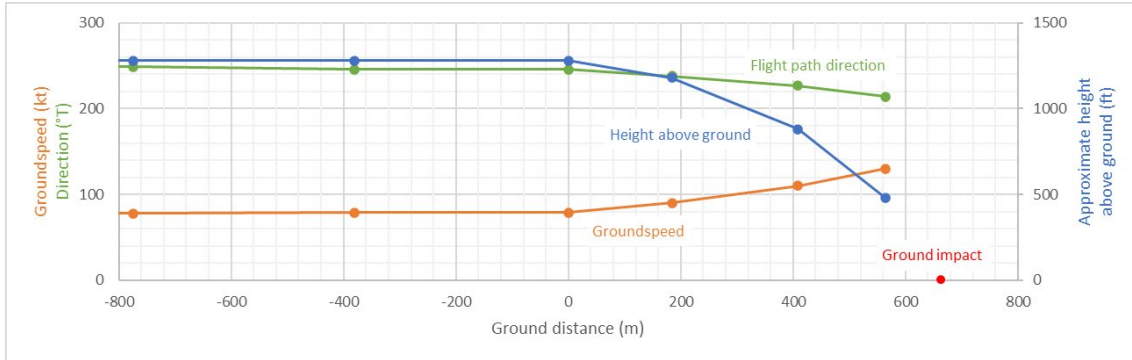
Figure 2: Recorded ADS-B data for the descent

ADS-B data showed the aircraft in level flight at 1,400 ft on the downwind leg. At about the time the aircraft would have been expected to turn onto base, the aircraft descended until it impacted the ground (Figure 2). The last recorded data point transmitted by the ADS-B system indicated a descent rate of about 10,500 ft/min with a groundspeed of 130 kt.

The height and distance axes are scaled 1:1. Ground distance is relative to the last recorded data point before the descent. Recorded altitude has been converted to height above the elevation at the point of ground impact. This was about 10 ft below the airport elevation. Source: ATSB

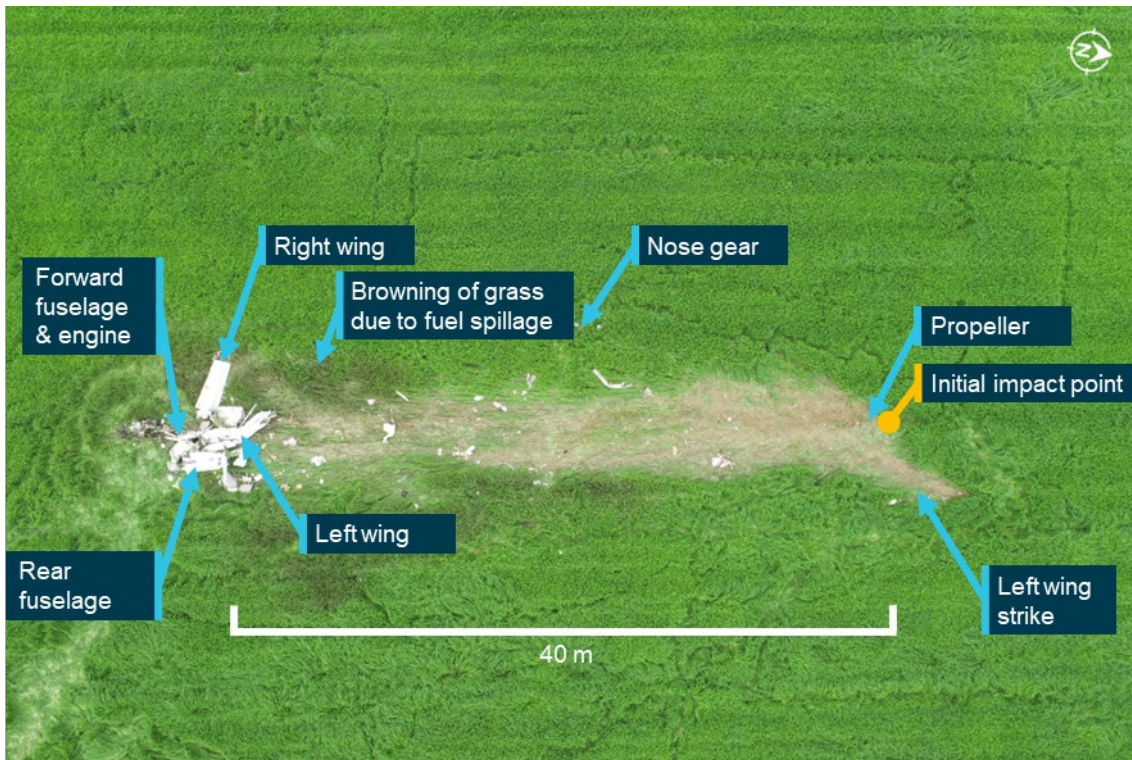
Figure 3: Overview of VH-CPQ accident site

The ATSB conducted an on-site examination of the aircraft wreckage. The accident site was approximately 1.9 NM west of Camden Airport, in a paddock. The wreckage trail extended in a southerly direction, about 40 m from the initial impact point to where the main wreckage, including the wings, empennage, and engine had come to rest (Figure 3). The propeller detached and was embedded in the soil at the point of initial impact. All components necessary for flight, including all major sections of the aircraft's structure and control surfaces, were accounted for at the accident site.

Ground impact marks and damage to the airframe indicated that the aircraft impacted the terrain in a slightly left wing-low, steep nose-down attitude at high speed. The airframe was heavily disrupted. Pre-impact flight control continuity was established and wing flaps⁸ were assessed to

have been extended but set at less than 10°⁹ at the time of impact. There was no evidence of an in-flight break-up or other pre-impact airframe or control defects.

On-site examination of the engine did not reveal any pre-impact mechanical issues, while damage to the propeller and marks in the soil at the impact indicated that the engine was producing power at impact.

Browning of the grass around the impact site was consistent with burning from contact with fuel. The distribution was consistent with fuel being released during the impact sequence.
