# Landing on a closed runway involving a Cessna 404, VH-HVR

near Pigeon Hole (ALA), Northern Territory, 24 July 2013

**ATSB Transport Safety Report**  
Aviation Occurrence Investigation  
AO-2013-127  
Final – 10 December

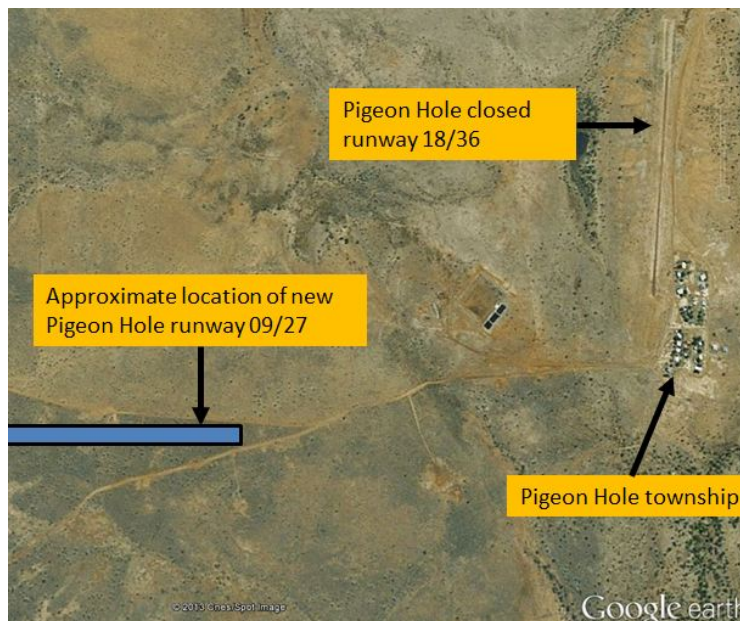
**Figure 1: Location of closed and new airstrip**

After landing, the pilot assessed the situation and elected to take off. During the take-off, the pilot confirmed that the engines were operating normally and after becoming airborne, observed the correct ALA about 2 km south-west of the Pigeon Hole Township (Figure 1).

The original Pigeon Hole airstrip was an uncertified, unregistered aeroplane landing area (ALA), located north of the Pigeon Hole Township. The airstrip had one runway aligned 18/36. The airstrip was privately owned and operated. About 1-2 years prior to the incident, the airstrip was closed. A new airstrip was developed about 2 km south-west of the Township, with one runway aligned 09/27.

The operator reported that, due to the proximity of the new airstrip to the closed airstrip and the fact that the latitude and longitude were provided in degrees and minutes only, the coordinates for both airstrips were the same. Furthermore, the operator's 'ALA book'<sup>2</sup> indicated that the runway direction was 09/27, but the electronic flight planning system indicated the runway was 18/36. The Aircraft Owners and Pilots Association of Australia (AOPA) National Airfield Directory 2012 also indicated the runway was 18/36.<sup>3</sup>

- **Closed airstrip:** They have asked the owners of the closed airstrip to place unserviceability cross markers at either end of the runway.
- **Pilot responsibilities:** Company pilots will be reminded of their responsibilities regarding the use of ALA's and the need to check and confirm all details contained in the ALA book prior to the commencement of a flight.

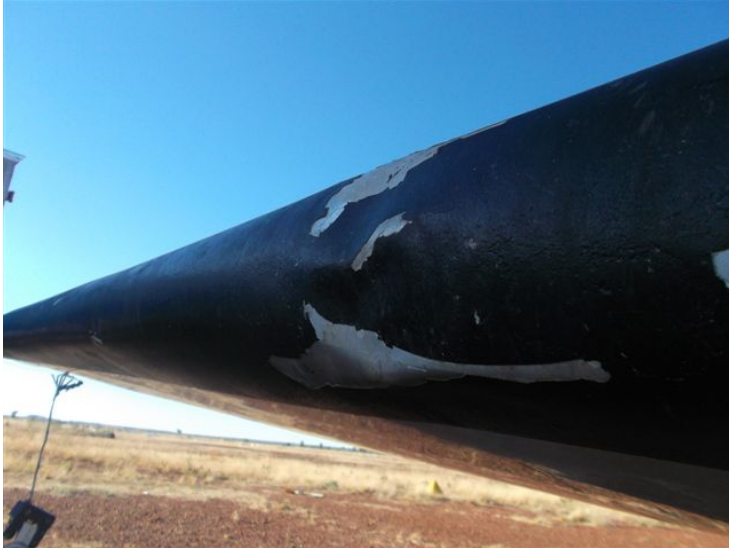
**Figure 2: Damage to leading edge**

At about 1500 CST, when below 300 ft above ground level, the pilot noted that there were no runway strip markers or windsock. The pilot then realised that the airstrip was closed, but due to the aircraft’s altitude, elected to continue the landing. During the landing, the aircraft struck vegetation, but the pilot did not believe the aircraft had collided with anything.

The pilot conducted an inspection of the aircraft and noted that minor damage had been sustained to the leading edge of the right wing (Figure 2) and propeller.
