**ATSB TRANSPORT SAFETY REPORT**  
Aviation Occurrence Investigation  
AO-2010-008  
Final

**Turbulence event**  
**Canberra Aerodrome, ACT**  
**31 January 2010**  
**VH-ERP**  
**Grumman Traveller AA-5**

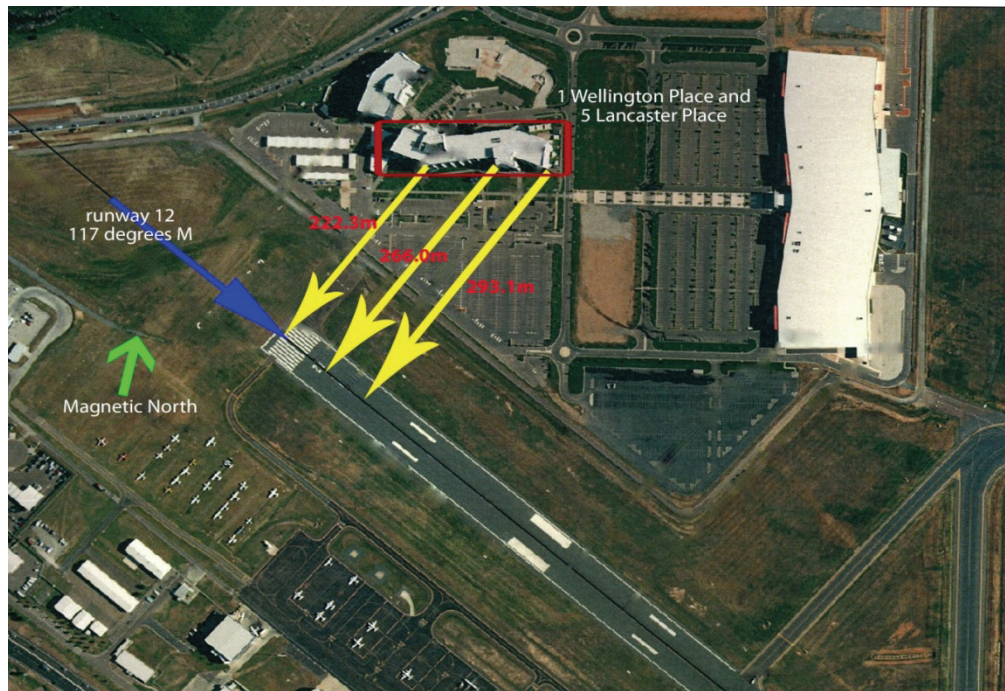
**Figure 1: Aerial view of runway 12 and Majura Park**

The pilot reported that, at about 1630 EDT<sup>3</sup>, just past the runway 12 threshold markings on approach to runway 12 and at an altitude of about 150 ft above ground level (AGL), the aircraft encountered severe turbulence<sup>4</sup>, which resulted in an uncommanded roll to the right of about 60° from the horizontal. The pilot's rapid input of full left aileron<sup>5</sup> restored control and the aircraft landed on runway 12, slightly past the marked touchdown zone.

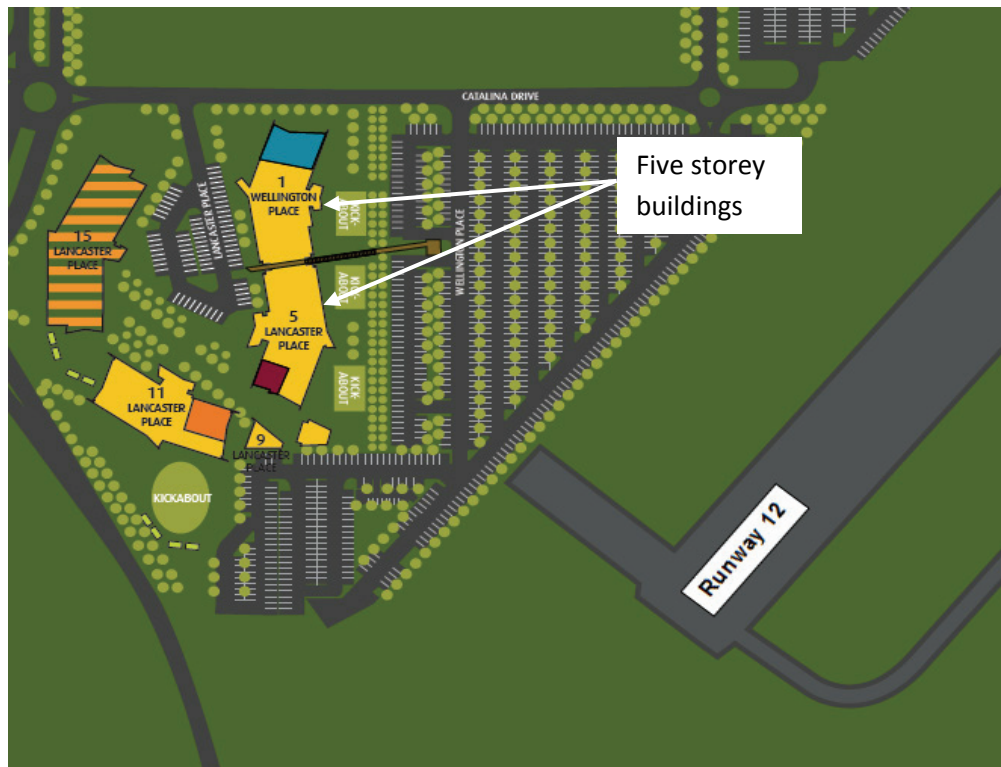
**Figure 2: The Majura Park precinct**

The two buildings adjacent and to the north of the runway 12 threshold were of five storeys, and were completed in April 2008 (Figures 2 and 3).

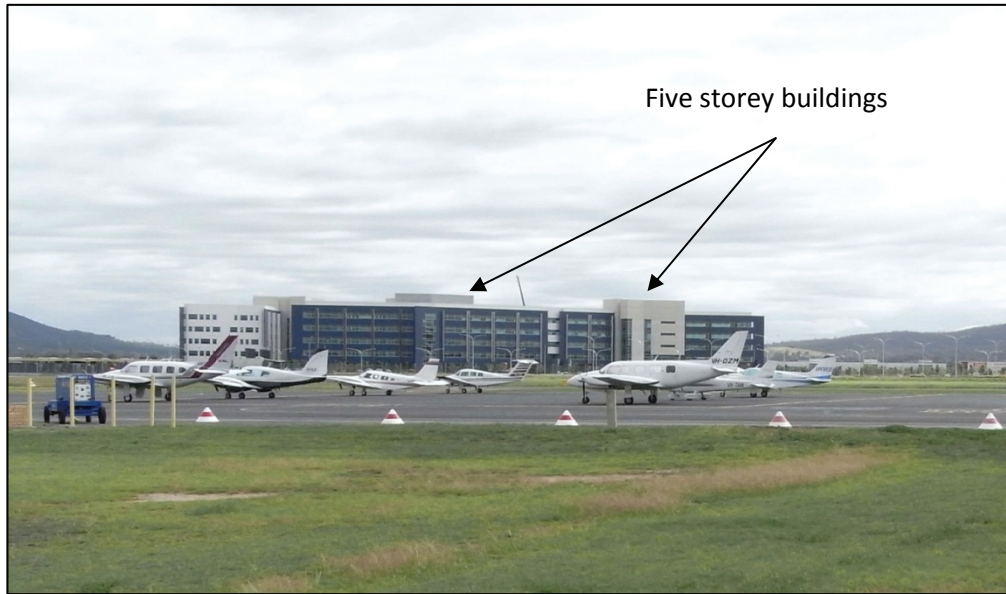
**Figure 3: Ground-based view of the adjacent buildings from the southern side of runway 12**

The buildings were 20 to 25 m in height and located between 222.3 m and 293.1 m from the approach and threshold areas of runway 12 (Figure 1). The position of the buildings was such that a large surface area faced directly into any north to north-north-easterly winds, interrupting the wind flow over the approach and landing areas of runway 12 (Figure 4).

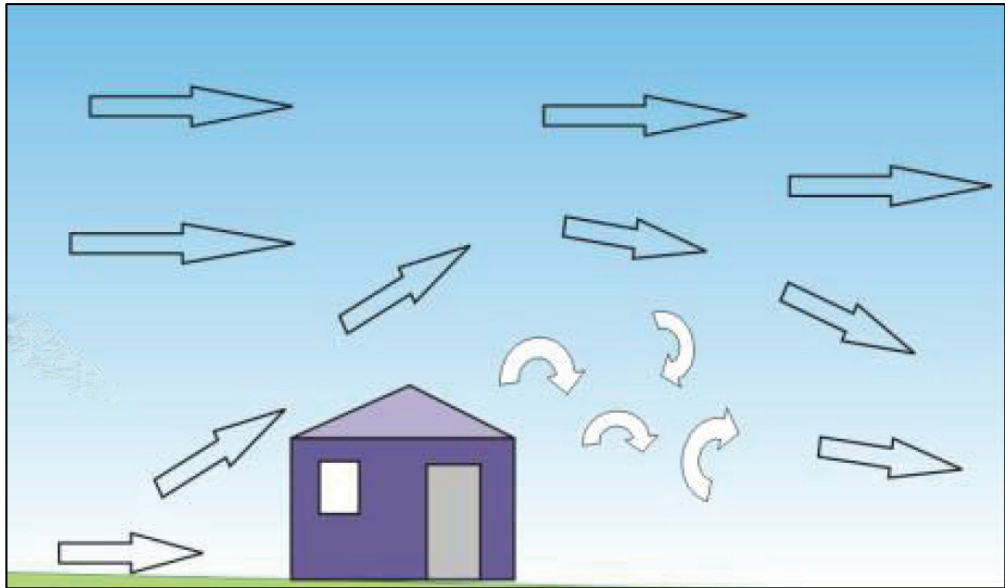
**Figure 5: Wind flow disturbance**

In such circumstances, the wind flow is diverted around and over the buildings causing the surface wind to vary along the runway (Figure 5). Horizontal windshear, which is normally very localised, shallow and turbulent, is of particular concern to light aircraft but has also been known to affect larger aircraft. In the case of low-flying aircraft, any significant eddies and gusts experienced during takeoff and landing may place an aircraft in a dangerous and possibly irrecoverable situation.

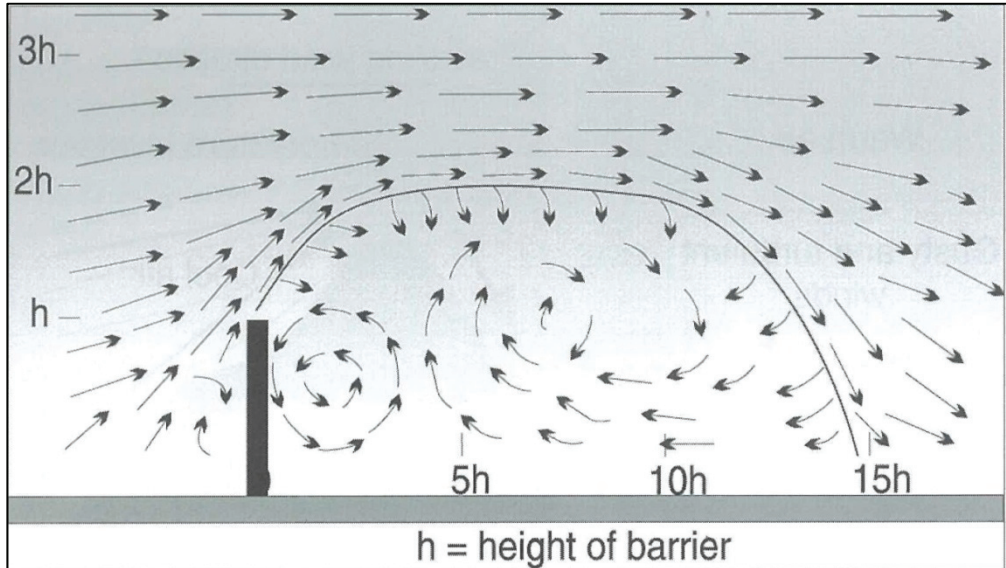
**Figure 6: Airflow near a solid (impermeable) crosswind barrier<sup>10</sup>**

In its report into the conditions that affected the aircraft's arrival, the BoM estimated that for smaller impermeable barriers, such as trees and buildings, it has been estimated that turbulence occurs up to about twice the height of the barrier vertically, and an equivalent distance downwind of up to 15 times the height of the barrier (Figure 6).
