Technical assistance to the New South Wales Police in the examination of components from amateur-built gyroplane G-2468

Collision with terrain near Allworth, New South Wales, 12 August 2023

ATSB Transport Safety Report

AE-2023-005

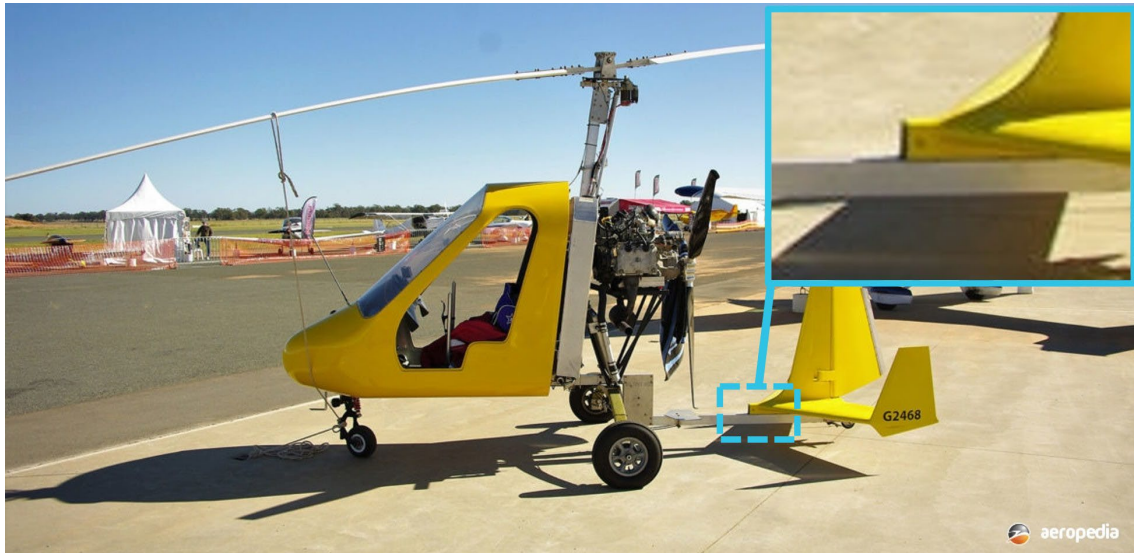
Figure 3: Tail installation on G-2468, highlighting the modified double-height keel

In contrast, when installed to G-2468, the tailplane was welded to the top of the existing keel, which introduced a second aluminium box section into the structure (Figure 3). The additional box section meant that the original rudder shaft was not long enough for this installation, and a replacement was manufactured.

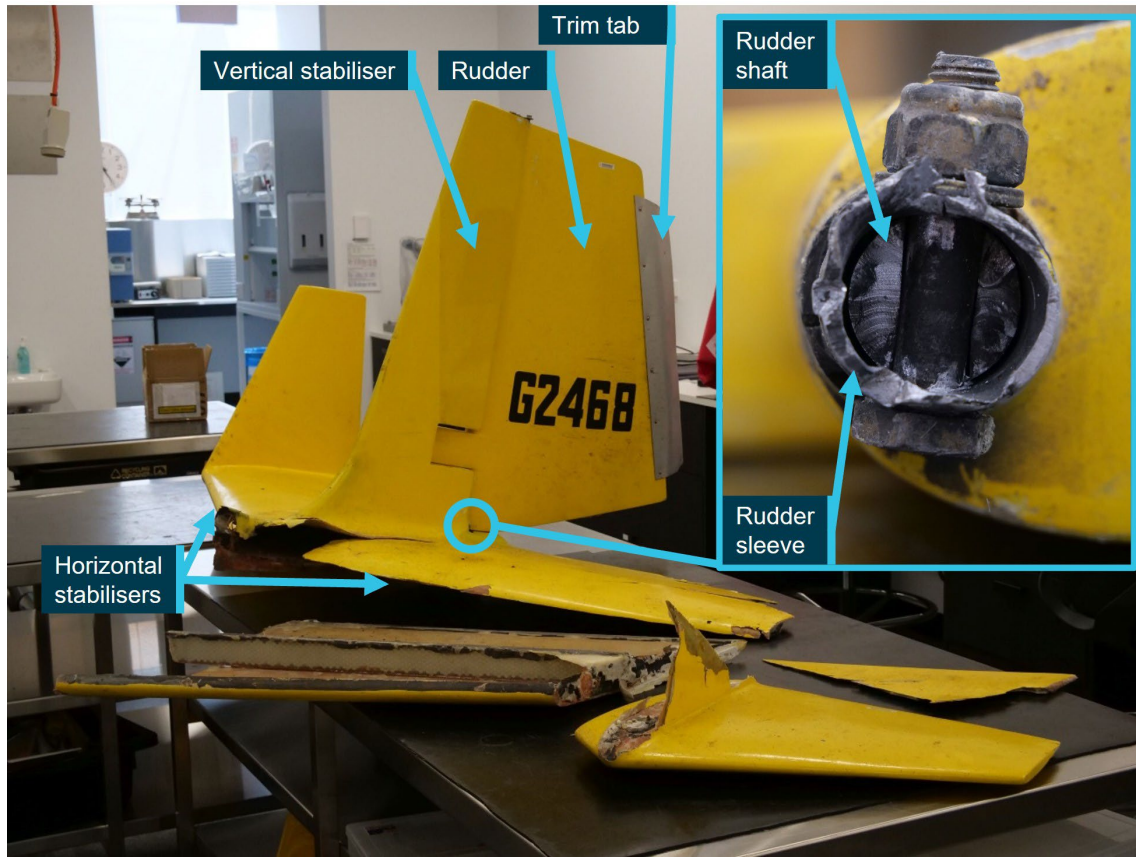
Figure 4: G-2468 tailplane as supplied for examination

The parts supplied for examination are shown in Figure 4. In addition to the requested examination, the ATSB noted that the trim tab on the trailing edge of the rudder was not original and had a larger surface area. Magni Gyro was unable to comment on the influence on flight loads of the rudder trim tab modification.

As shown in Figure 4, the majority of damage to the fibreglass tail structure was to the left side. The vertical tip was separated, the lower skin and spar was split from the left horizontal stabiliser and a triangular-shaped piece had fractured from the upper skin. No sections had separated from the right side of the tail, however there were large splits in the upper and lower skins at the leading and trailing edges. The underside of the right horizontal stabiliser, adjacent to the keel, appeared to have been sanded in preparation for painting, however the paint coating had not been applied.

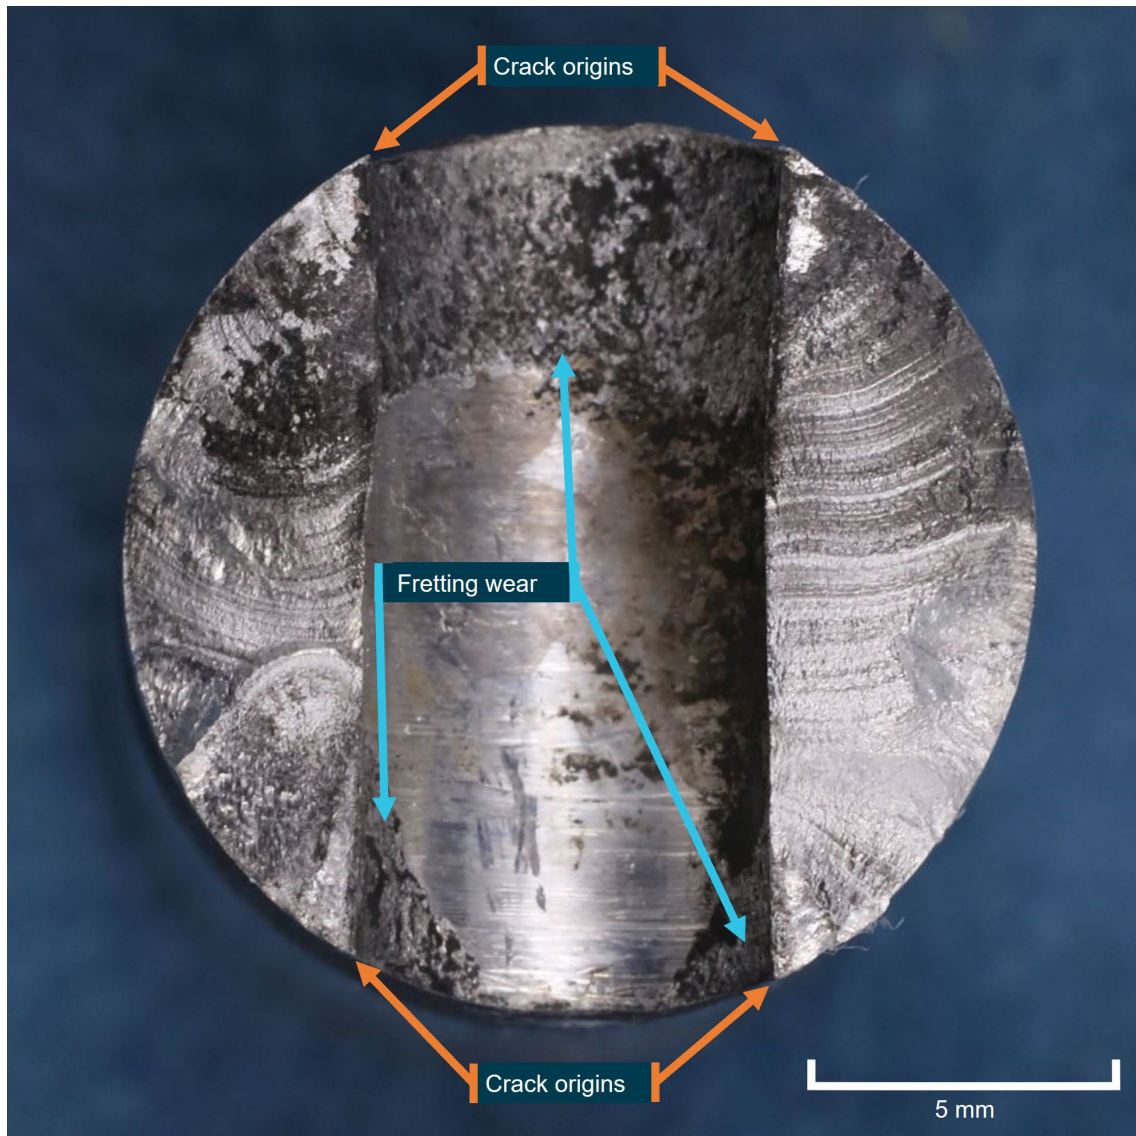
Figure 5: Rudder shaft fatigue fracture surfaces, and bolt hole exhibiting fretting wear

The rudder shaft was fractured at the point coincident with the bolt hole for attachment to the outer rudder sleeve (Figure 2, 4). The fracture surface exhibited extensive 'beach mark' features consistent with high cycle fatigue¹ crack progression (Figure 5). ATSB examination using optical and scanning electron microscopy identified that cracks had originated at all 4 corners of the bolt hole and progressed across approximately 98% of the cross-sectional area before final fracture.

Note: Concentric beach marks radiating outwards from the corners of the central bolt hole. The inside edges of the bolt hole are not square, and there is a difference in cross sectional area between the two sides of the fracture; The bolt hole is slightly offset to the left of the shaft centreline.
Source: ATSB

There was evidence of severe fretting² wear between the bolt and the shaft bolt hole. The shaft bolt hole was enlarged at either end, likely due to material loss from the fretting wear. The hole was slightly offset from the shaft centreline and there were no fillets applied to the hole edges for stress relief.

The fatigue cracking of the rudder shaft was the result of fretting fatigue at the areas of highest stress concentration: the sharp corners of the bolt hole. Compared to plain fatigue, fatigue under fretting conditions results in a significant reduction in fatigue life. The progressive wear of the bolt hole and the rudder sleeve would also have resulted in an abnormal loading condition due to the excessive bolt clearance.

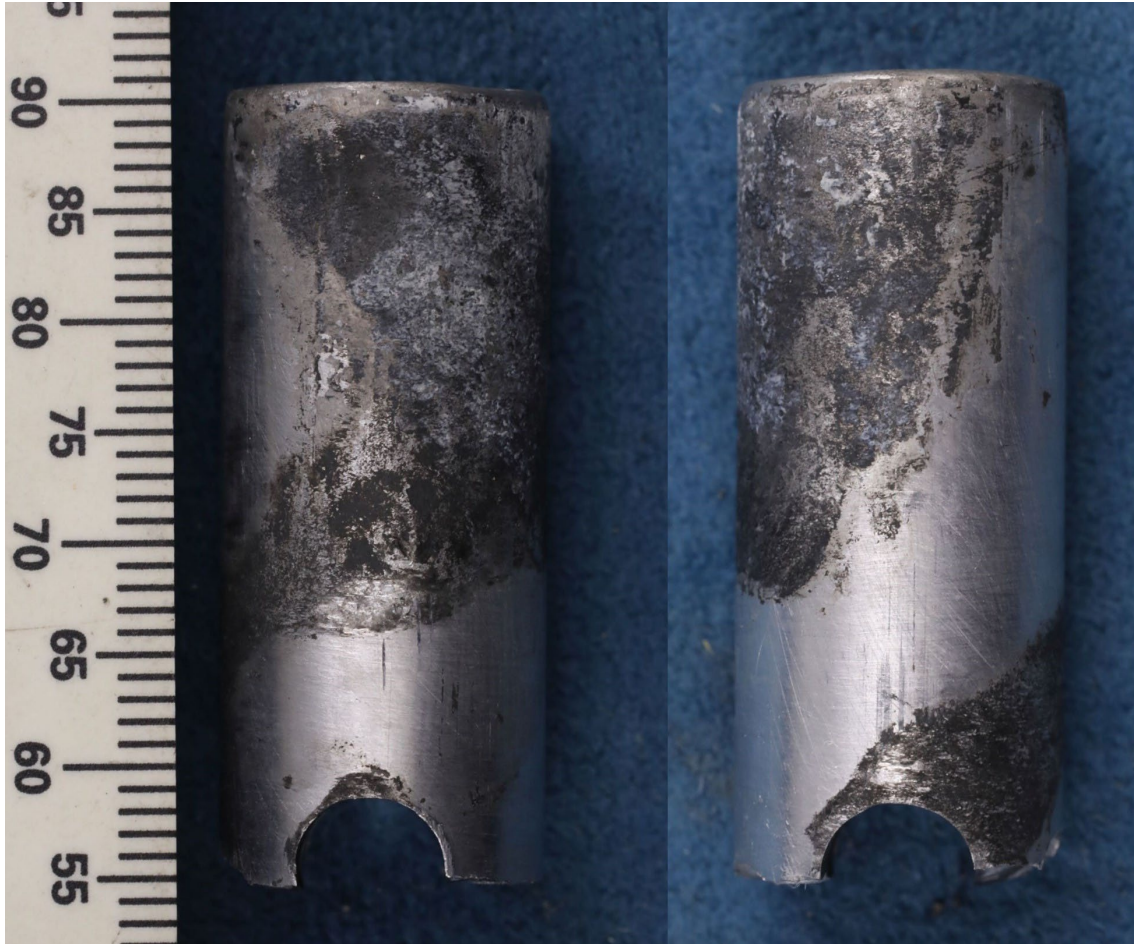
Figure 6: Rudder shaft wear from contact with outer sleeve

There was also wear between the shaft and the rudder outer sleeve (Figure 6), and between the outer sleeve and the bolt (Figure 7). The sleeve bolt holes were deformed ('ovalised') and one side was fatigue-cracked.

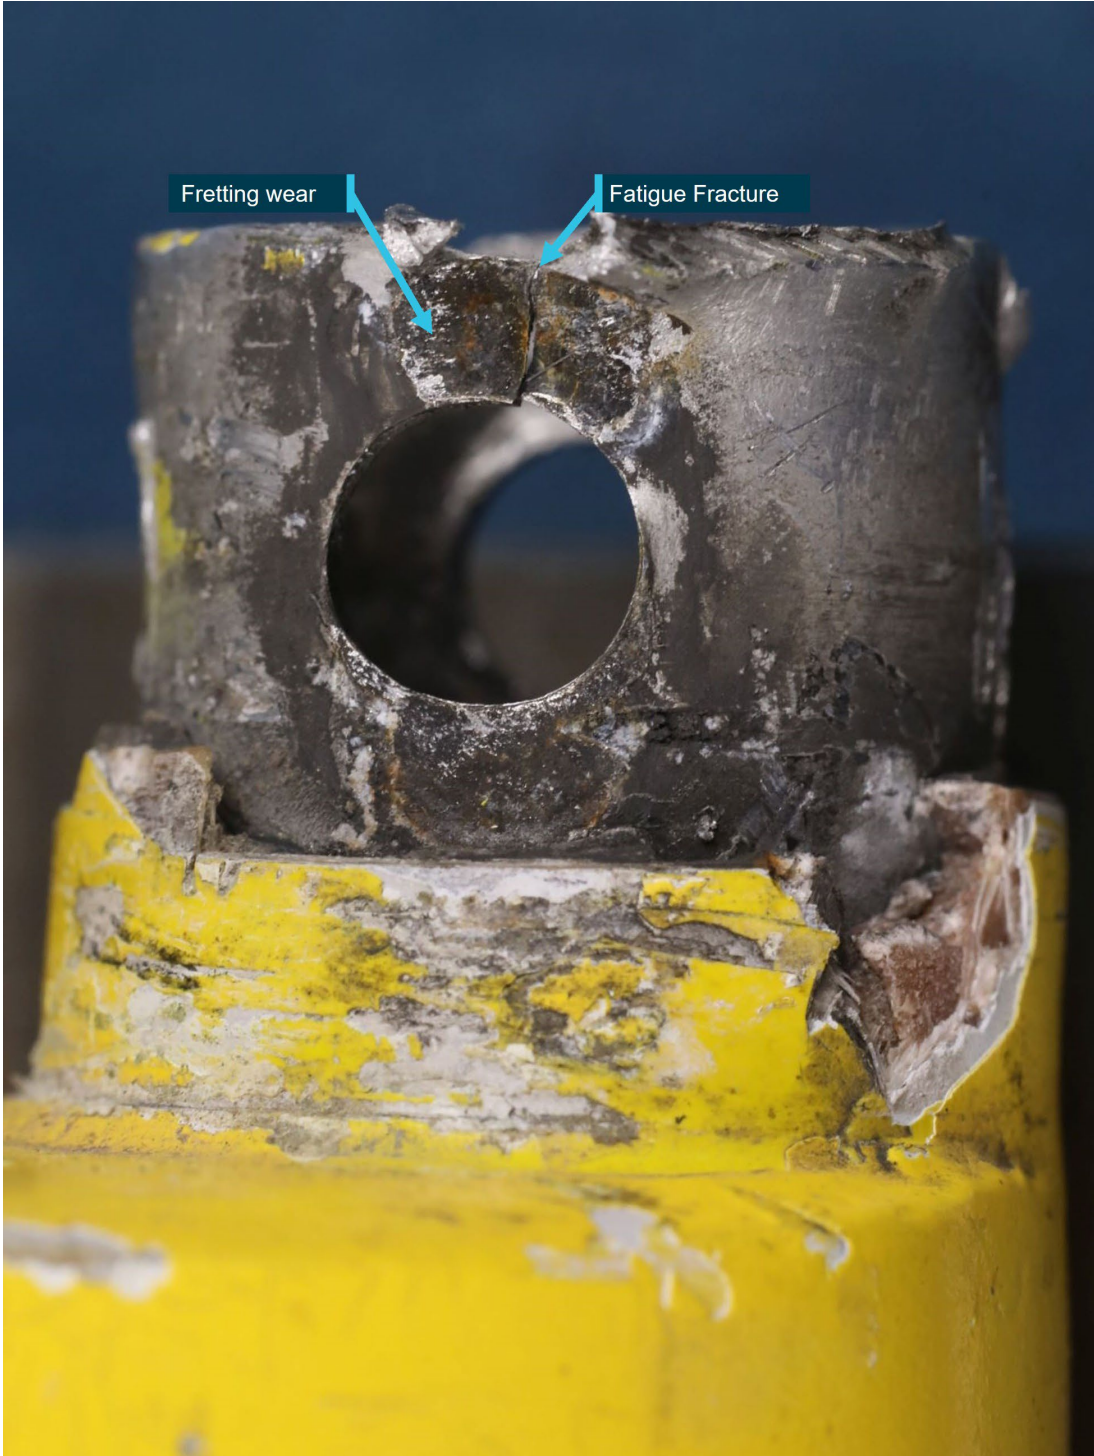
Figure 7: Rudder sleeve wear from contact with washer, and associated cracking

The rudder sleeve was the original part, though had been modified. It had been involved in two reported rollover accidents, the most recent of which required manufacture of a new rudder shaft. The condition of the sleeve at the time could not be established, however it was possible that the sleeve had been damaged in one of these events, resulting in deformation of the bolt holes which would have allowed movement and fretting to occur between the components.

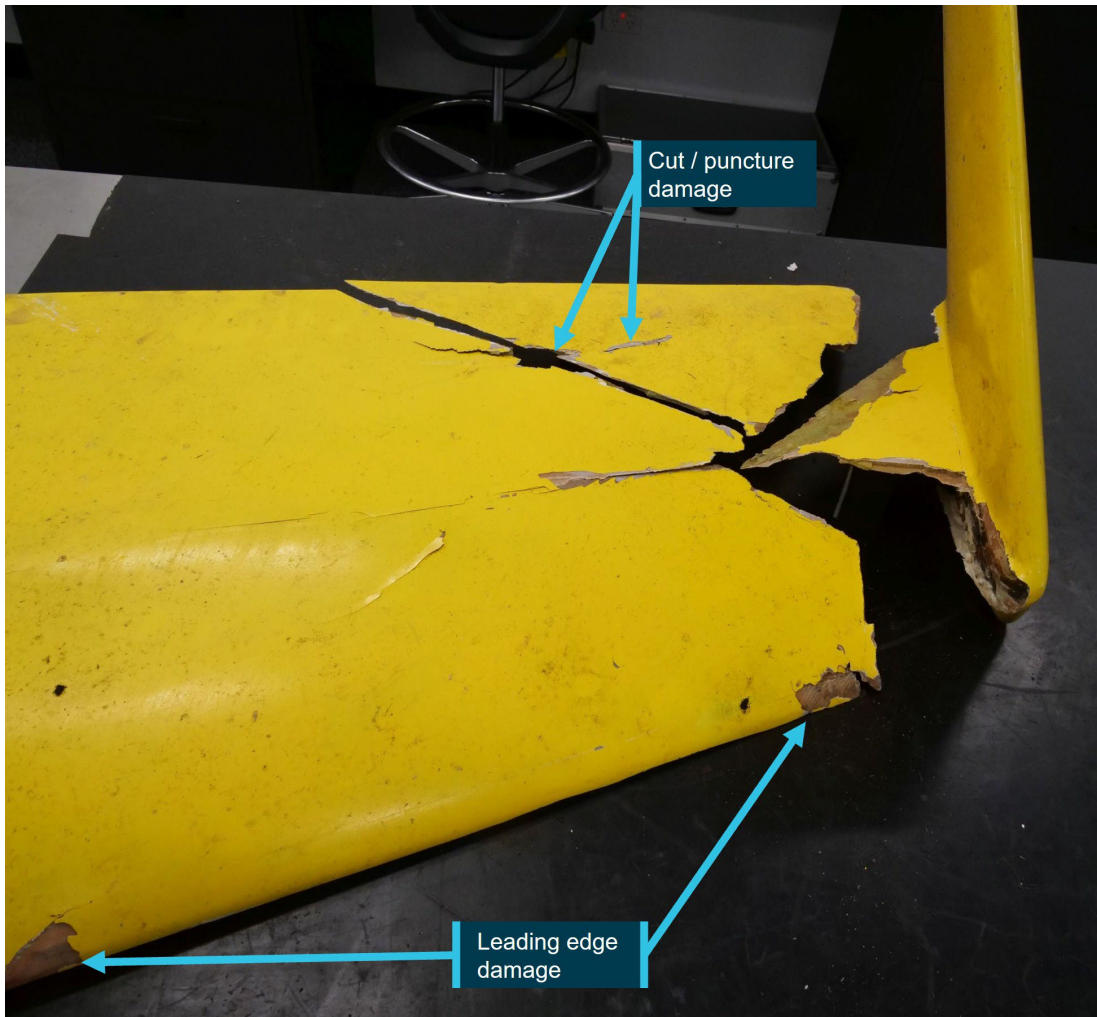
Figure 8: Damage to upper skin of left horizontal stabiliser

There were 2 areas of paint and fibreglass damage to the leading edge of the left stabiliser upper skin (Figure 8). There was also a cut through the upper skin and a larger puncture spanning both halves of the upper skin sections.

Damage to the tail assembly was largely to the upper surface of the left stabiliser, which was consistent with the ASRA finding that the gyroplane was inverted as it impacted the trees.

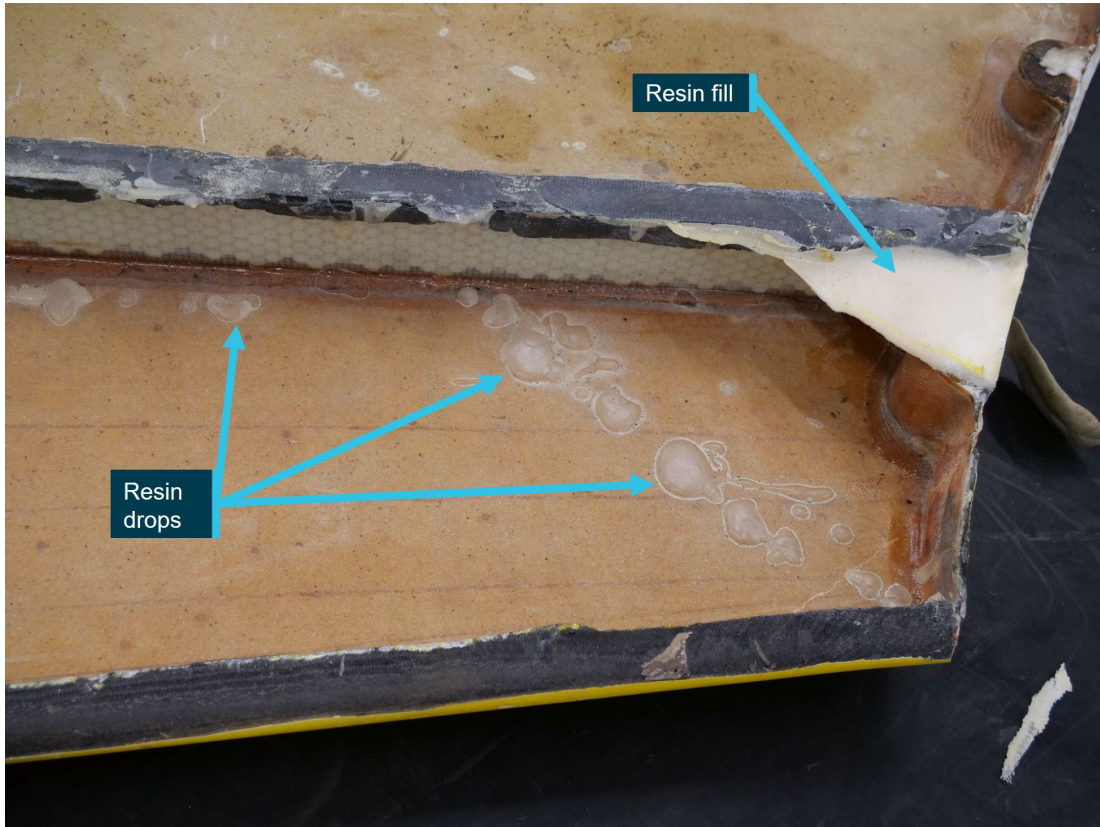
Figure 9: Evidence of prior repair with large volume of disbonded resin.

The skin of the tail structure was a sandwich panel consisting of fibreglass skins separated by a foam core. The interior of the left stabiliser had evidence of the reported previous repairs. This included significant amounts of resin fill and drops on the lower skin along the spar (Figure 9). Although there was a considerable amount of resin area at the inboard end of the left spar, none of the upper skin panel remained bonded. There were also areas where the inner fibreglass skin and sections of core were missing and resin had been applied over the top of the damaged structure (Figure 10). One of the larger areas of this type had cracked from one side but was otherwise intact after the accident.

Some of the fibreglass repairs on the tail structure were not carried out to a standard that preserved the integrity of the original part. The missing sections of fibreglass skin and core would be detrimental to the strength and stiffness of the structure. Additionally, the large areas of resin that were disbonded from the substrate suggested that those areas of repair likely had a low adhesive strength, which would similarly be detrimental to the structural integrity of the tail.
