# Collision with terrain involving Air Tractor AT-400, VH-ACQ

75 km west-south-west of Moree, New South Wales, on 4 December 2021

## **ATSB Transport Safety Report**

AO-2021-052

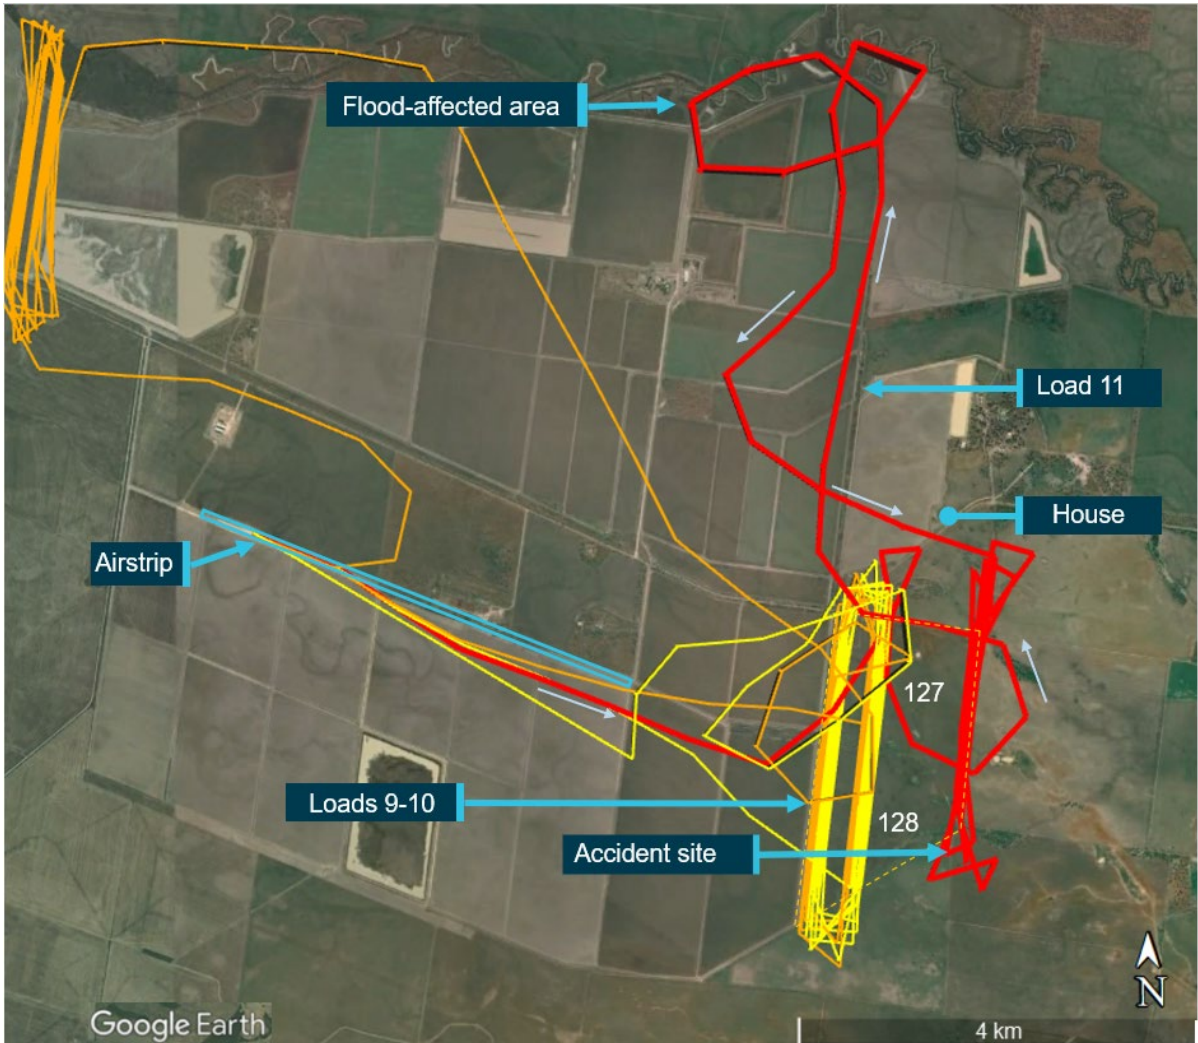
Figure 3: GPS data showing the aircraft's track on the accident load

At 1126:15, the aircraft departed on the eleventh load and tracked again towards blocks 127 and 128 to recommence spraying the next run from where they had left off (as can be seen in Figure 3), in the racetrack pattern. The pilot commenced a run to the south, but before reaching the target crop, the aircraft climbed and turned left. The aircraft then overflowed the northern boundary of block 127, which was also the property boundary. The operations manager heard the pilot on the radio expressing concern about the potential for chemical spray to drift towards a house on the neighbouring property due to the wind. The aircraft then tracked north and again overflowed the flood-affected area (top of Figure 2 and Figure 3), before returning to the north-eastern end of block 127 (Figure 3).

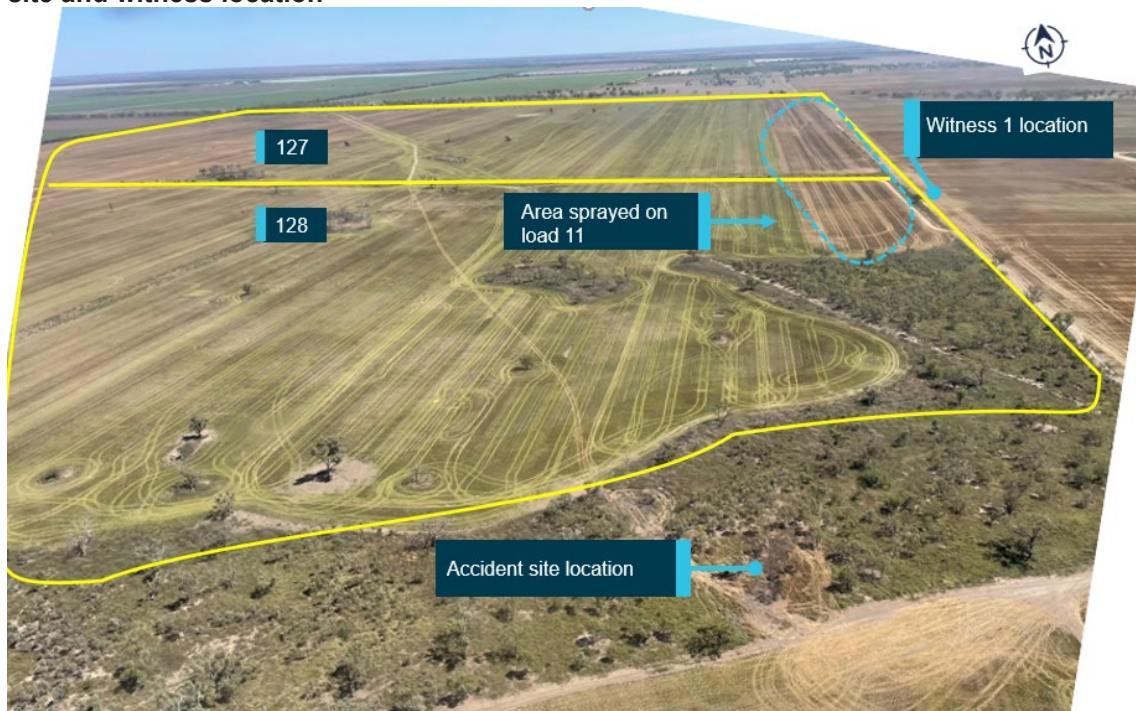
**Figure 5: Aerial photo of target spray area taken 10 December 2021, showing accident site and witness location**

A witness ('Witness 1', Figure 5) located in the neighbouring paddock to the east, observed the aircraft turn slightly left then enter a right turn, consistent with a procedure turn. During the turn, the witness observed the aircraft's nose pitch down and it descended rapidly, right-wing low, then disappeared behind trees. The witness reported seeing a black plume of smoke rise almost immediately afterwards.

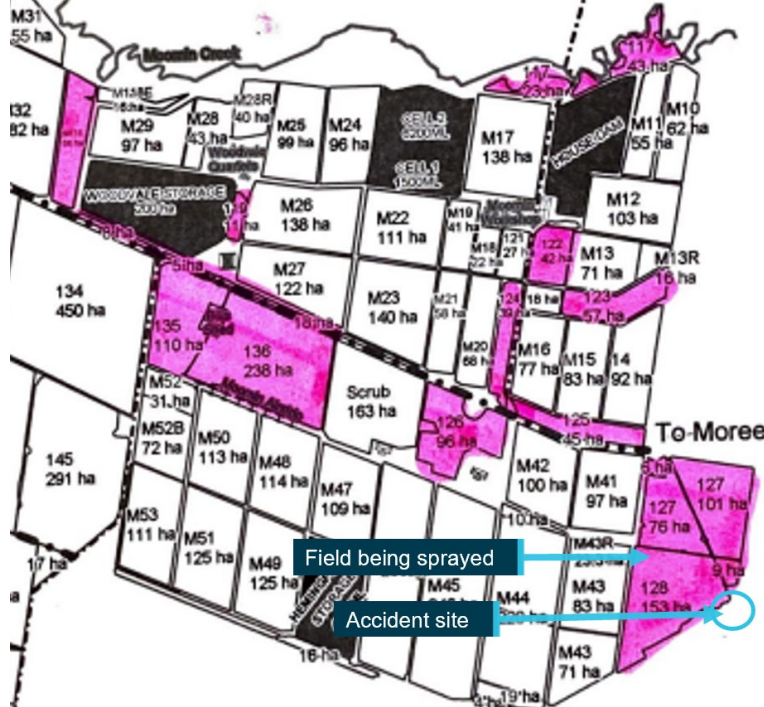
Figure 8: Work order map depicting areas to be sprayed and location of the accident site

The pilot had operated at the same property on 2–4 December. The blocks allocated to the pilot to be sprayed were depicted on multiple work orders for the property, one of which is depicted in Figure 8. Of the blocks depicted in Figure 8, on 4 December the pilot sprayed blocks M10, M11, M24, M25, M118, before commencing blocks 127 and 128. Block 117 was the wet area along the river and 123, 124 and 125 were not to be sprayed (although as they had powerlines in them, the pilot had been told not to spray them anyway).

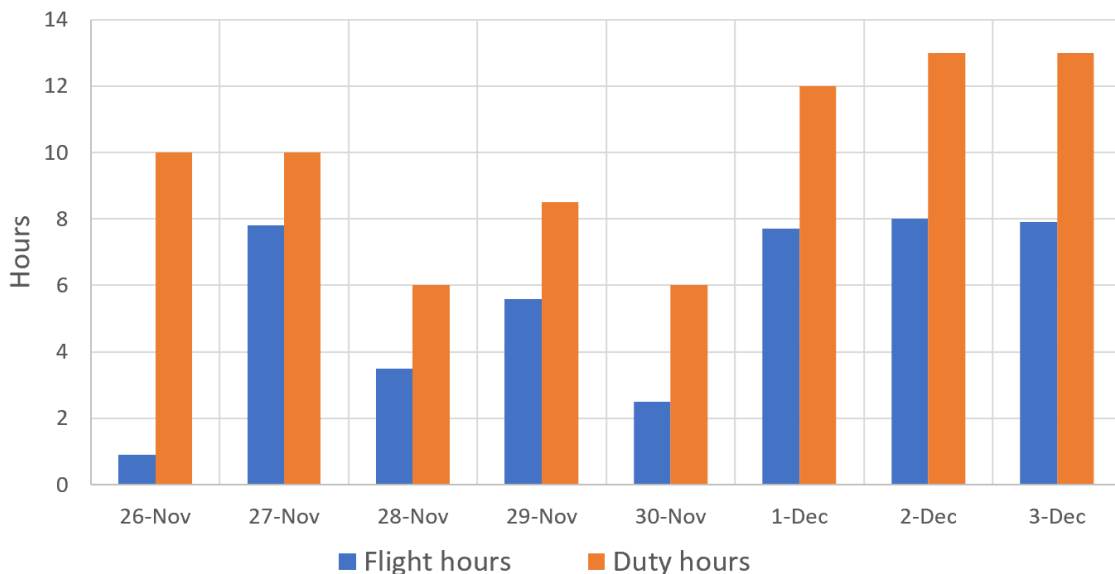
**Figure 9: Recorded flight and duty times from 26 November to 3 December 2021**

The pilot’s most recent day off work prior to the accident was 25 November. After their day off, on 26 November the pilot commenced the transition to turbine-engine aircraft. Figure 9 and Table 2 show the pilot’s flight and duty records from 26 November to 3 December. The first time (ever) that the pilot flew VH-ACQ, was 5 days before the accident on 29 November. On that day, the pilot was awake at 0454 and home at 2126, having logged 5.6 hours of flight time in VH-ACQ.

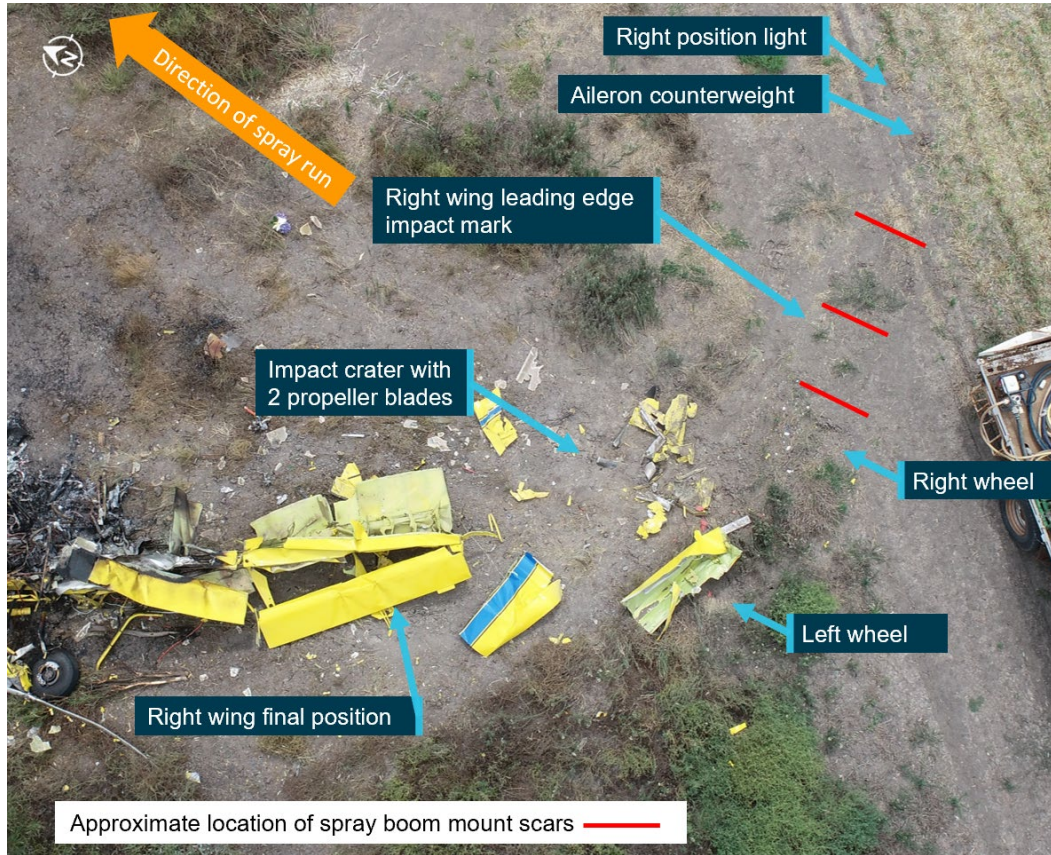
Figure 10: Initial impact points – right wing, main landing gear and propeller

On-site examination of the wreckage and surrounding ground marks indicated that the aircraft impacted terrain upright, in a nose-down attitude of about 40°, with the right wing down about 10°. The propeller, main wheels and wing leading edge impacted the ground first (Figure 10), during which the fuselage right bottom longeron<sup>16</sup> fractured and punctured the right wing main spar (Figure 11). Two propeller blades were located at the engine point of impact.

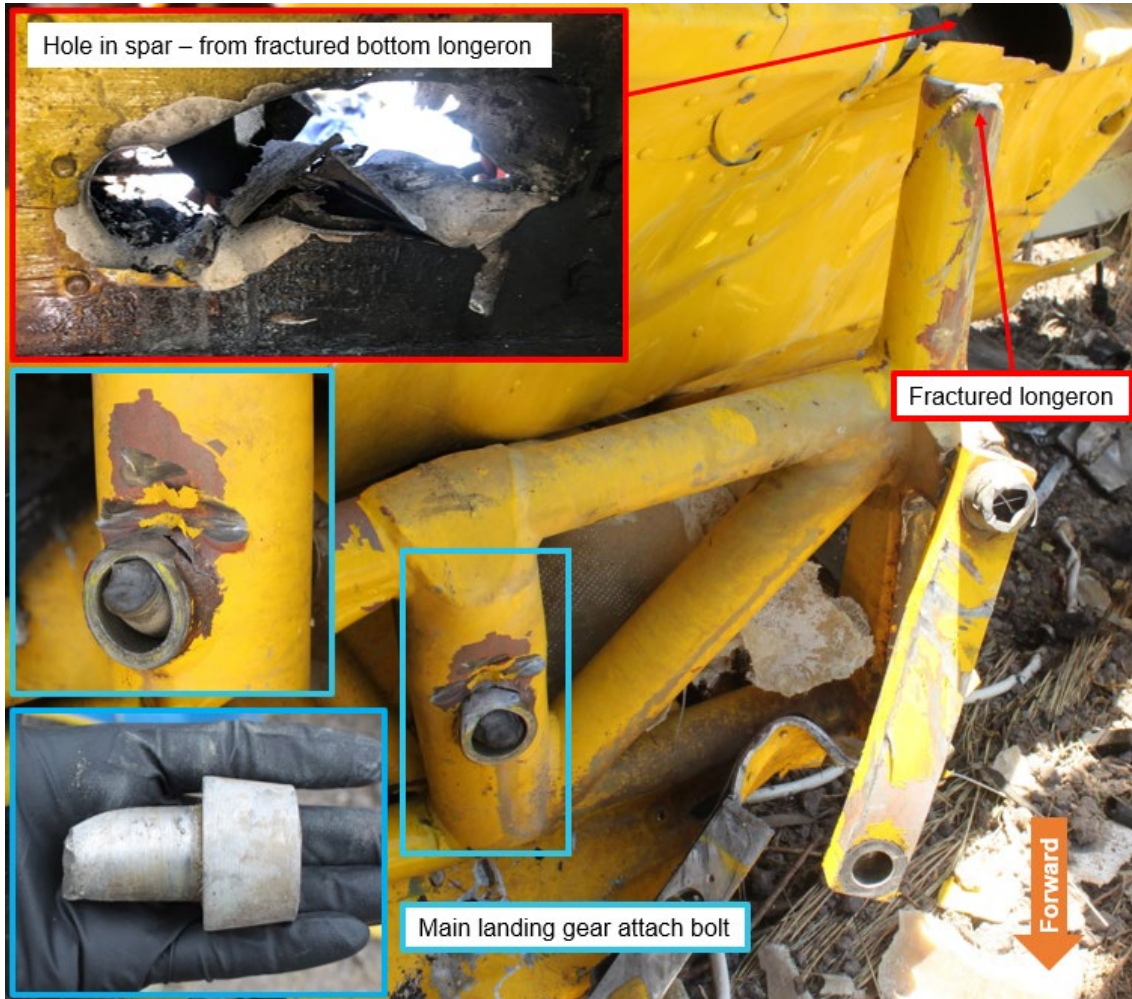
**Figure 11: Fuselage frame longeron fracture and associated impact damage with main spar damage to right wing**

Forward momentum then collapsed the forward section of the fuselage and resulted in the main spar rotating about 120° and separating from the fuselage. The aircraft then continued a short distance rotating to the right, consistent with a right turn/spin, and came to rest facing approximately east.

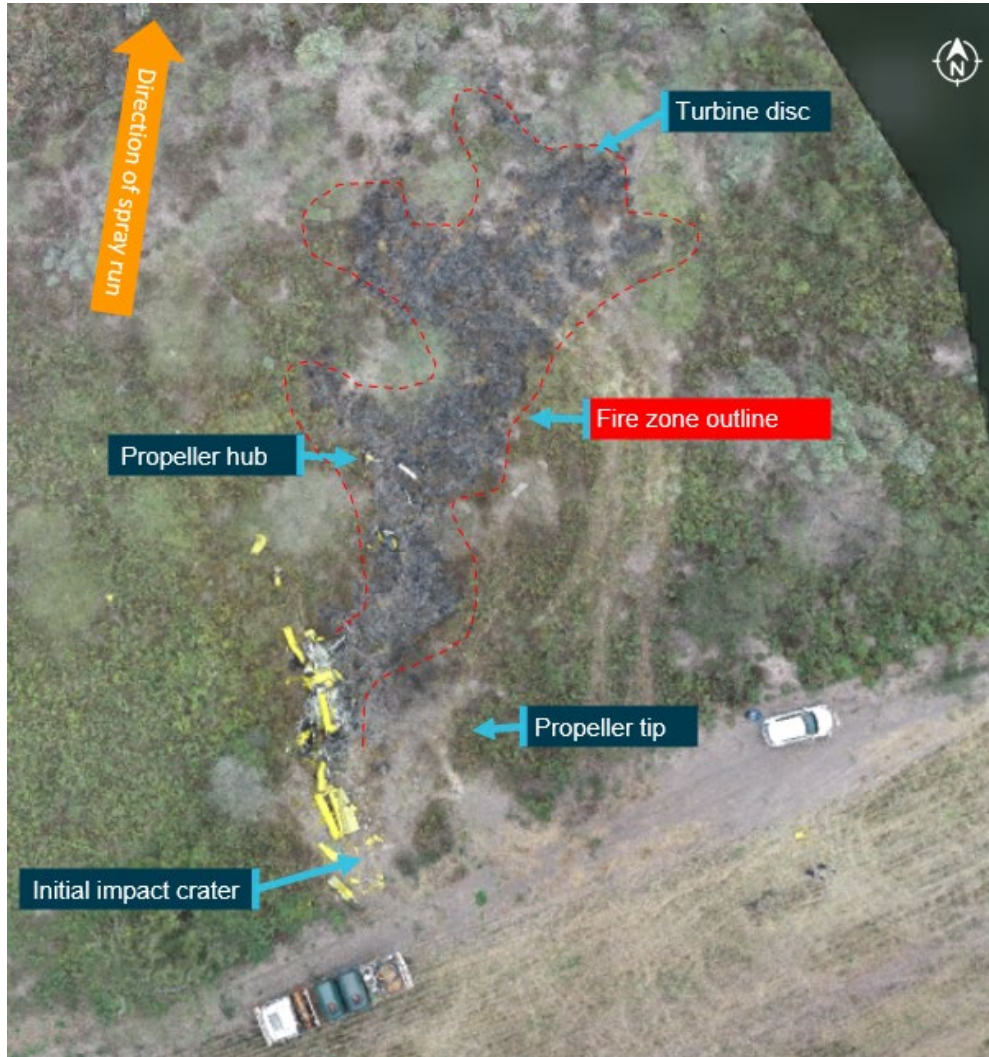
Figure 12: Overview of accident site and fire zone

The engine fractured in half around the flange 'C' area (ring of bolts joining the exhaust casing to the gas generator casing), with the gas generator module remaining near the fuselage. The propeller hub, with propeller blade, the engine power section module, including power turbine wheel, was recovered about 27 m from the impact point, in the direction of the target crop (north). The liberated compressor turbine disc was found a further 30 m beyond the hub in a similar direction (north-east), and at the edge of the fire zone (Figure 12).

The flame front and debris trail were in the direction of the wind (towards the north-east) and towards the target crop (north). The propeller hub displacement and fire zone were consistent with the aircraft's trajectory prior to the loss of control, and with ignition at the final resting place. There was no evidence of fire at the initial impact point.
