Flight crew incapacitation involving Boeing 717, VH-NXM

on approach to Hobart Airport, Tasmania on 6 June 2023

ATSB Transport Safety Report

AO-2023-026

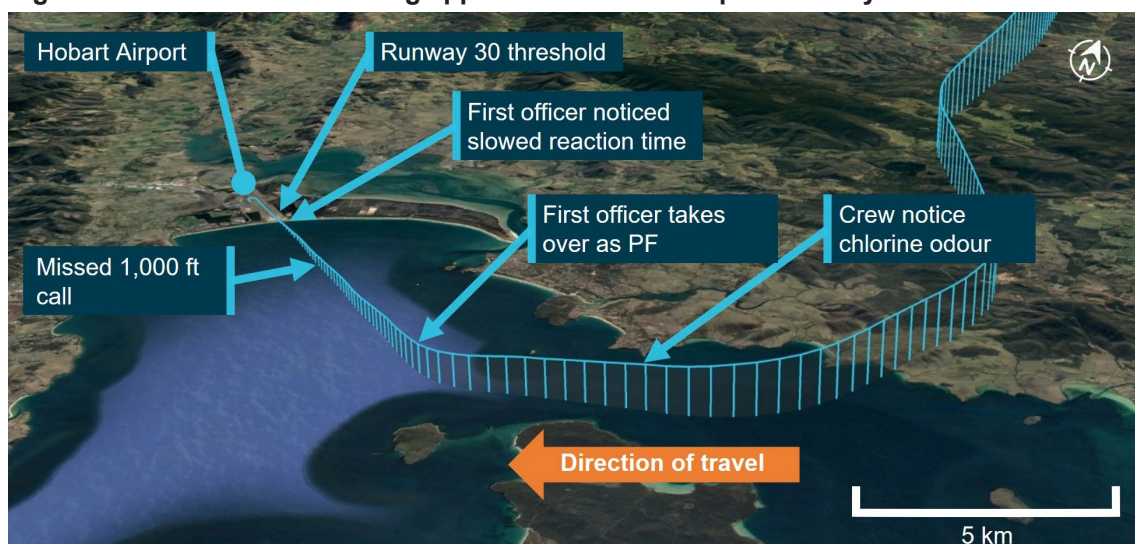
Figure 1: VH-NXM track showing approach to Hobart Airport and key events

At about 2108, about 10 NM from Hobart Airport (Figure 1) and at an altitude of about 4,000 ft, the captain noticed a chlorine odour, which they assessed as coming from the flight deck air-conditioning gasper vents. The first officer noticed the odour shortly after the captain but neither the captain nor first officer experienced any effects at this time. The captain and first officer reported that the odour was transient and disappeared after about 10 seconds.

About 30 seconds later, while the flight crew were configuring the aircraft for landing² on runway 30, the captain noticed quickly developing adverse effects on vision, mental capacity, and movement, and self-assessed as unable to safely fly the aircraft. The captain later described the symptoms as fogginess of thought, confusion, deteriorating situational awareness, weakness and tingling in the arms and legs, and narrowing of vision. The captain indicated their intention to transfer control of the aircraft to the first officer by stating 'your controls'. At that time the first officer noticed that the captain looked pale but did not appear incapacitated.

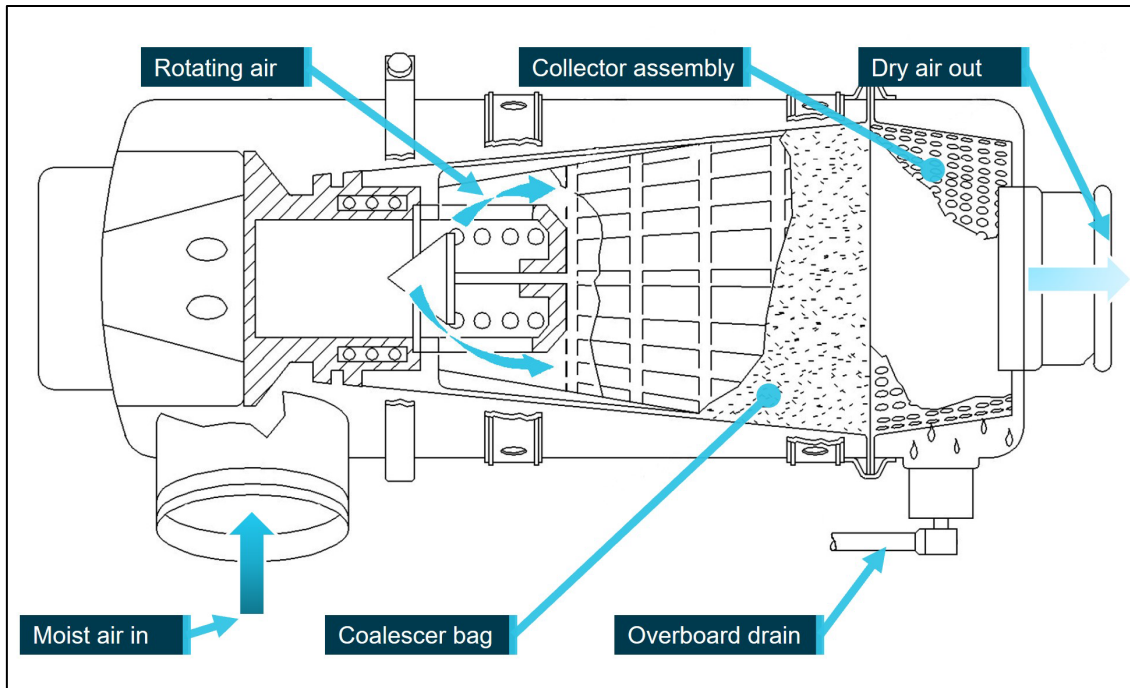
Figure 3: Water separators

Condensation is removed from the conditioned air by 2 independent water separators located at each PACK output manifold. Air entering the water separator is made to rotate by vanes in the inlet ducting. Centrifugal force causes the heavy water droplets to move to the outside of the separator and is collected by a coalescer bag and collector assembly, the water is then directed overboard, and the dry air continues through the system (Figure 3). The coalescer bags can be cleaned or replaced as required to prevent the build-up of contaminants and odours in the system.
