Descent below segment minimum safe altitude involving Fokker 100, VH-FGB

near Adelaide Airport, South Australia on 30 August 2023

ATSB Transport Safety Report

AO-2023-041

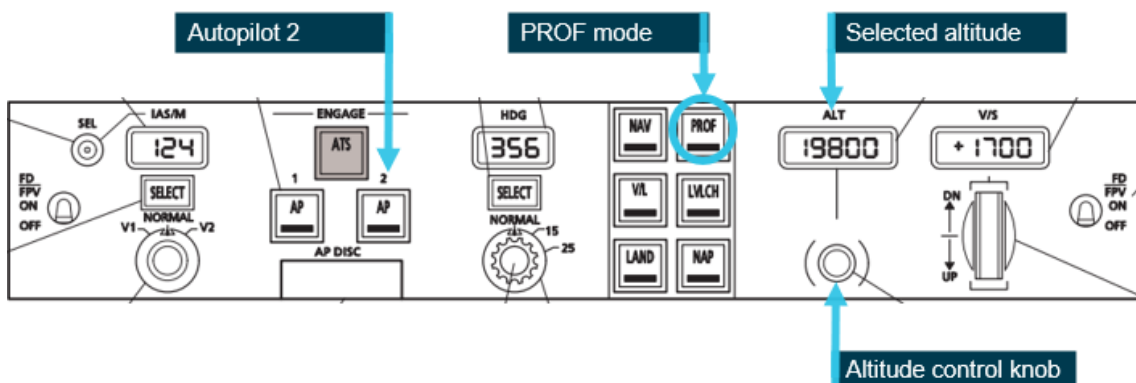
Figure 1: Flight mode panel

Prior to departure from Brisbane, the flight crew entered the planned route, arrival, and approach procedures into the flight management computer. The flight crew selected the vertical navigation profile (PROF) mode, which was then armed to automatically capture the altitude at which the climb thrust was reduced (see the section titled *Automated flight*). The PROF mode is a flight management system (FMS) managed mode, in which the FMS controls the aircraft's vertical path. However, an altitude selected by the flight crew at the flight mode panel (FMP) (Figure 1) takes precedence over PROF commands. The flight crew also selected and armed the FMS-managed lateral navigation (NAV) mode.

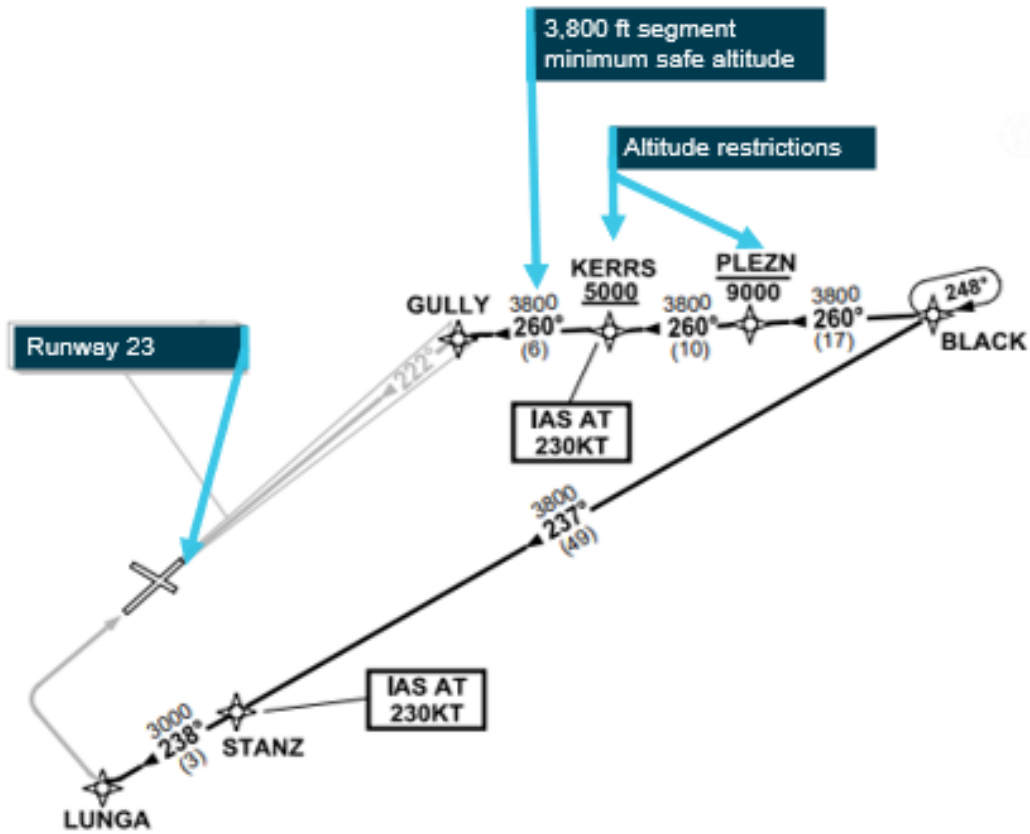
Figure 2: Extract of BLACK 3A standard instrument arrival chart

The flight crew had entered the expected Adelaide BLACK 3A standard instrument arrival (STAR) and instrument landing system (ILS) – Z for runway 23 into the FMS. For that STAR, there were FMS-coded altitude restrictions at waypoints PLEZN (at or below 9,000 ft) and KERRS (at or above 5,000 ft) (Figure 2). The aircraft was required to remain at or above the segment minimum safe altitude of 3,800 ft until reaching GULLY. There was no altitude restriction and therefore no FMS-coded altitude for waypoint GULLY on the STAR (Figure 2). However, the ILS had the FMS-coded altitude constraint at GULLY as depicted on the ILS chart (Figure 3).

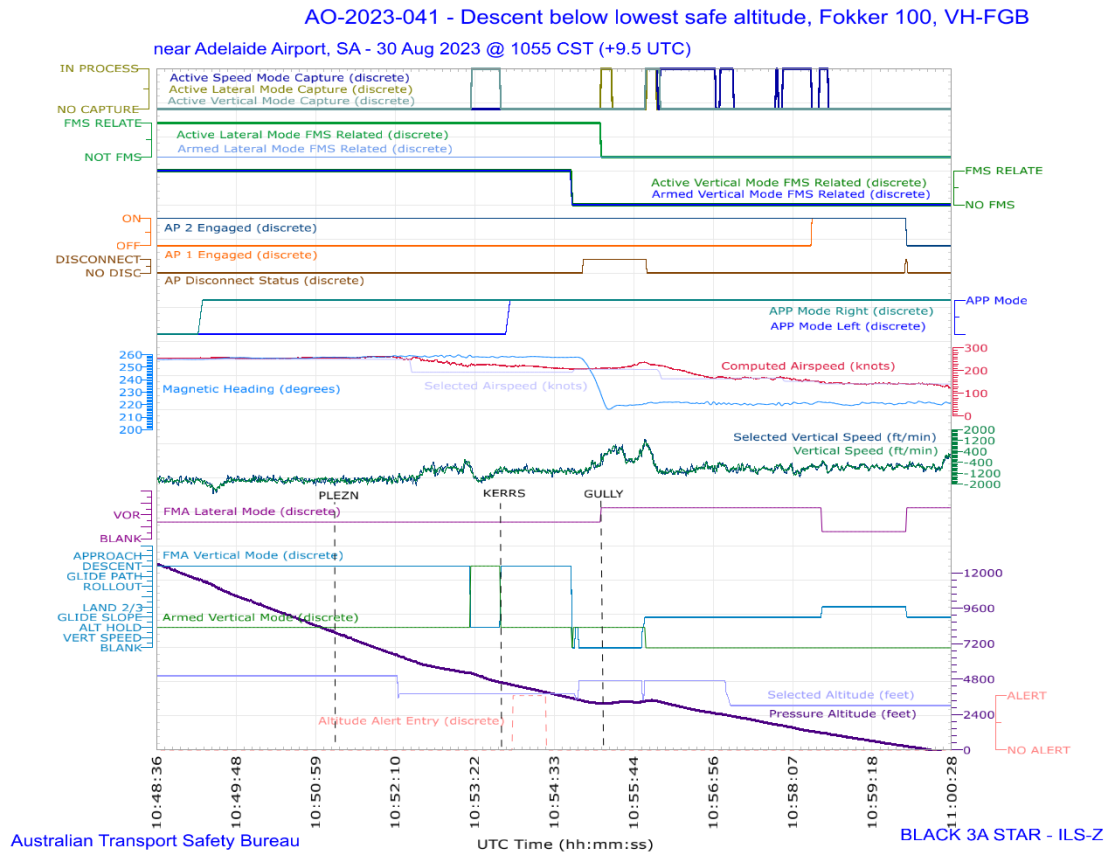
Figure 4: Recorded flight data for the incident flight showing selected parameters

Recorded flight data from the incident flight is depicted in Figure 4. ATSB analysis of the recorded data was unable to determine the reason for the descent below the selected altitude. The ATSB therefore requested assistance from Fokker and Honeywell, as the manufacturer of the flight management computer.

Fokker advised that the flight data recorder only showed No. 1 (left side) parameters. As the first officer was the pilot flying, the aircraft was flying on autopilot No. 2. Therefore, it was possible that the systems were in independent operation and that there was a difference between the 2 systems. However, Alliance Airlines advised that the flight management systems were operating in cross-talk configuration, so both side parameters should have been evident in the recorded data.

Fokker also observed that when the flight crew changed the selected altitude to 3,800 ft, they initially wound the dial down to 3,500 ft before selecting 3,800 ft. Fokker advised that had the system been in altitude hold mode at the time, it would have captured 3,500 ft. However, it was in descent mode at that time and the recorded selected altitude was 3,800 ft. Fokker advised that the alert would activate about 750 ft above the selected altitude and the alert commenced as the aircraft descended through 4,562 ft, supporting that 3,800 ft was selected.

In data from a flight on 15 October 2023, the auto-flight system entered altitude hold mode and levelled the aircraft at about 4,500 ft halfway between KERRS and GULLY, with the selected altitude of 3,800 ft. No difference was identified in the data to explain why that flight met the minimum safe altitude requirement, and the incident flight did not.

- For reasons that could not be determined, the flight management system did not capture the selected altitude. This resulted in the aircraft descending about 480 ft below the segment minimum safe altitude.
