Ground strike during a marine pilot transfer, involving Agusta A109, VH-RUA and ship *Tai Keystone*

About 240 km north-east of Mackay Airport, Queensland on 7 December 2023

ATSB Transport Safety Report

AO-2023-059

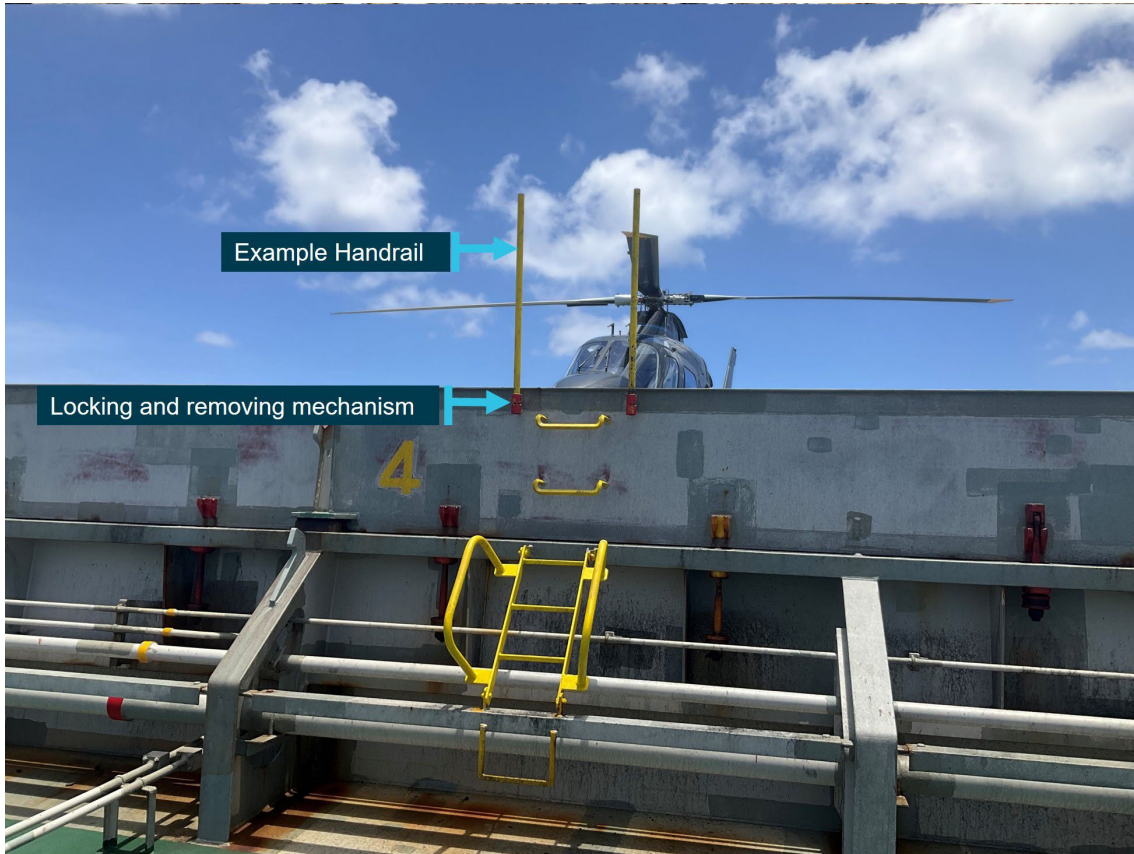
Figure 2: Starboard⁶ handrails (removed at the time of the occurrence)

The helicopter pilot reported that, after exiting the helicopter, they observed the vessel's starboard-side handrails were removed. However, the port-side handrails that were struck were still installed (Figure 3).

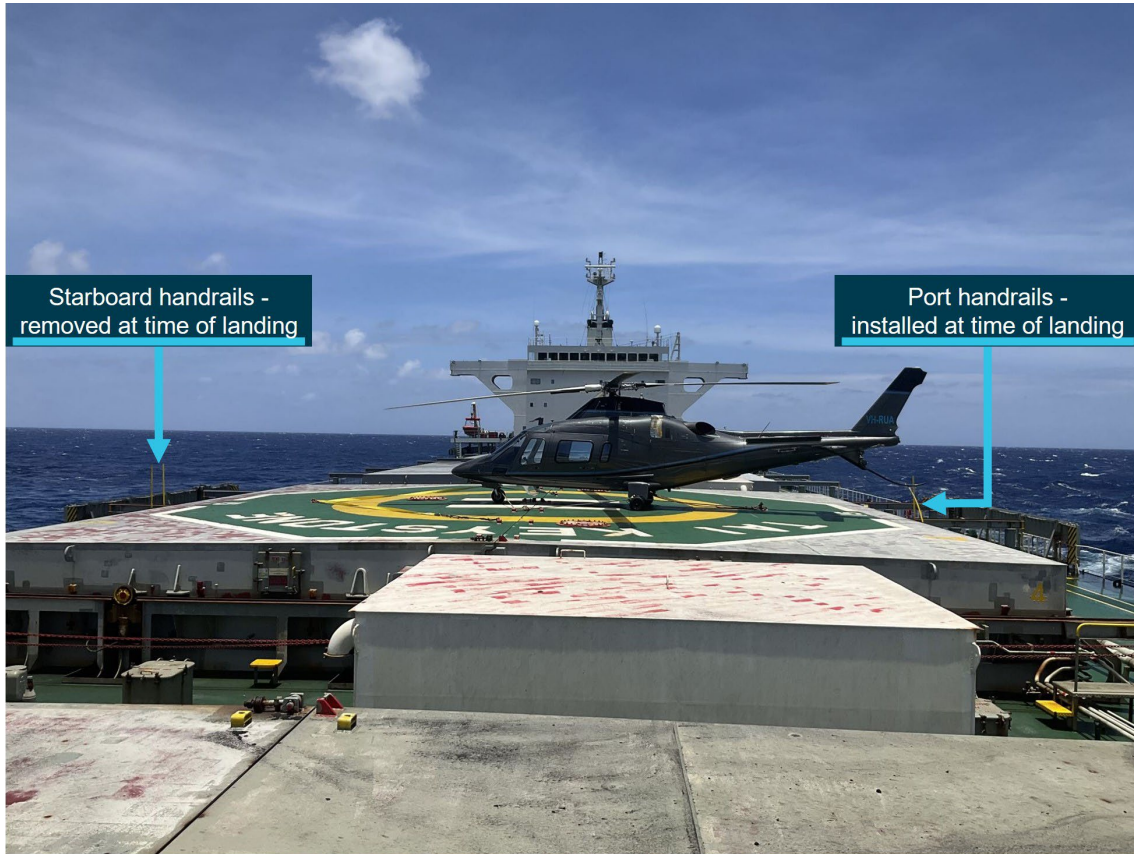
Figure 3: Handrail positions

The port-side handrails were within the obstacle free sector (clear zone) (Figure 6). The clear zone is required to be free of obstacles that present a risk to the helicopter operation.

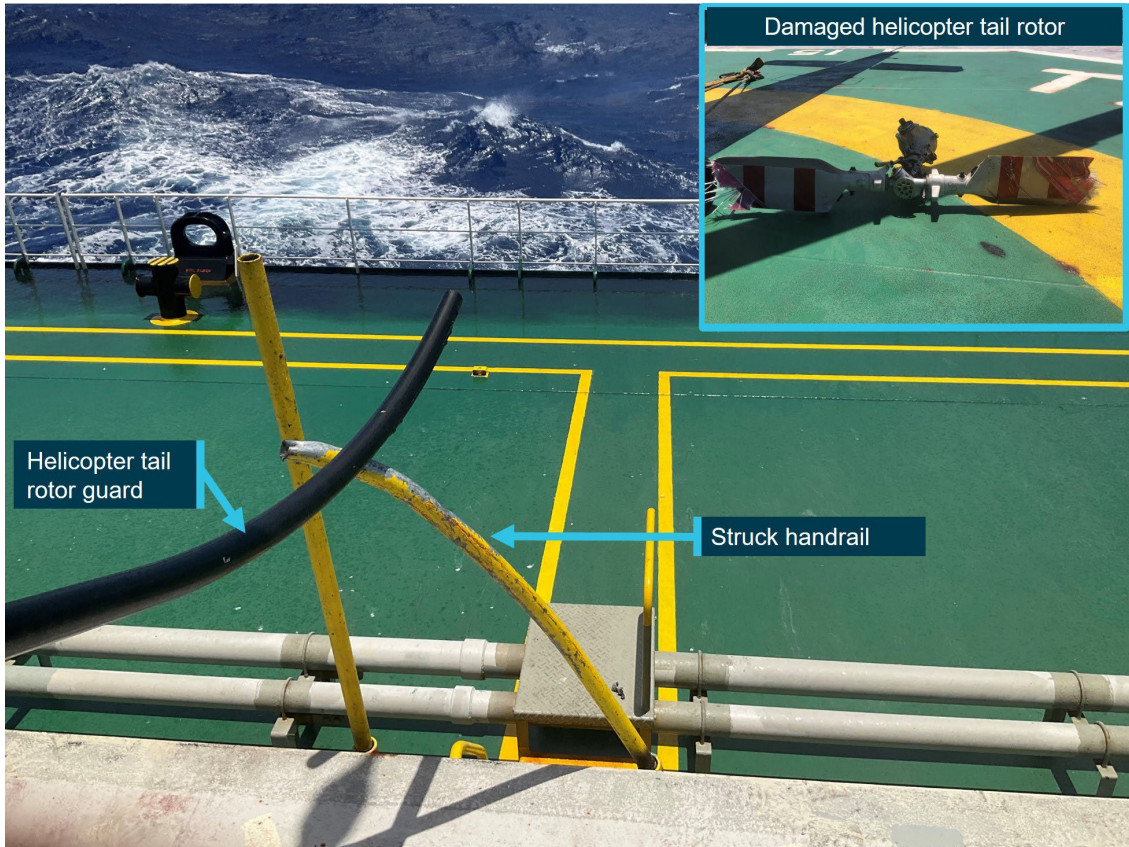
Figure 4: Struck handrail and damaged tail rotor

At about 1042, the helicopter landed on the ship and as the wheels touched the deck, the tail rotor struck an upright handrail that was not identified by the pilot during the approach. The helicopter pilot reported hearing a shredding noise and an increase in the engine pitch before completing the emergency shutdown procedure.

The HLS was predominantly painted in green with a yellow circle and a white 'H'. The vessel's name was also painted in white in the HLS. There was a permanent yellow ladder (Figure 2) leading up to the HLS and yellow painted walkway lines leading to the ladder, on the deck of the ship (Figure 4).

The helicopter pilot also advised that at 300 ft, a narrow yellow pole was almost impossible to detect. In addition, the ladder leading to the poles was painted yellow, there was yellow on the hatch, and yellow lines on the edge of the landing hatch (the yellow walkway) (Figure 4). They advised yellow was a very common colour on a ship and, on this occasion, impeded detection of the port-side handrails during the approach.

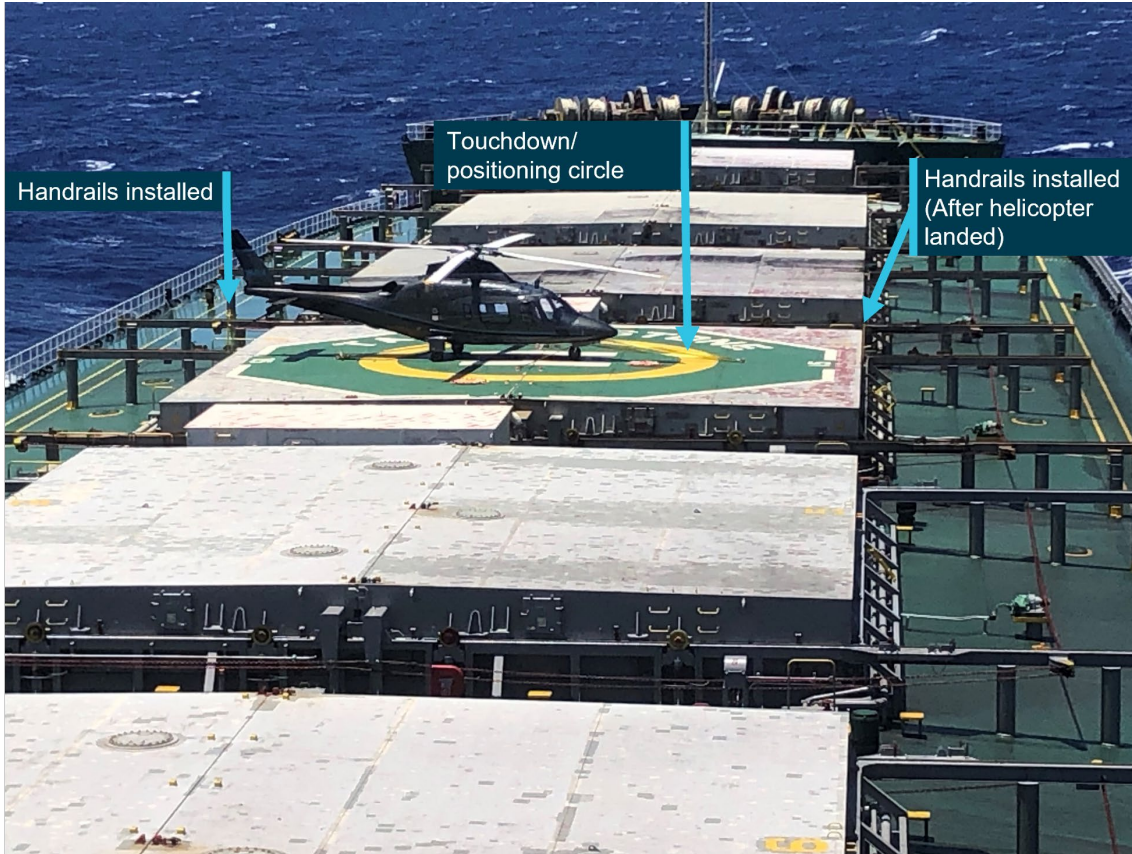
Figure 5: Tai Keystone's helicopter landing site viewed from the bridge

On this occasion, the helicopter was positioned with the pilot's seat over the centre of the white 'H', rather than as required with the pilot's seat above the yellow TDPC (Figure 5).

However, despite the handrails being within the obstacle free sector, as they were removable, they were not notifiable objects. In addition, the HLS surface was painted green with yellow markings and, the environment surrounding the handrails, including the permanent ladder leading to the handrails, consisted of items which were also mostly painted in yellow. As such, the yellow handrails did not visually stand out to the helicopter pilot.
