Double propeller overspeed involving Bombardier DHC-8 VH-SBV

near Weipa, Queensland | 6 December 2011

ATSB Transport Safety Report
Aviation Occurrence Investigation
AO-2011-159
Final – 25 February 2013

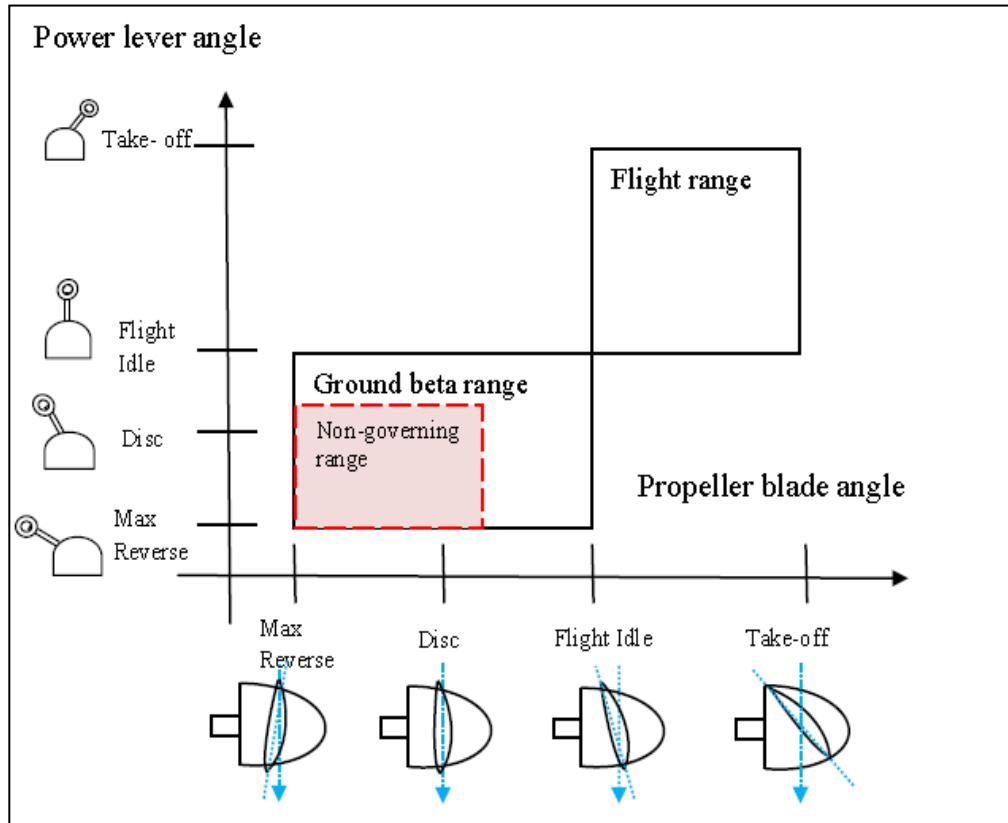
Figure 3: Power lever angle and propeller blade pitch angle

When the power levers are moved to an angle of 13° below the flight idle gate, the governing function of the propeller control unit and the overspeed governor are inhibited and the beta backup system is deactivated. This is an intended design feature to allow the power levers to control the propeller pitch directly during ground operations. The propeller does not require speed governing during ground operations as there is insufficient airspeed to drive the propeller to an overspeed condition.

In summary, propeller overspeed is prevented by three systems, provided the power levers are maintained above the flight idle gate in flight. If the power levers are moved below flight idle in flight, the propeller speed is no longer controlled by the propeller control systems, leaving the propellers susceptible to an overspeed condition that could rapidly lead to engine damage and, in the worst case, engine failure.

Figure 3 shows the relationship between power lever angle and propeller blade pitch angle and the area where propeller speed is not governed.

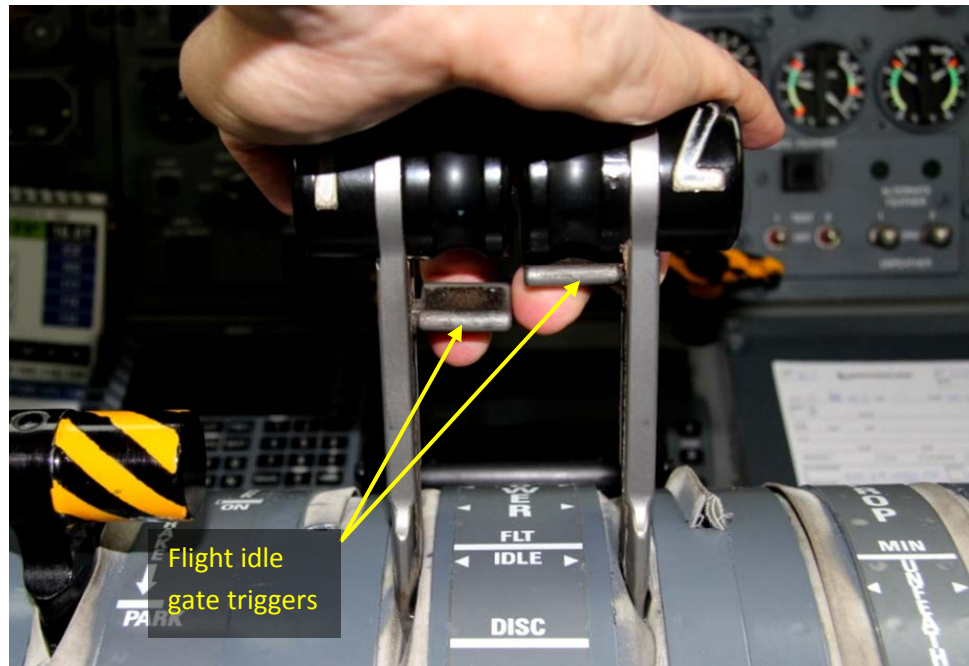
Figure 4: Power levers showing flight idle gate triggers

The first officer could not recall precisely how he had been gripping the power levers at the time of the occurrence. His normal practice was to rest the palm of his hand on top of the levers and he believed that was the case on this occasion. He thought that his fingers were angled downwards, with the middle finger between the levers. He could not recall if he had any backwards pressure on the levers but felt that his hand moved upwards during turbulence and that one of his fingers had lifted one of the triggers.

The ATSB conducted testing on the same aircraft type while alternatively seated on the captain's and first officer's side, with the seat correctly adjusted to the normal flight position. With the hand placed with the palm on top of the power levers there was a noted tendency for the middle two fingers to touch the flight idle gate release triggers when moving the power levers rearward.

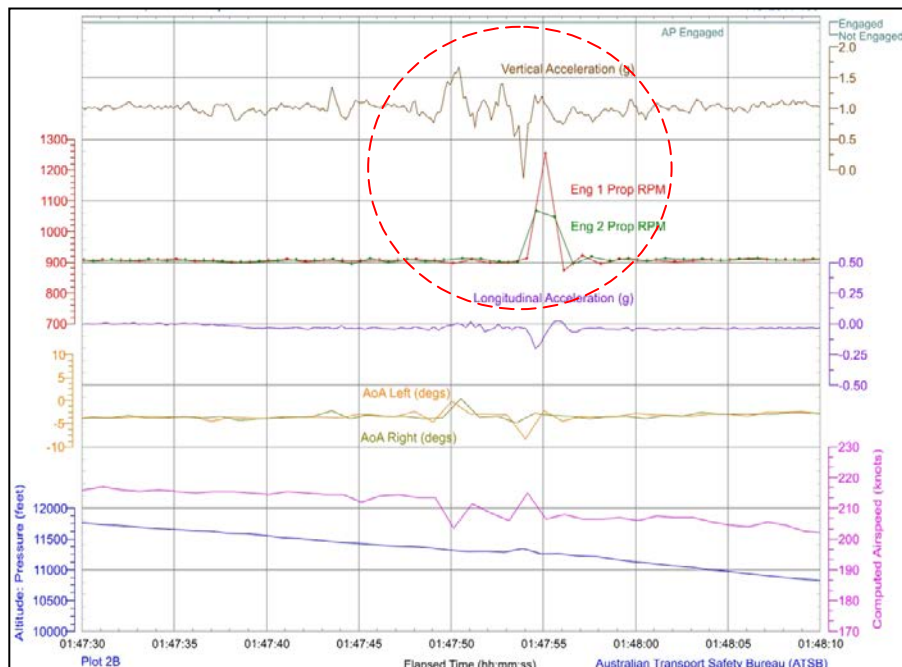
Figure 5: DFDR data showing propeller speed increase

Examination of the data from the aircraft's DFDR showed that, at an altitude of 11,300 ft and at a computed airspeed of 215 kts, there was a period of approximately 3 seconds during which the rpm of both propellers increased above the set 900 rpm. The maximum recorded rpm for each propeller was 1,253 rpm for the left propeller and 1,067 rpm for the right propeller (Figure 5).⁵

Prior to that period, there were fluctuations in computed airspeed, angle of attack and vertical acceleration which were consistent with the aircraft operating in turbulence. There was a period of positive vertical acceleration, consistent with an updraft, which commenced about 4 seconds before the propeller RPM increased. This was followed by a rapid decrease in vertical acceleration from $+1.5$ g to -0.1 g⁶ just before the propeller speed increases occurred. There was a decrease in longitudinal acceleration coincident with the propeller rpm increases, due to an increase in propeller drag as the blades moved to a finer angle.
