Flight below minimum altitude involving Beech Aircraft Corp 95-B55, VH-ALR

20 km north-north-east of Parafield Airport, South Australia on 12 August 2022

ATSB Transport Safety Report

AO-2022-039

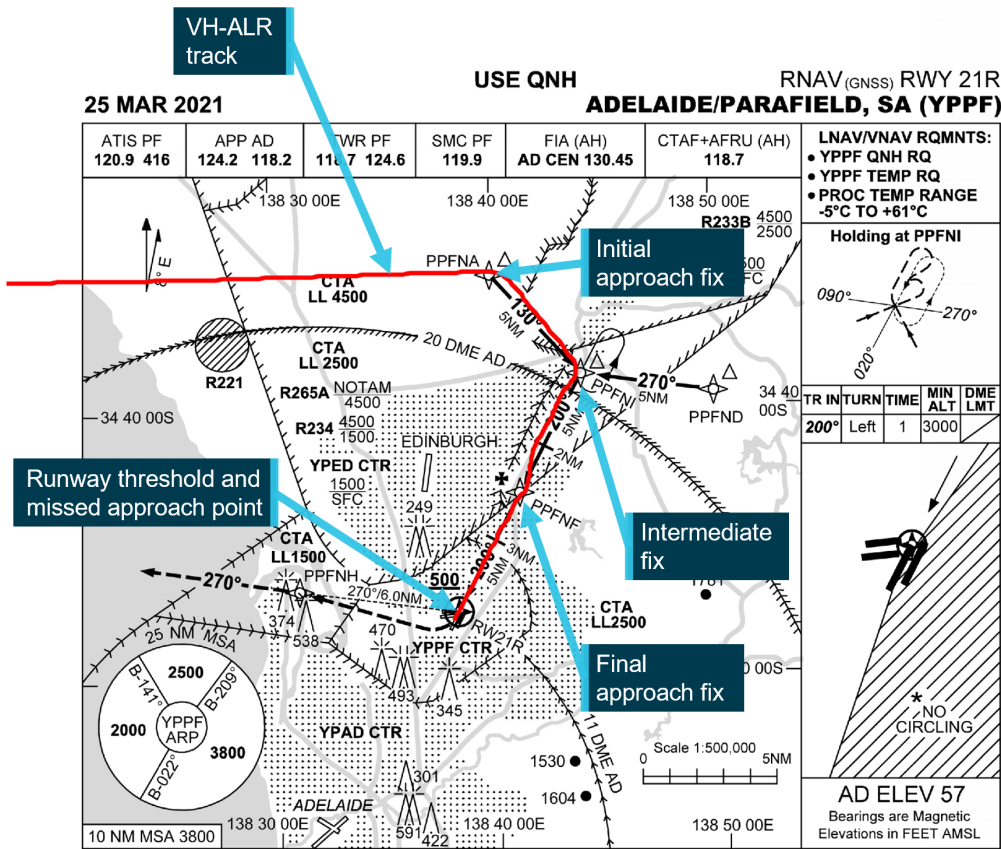
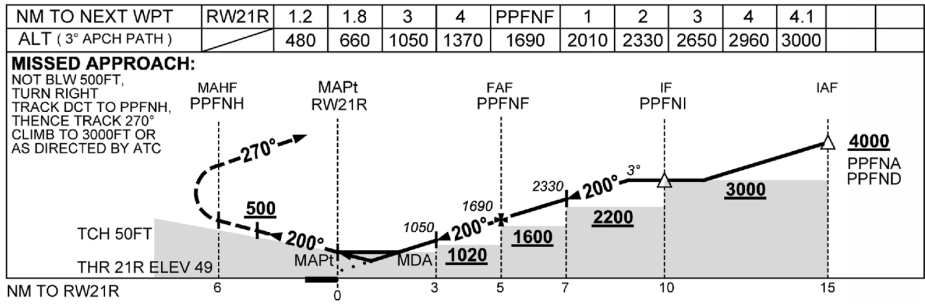
Figure 1: Parafield RNAV GNSS RWY 21R instrument approach procedure chart with VH-ALR track overlaid

The aircraft departed Port Augusta just after midday (local time) and was climbed to 5,000 ft above mean sea level for the flight to Parafield. As the aircraft approached Adelaide, the weather conditions in the Parafield control zone were unsuitable for a visual arrival and the approach controller instructed the pilot to track the aircraft to waypoint PPFNA,² one of the initial approach fixes (IAF) for the Parafield RNAV GNSS RWY 21R³ instrument approach procedure.⁴ The instrument approach procedure chart overlaid with the aircraft's ground track is depicted at Figure 1.

After passing the IAF, the pilot turned the aircraft to track to the IF and commenced descent from 4,000 ft. The segment minimum safe altitude between the IAF and IF was 3,000 ft. During the first part of that segment, the pilot descended the aircraft at an appropriate rate. The aircraft was about 2 NM from the IF when it reached and then descended below the segment minimum safe altitude.

As the aircraft approached and then passed the IF, the descent rate increased slightly, with the pilot turning the aircraft to intercept the final approach track (Figure 1) at an altitude of about 2,000 ft. After the IF, the segment minimum safe altitude reduced to 2,200 ft.

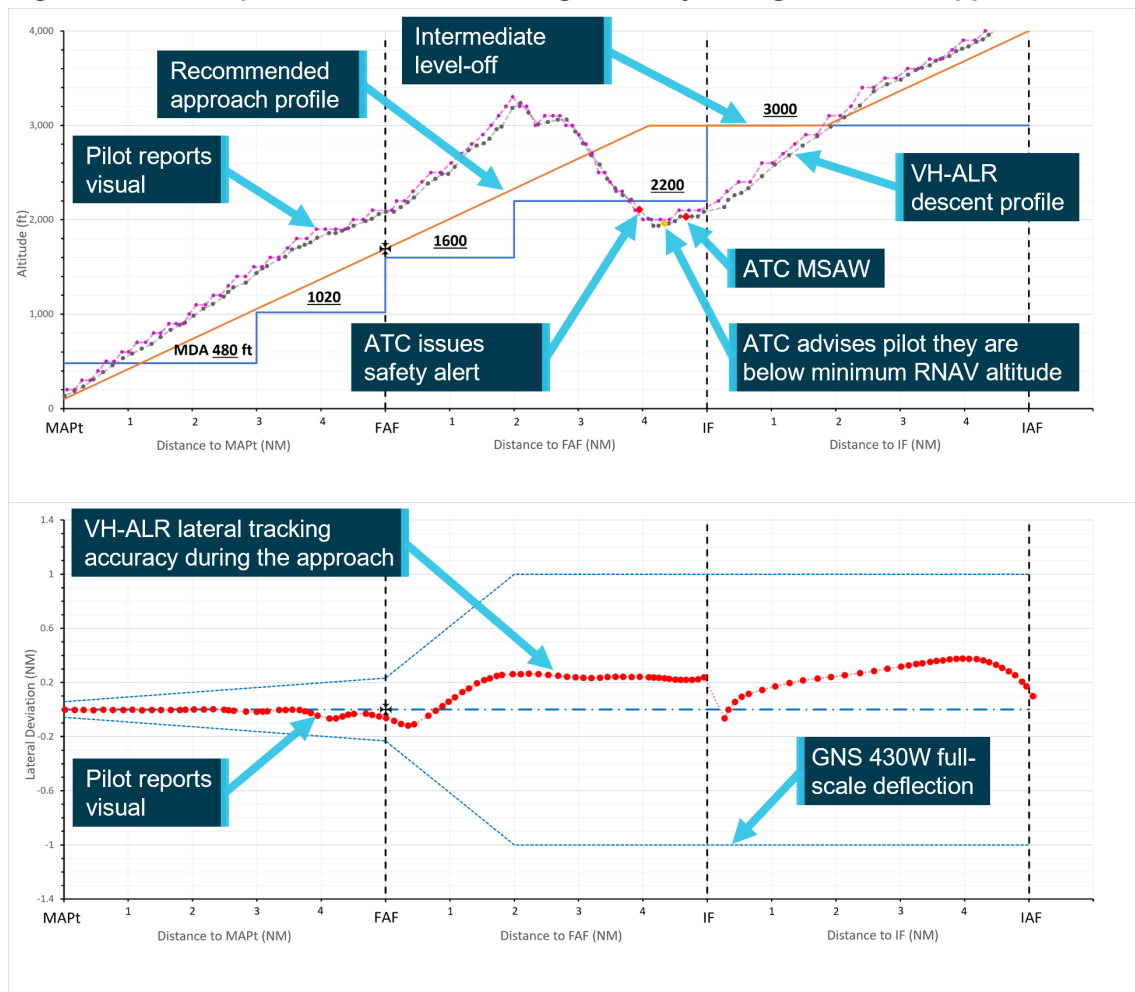
Figure 2: Descent profile and lateral tracking accuracy during instrument approach

The aircraft's lateral track was within the required lateral tracking tolerances passing the final approach fix (FAF) PPFNF and about 300 ft above the recommended approach profile. The aircraft was about 4 NM from the runway at an altitude of 1,900 ft when the pilot reported to the tower controller that they were 'visual' and the final part of the approach was flown at an airspeed of about 100–110 kt.

The aircraft descent profile during the approach and the lateral tracking accuracy with reference to the global positioning system (GPS) course deviation indicator's full-scale deflection is depicted in Figure 2.
