Taxiway excursion, ground strike and near collision with terrain involving Cessna 172R, VH-EWW

at Gold Coast Airport, Queensland on 6 February 2024

ATSB Transport Safety Report

AO-2024-004

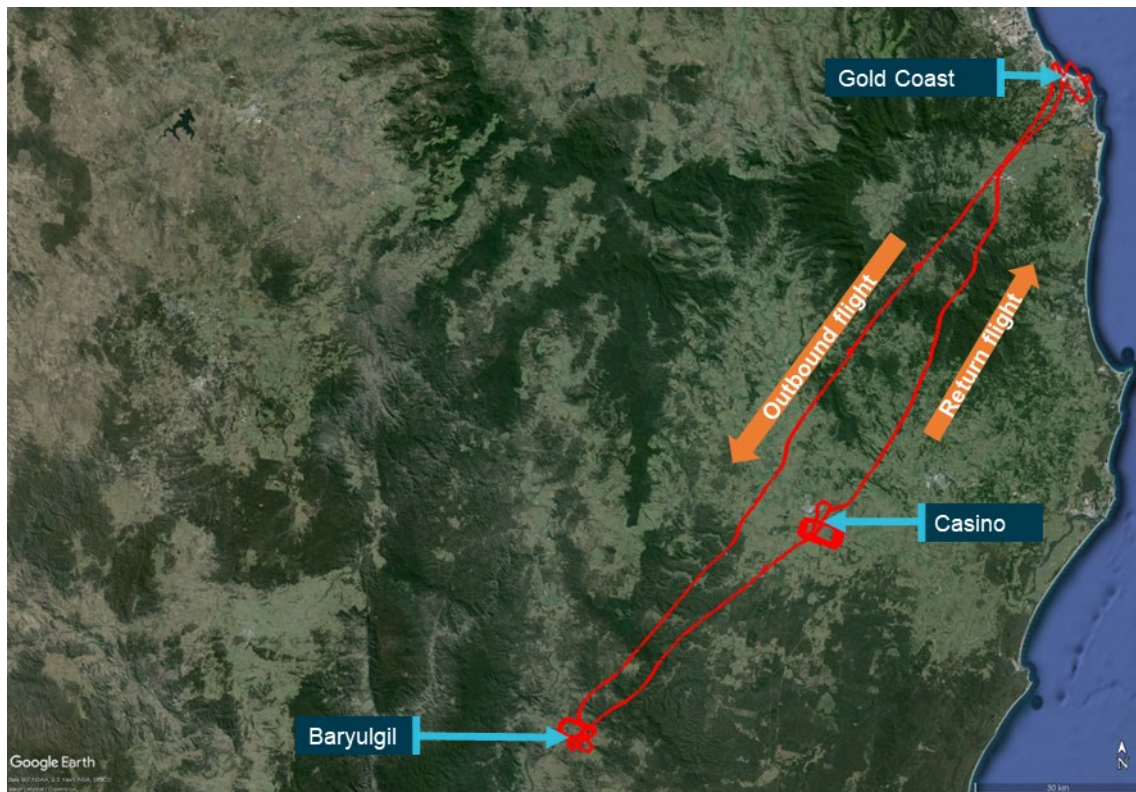
Figure 1: VH-EWW track Gold Coast – Baryulgil – Casino – Gold Coast

On 6 February 2024, a student pilot and flight instructor were conducting a dual training flight in a Cessna 172R aircraft, registered VH-EWW. The aircraft took off from Gold Coast Airport, Queensland, at about 1138 local time, and tracked to the locality of Baryulgil, New South Wales (NSW), where the flight crew conducted aerial work overhead. The aircraft then tracked to Casino Aerodrome, NSW, where the student conducted 5 circuits, before departing at about 1354 to return to Gold Coast Airport (Figure 1).

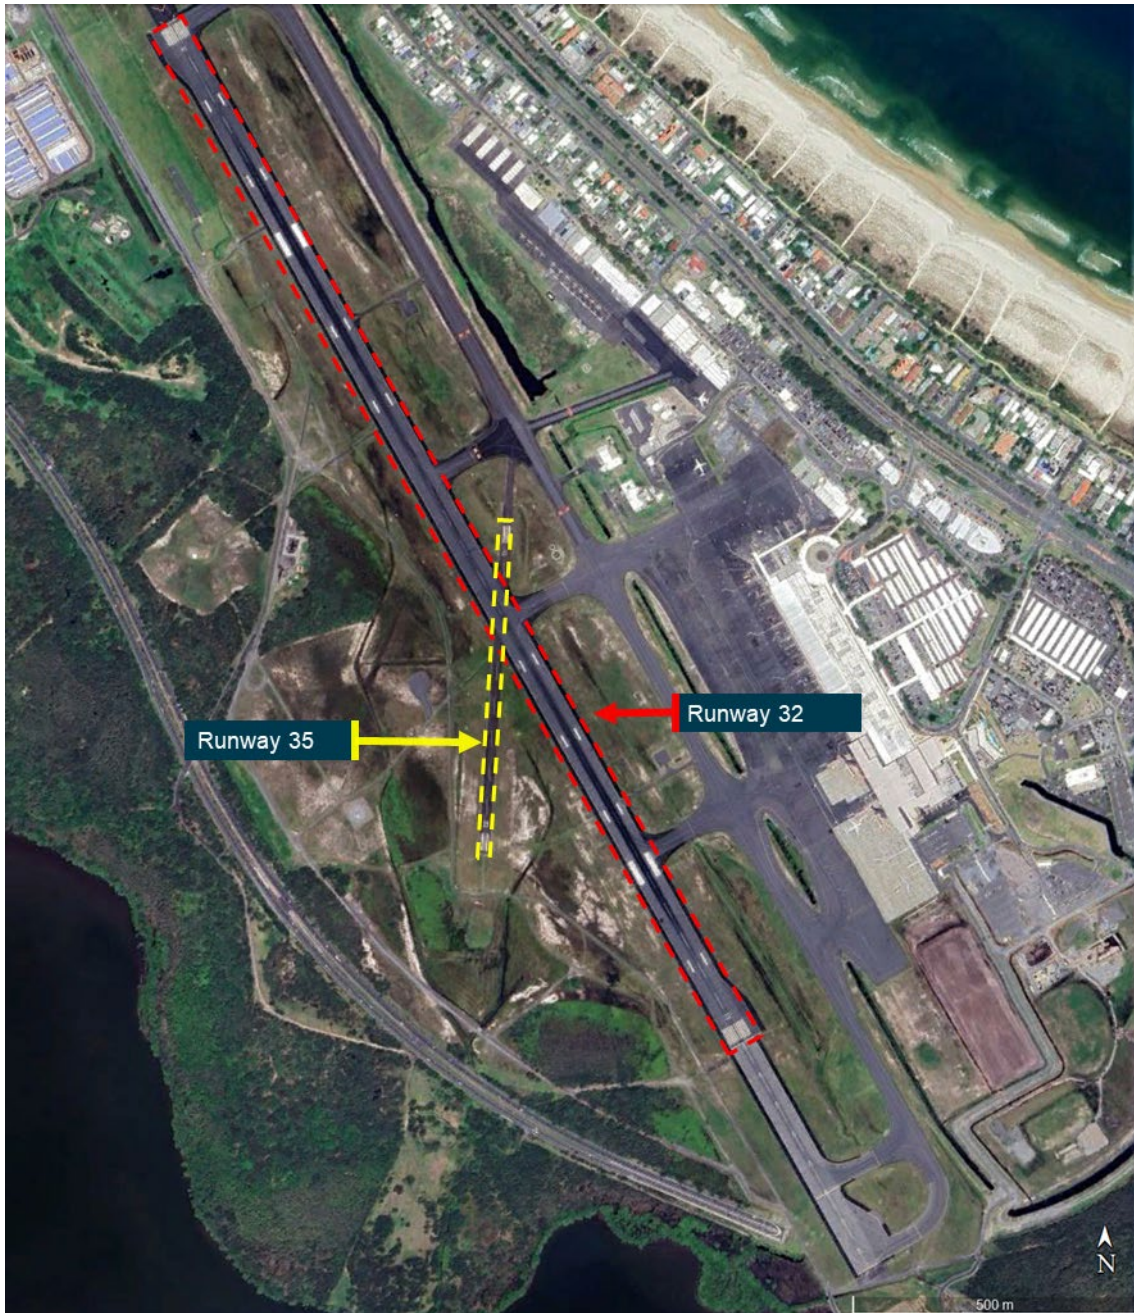
Figure 2: Gold Coast Airport showing runways 32 and 35

at the instructor and shaking their head thinking the aircraft was too high and close to that runway. At that time, VH-EWW was 3.9 NM from the threshold of runway 35, which was 582 m long, and significantly shorter than runway 32, at 2,492 m (Figure 2). The student's assessment was probably due to inexperience, having only landed on runway 35 once before. Had they been cleared to commence the approach from that position, a landing should have been readily achievable, with an approach profile of about 2.4°.

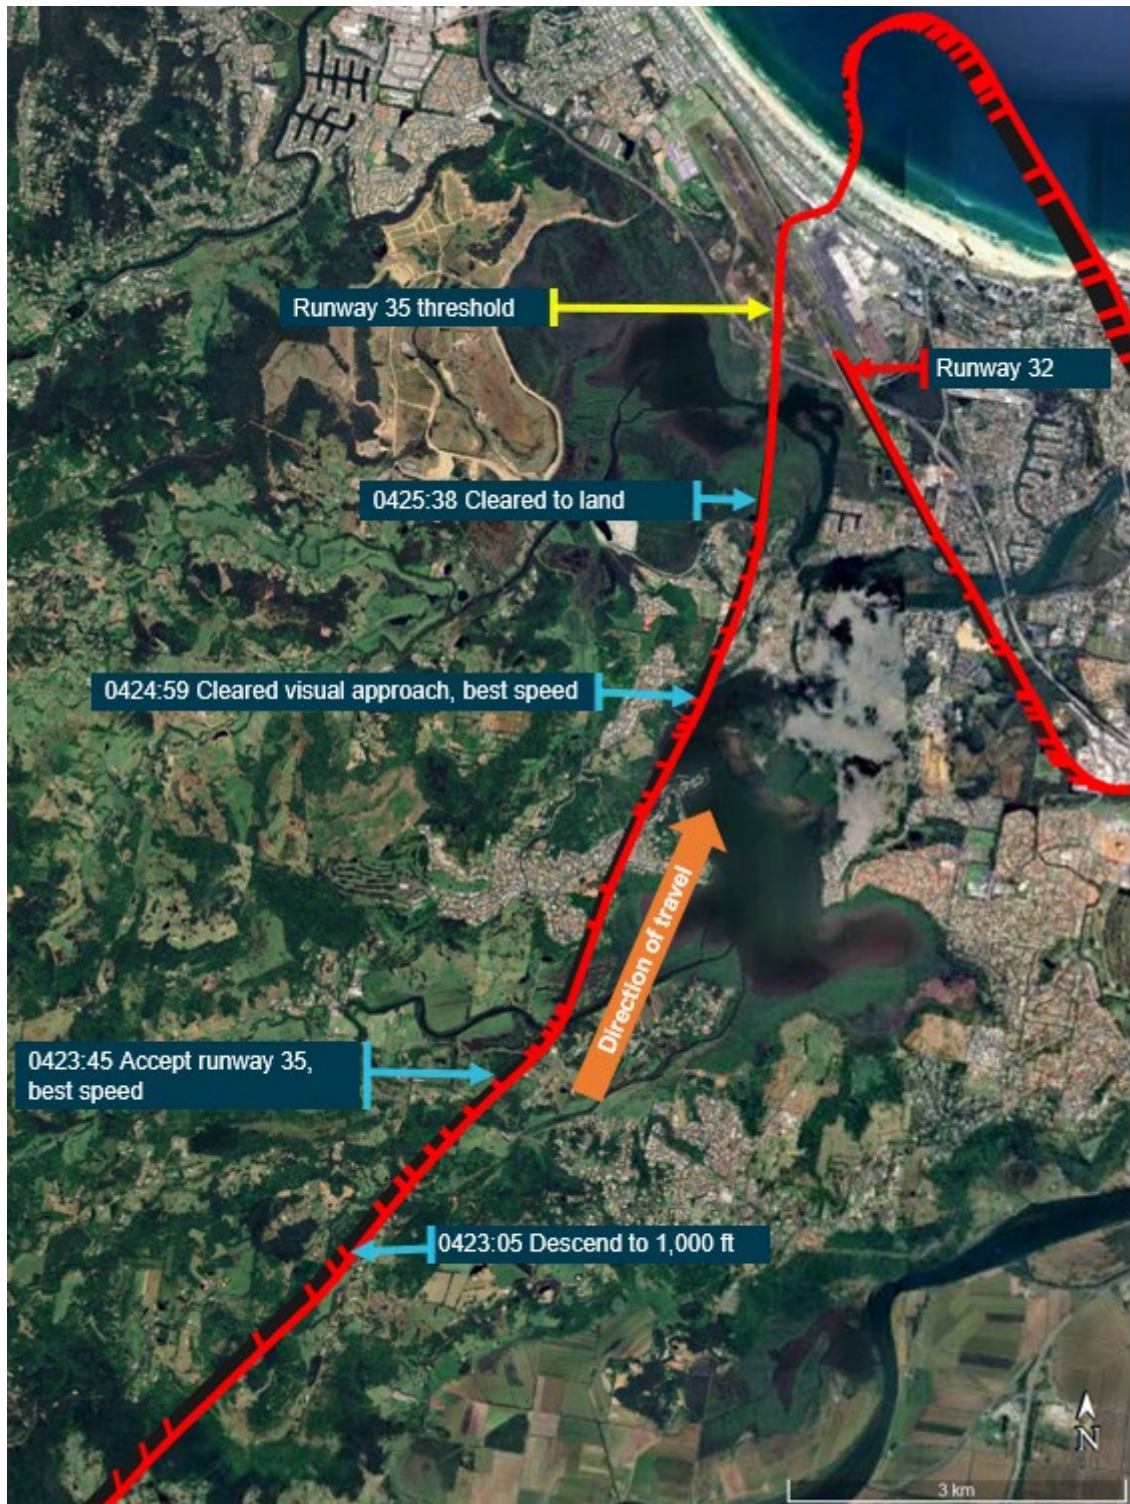
Figure 3: VH-EWW track showing positions of key air traffic control communications

According to radar data, VH-EWW was about 1 NM from the runway 35 threshold, descending through about 500 ft at 95 kt ground speed, when the ADC cleared the flight crew to land and to 'continue to taxi into GOLF' (Figure 3 and Figure 4). This was to reiterate that they were cleared to continue through the runway 32 intersection. As VH-EWW approached the runway, the controller observed that the aircraft appeared to be faster than normal and, expecting the flight crew would conduct a go-around,² started planning to re-sequence the aircraft.

When the flight crew were issued the clearance to conduct a visual approach, the aircraft was at about 1,000 ft and 1.9 NM from the runway threshold. A stabilised approach is generally based on a 3° approach profile. In this case the aircraft's flight path to the threshold was steeper at about 5° (to the horizontal). To achieve that flight path, and maintain what they interpreted as the required airspeed, the crew reduced the throttle to idle and lowered the aircraft's nose. Those actions resulted in an approach airspeed significantly faster than that published in the POH.

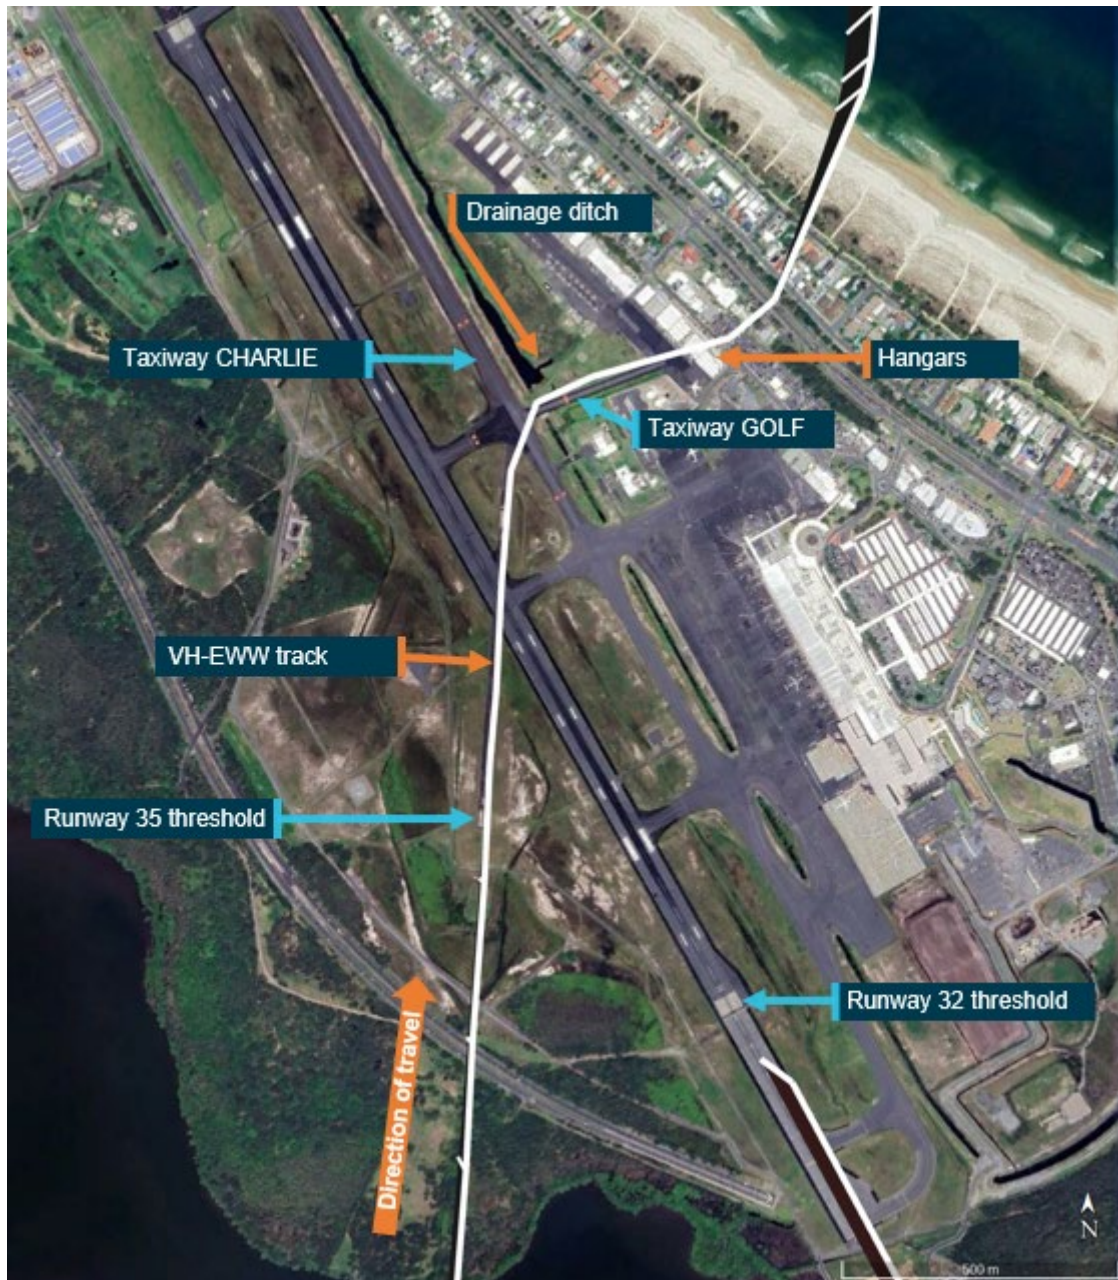
Figure 4: Gold Coast Airport taxiways CHARLIE and GOLF, drainage ditch, hangars and VH-EWW track

The instructor assessed that the aircraft was still travelling faster than expected. At this stage the aircraft was past the runway 32 intersection and rapidly approaching the end of the runway. Seeing this, the ADC stated, ‘turn up [taxiway] CHARLIE if need be’, to alert the flight crew that they could make a 20° left turn onto that taxiway, instead of a 66° right turn onto GOLF. The instructor heard the call but did not recognise the alternate option, as they were focused on making the turn onto GOLF (Figure 4).

During the turn, the aircraft skidded left off the taxiway onto grass and towards a drainage ditch. The instructor then applied full power and back pressure on the control column to clear the ditch,

Although still travelling at speed, the instructor attempted to turn onto taxiway GOLF. The instructor did not identify the controller's intent for them to make a much smaller left turn onto taxiway CHARLIE, while focused on trying to achieve the right-hand turn onto GOLF. The turn at speed resulted in the aircraft skidding off the side of the taxiway into grass.

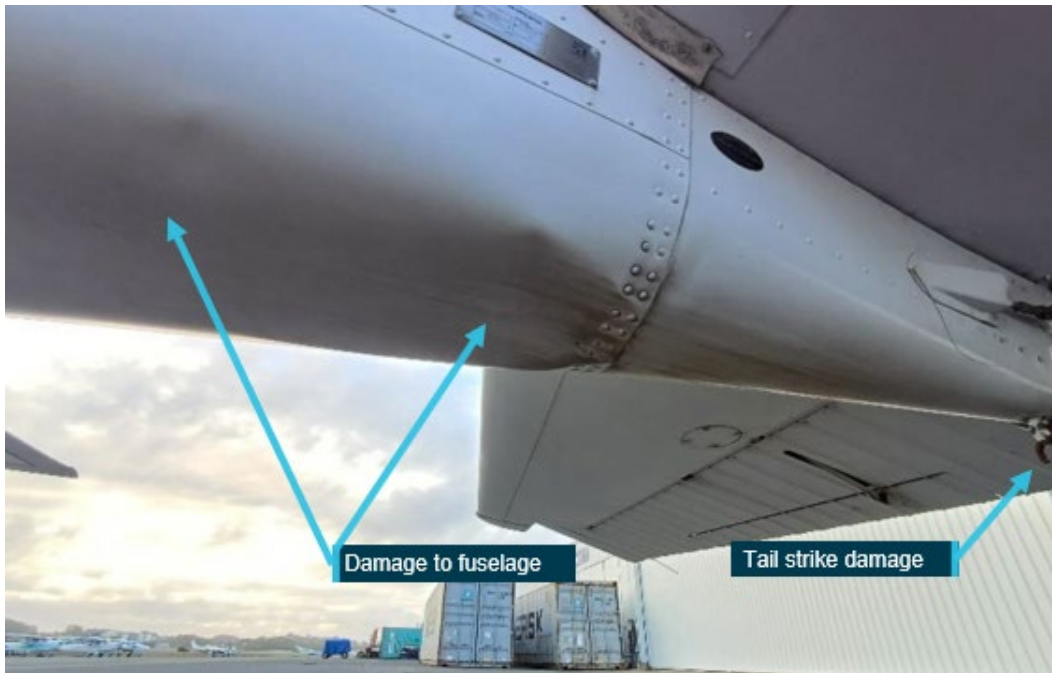
Figure 5: Ground strike damage to VH-EWW

which resulted in a ground strike, damaging the rear fuselage (Figure 5). Having observed the aircraft exit the taxiway, the ADC activated the crash alarm³ to alert aviation rescue fire fighters.

The instructor's application of full throttle and back pressure to avoid the aircraft nosing forward into a ditch resulted in the fuselage and tail striking the ground. Unaware that the ground strike had occurred, the instructor initiated a go-around from the grass. By that stage, the airspeed had reduced such that the stall warning indicated an impending stall. The instructor's action to lower

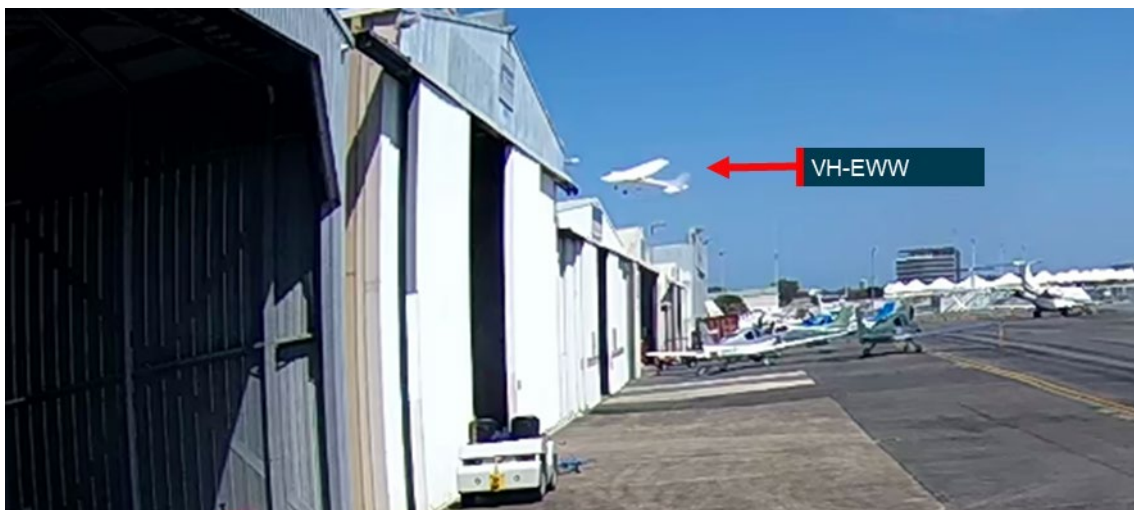
Figure 6: Image from CCTV footage showing VH-EWW passing close above hangars

Unaware of the ground strike, the instructor commenced a go-around, with the aircraft climbing towards a row of hangars. The instructor turned the aircraft slightly right towards the lowest roof to maximise the clearance from the buildings. The instructor reported that the stall warning horn⁴ was sounding, and therefore they had to lower the aircraft's nose to prevent a stall, but also maintain a high enough nose attitude for the aircraft to climb above the hangar (Figure 6). The instructor advised the ADC that they 'just had to make an emergency go-around'.

the aircraft's nose prevented the stall but resulted in a low climb gradient and near collision with hangars.

- The safety committee reviewed the company's standard operating procedures for stabilised and unstable approaches. Company procedures and training were found to be aligned with the United States Federal Aviation Administration Private Pilot – Airplane Airman Certification Standards – Short field approach and landing speed tolerance (+10/-5 knots with gust factor applied) and the Civil Aviation Safety Authority's Part 61 Manual of Standards Schedule 8, Table 1 Final approach speed tolerance (+5/-0 knots).

- A review of training material and sequences for instructors and students, including human factors aspects regarding communication, decision making and assertiveness.

- Discussions with the instructor team focused on training challenges at Gold Coast Airport for non-standard air traffic control requests and clearances, including refusal of clearances considered operationally unacceptable.
