Propeller failure involving de Havilland DH-82, VH-ARU

near Shute Harbour ALA, Queensland, 2 July 2016

ATSB Transport Safety Report
Aviation Occurrence Investigation
AO-2016-071
Final – 22 November 2016

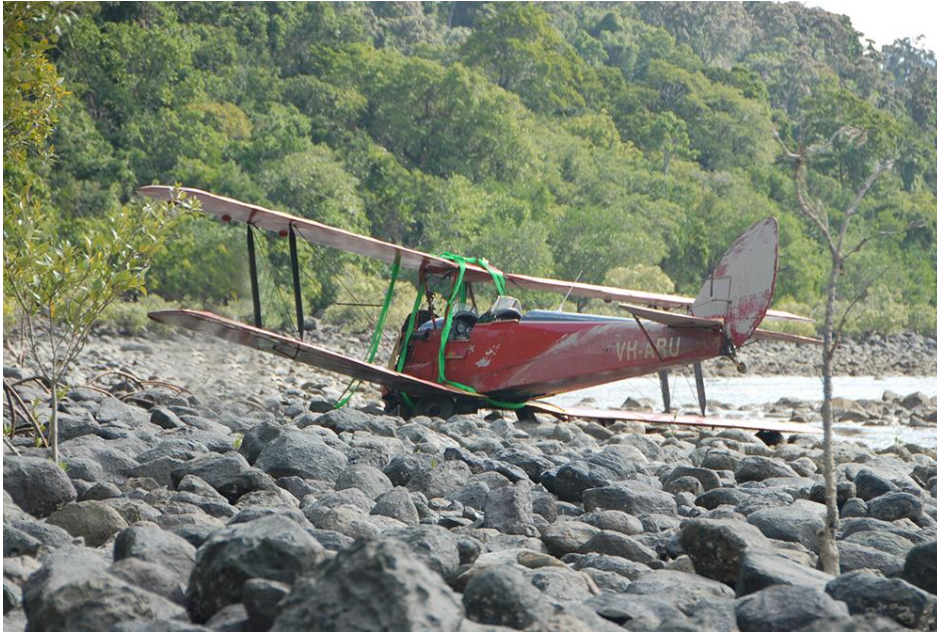
Figure 2: Accident site showing damage to VH-ARU

The pilot was uninjured and the passenger sustained minor injuries. The aircraft sustained substantial damage (Figure 2).

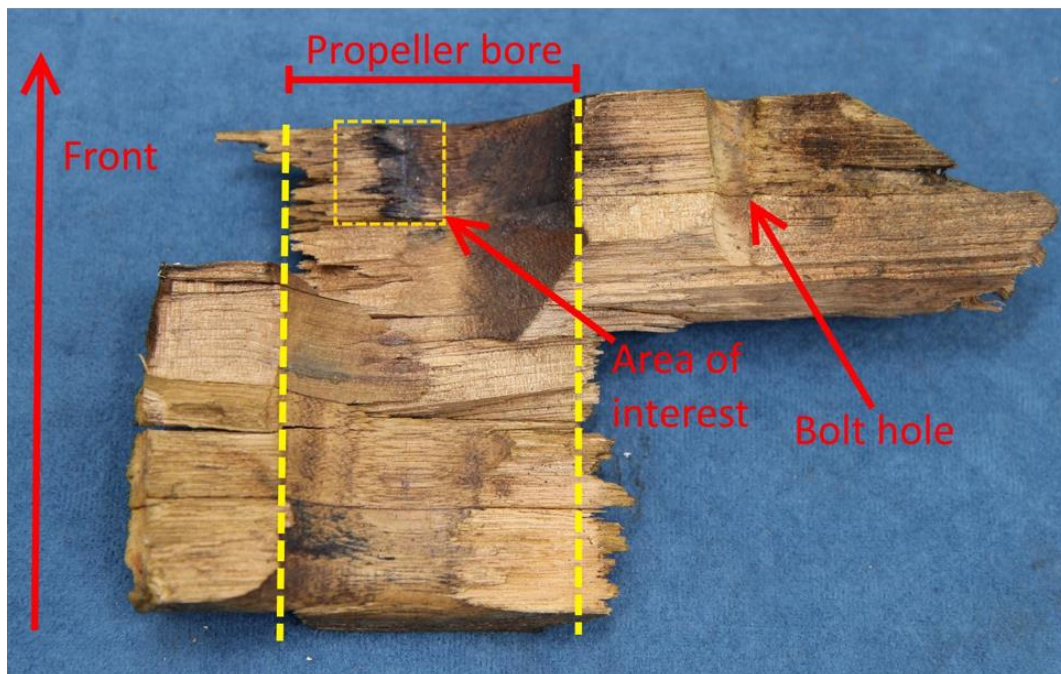
Figure 3: Propeller remnants

The ATSB examined two fragments of the propeller that were identified as parts of the hub section. An area of interest, depicted in Figure 3, showed evidence of bending consistent with the blade breaking away from the hub while under load. No bird remains were found on the fragments. The factors contributing to the propeller failure could not be determined from the timber fragments.
