# Loading event involving Embraer EMB-120, VH-ANQ

Darwin Airport, Northern Territory, 6 August 2016

**ATSB Transport Safety Report**  
Aviation Occurrence Investigation  
AO-2016-091  
Final – 22 November 2016

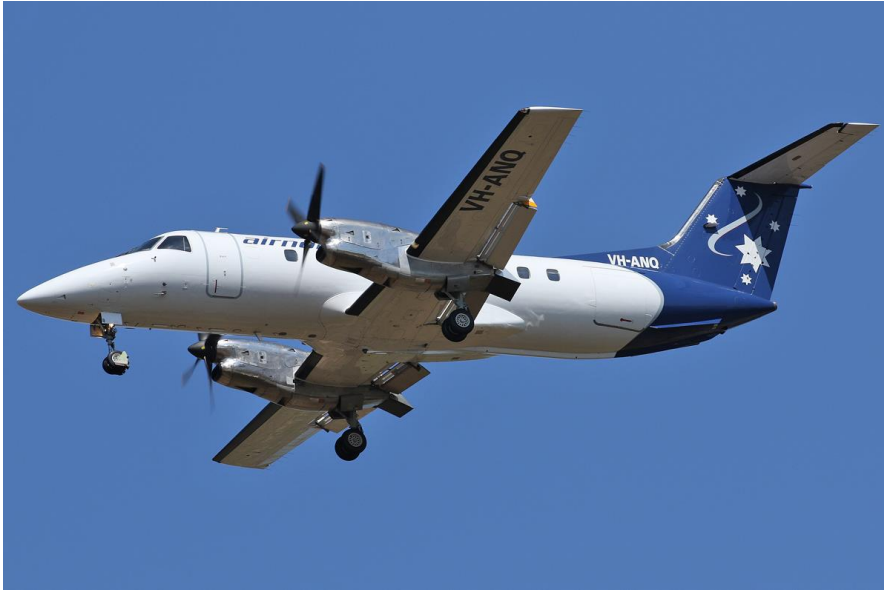
**Figure 1: Embraer 120, VH-ANQ**

On the morning of 6 August 2016, the flight crew of an Airnorth Embraer EMB-120 aircraft, registered VH-ANQ (ANQ) (Figure 1), prepared to conduct flight TL414 from Darwin to Groote Eylandt, Northern Territory. On board were three crew and 30 passengers. The first officer for the flight was undergoing training to become a captain. This involved undertaking all tasks normally performed by the captain including the completion of the aircraft trim sheet.<sup>1</sup>
