Taxiing incident involving Airbus A330, 9M-XXK

Melbourne Airport, Victoria, 9 September 2016

ATSB Transport Safety Report
Aviation Occurrence Investigation
AO-2016-117
Final – 9 February 2017

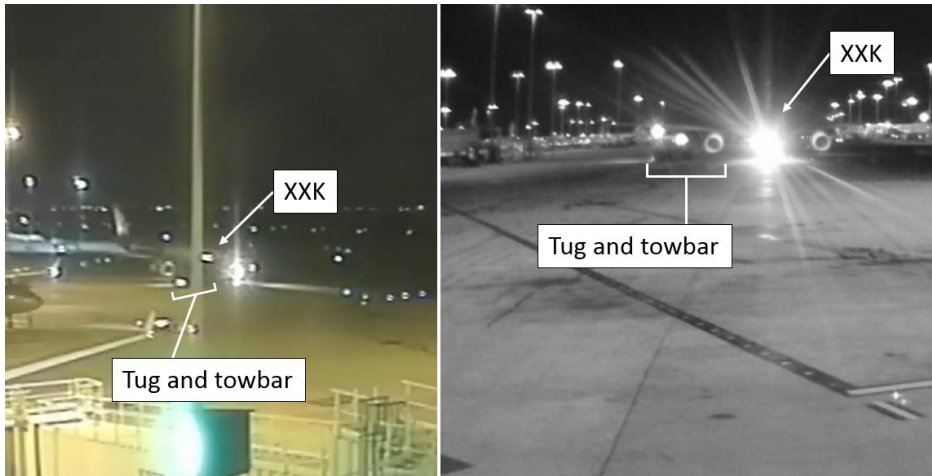
Figure 2: Positions at commencement of aircraft taxi

At 0009, the first officer confirmed to the captain that the AME and tug were clear, the captain then began to taxi. At this time, the AME was walking towards the left side of the tug, which remained parked forward of the aircraft's right engine and wing. As the AME walked, they detected the aircraft's taxi light illuminate and the aircraft begin to move. The AME then ran toward the tug door and alerted the tug driver to the aircraft movement.

The flight crew procedures required the flight crew to visually confirm that all ground equipment was clear of the aircraft prior to taxi. The first officer assessed that the tug and tow bar were clear of the right engine when they were not, although their perception may have been influenced by an expectation of them being clear given the communications with the AME and ATC providing taxi clearance.

- The flight crew and ground crew had differing understandings of procedures. These differing understandings led to different expectations of when the aircraft would commence taxi which resulted in the near collision.
- The first officer incorrectly assessed the distance of the tug from the aircraft.
