Wheels up landing involving Cessna 210, VH-UPN

Broome Airport, Western Australia, 10 October 2016

ATSB Transport Safety Report
Aviation Occurrence Investigation
AO-2016-134
Final – 17 January 2017

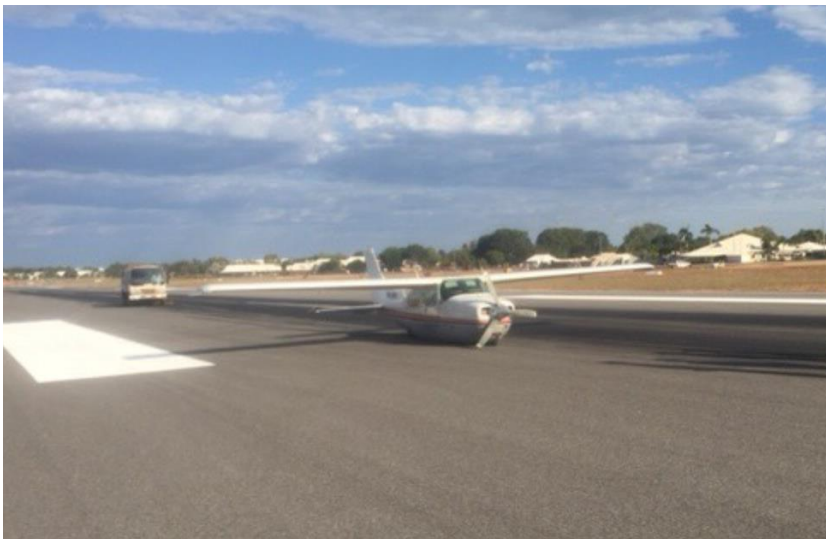
Figure 1: UPN after the wheels-up landing

At 1548, the aircraft touched down on runway 28 with the undercarriage retracted (Figure 1). The aircraft slid along the runway on the underside of the fuselage before stopping. After the aircraft stopped, the pilot contacted ATC to request assistance. The pilot then raised the flaps to provide a clear evacuation path for the passengers. After raising the flaps, the pilot shut the aircraft down, selected fuel off and assisted the passengers with exiting the aircraft.

No persons were injured in the incident and the aircraft sustained minor damage.

- An engineering inspection conducted after the incident found no fault with the landing gear system or landing gear unsafe warning system.
- The damage to the underside of the fuselage and absence of damage to the landing gear indicated the landing gear was fully retracted during the landing.

The aircraft was observed on final approach with the landing gear retracted. The pilot commented that after exiting the aircraft the landing gear was found sagging against the runway surface. However, the absence of damage to the nose landing gear doors and the main landing gear legs and tyres indicated that the landing gear was fully retracted when the aircraft landed.

The propeller control was found positioned about 5 cm from the high RPM position required by the final approach check. This was a position consistent with a cruise and approach setting. Therefore, the pre-landing checklist and final approach check were likely not completed resulting in the aircraft landing with the landing gear selected up.

- The pilot did not complete the pre-landing checklist and the final approach checks resulting in the aircraft landing with the landing gear retracted.
- The operator’s procedures did not define a distance where the pre-landing checks should be completed and the final approach checklist was not documented.
- The landing gear warning system did not alert the pilot to the retracted landing gear, probably as the pilot was wearing a noise-cancelling headset.

The final approach check has been added to the company operating procedures and aircraft checklists and a distance has been added to the pre-landing checklist to specify when the pre-landing checks should be completed.

Company pilots have been reminded to confirm the position of the landing gear during the pre-landing and final approach checks on all company aircraft, regardless landing gear type. This assists in building well established routines for operating aircraft with retractable landing gear.
