Engine failure involving Fairchild SA227, VH-VEU

170 km south of Brisbane, Queensland, 12 October 2016

ATSB Transport Safety Report
Aviation Occurrence Investigation
AO-2016-136
Final – 9 February 2017

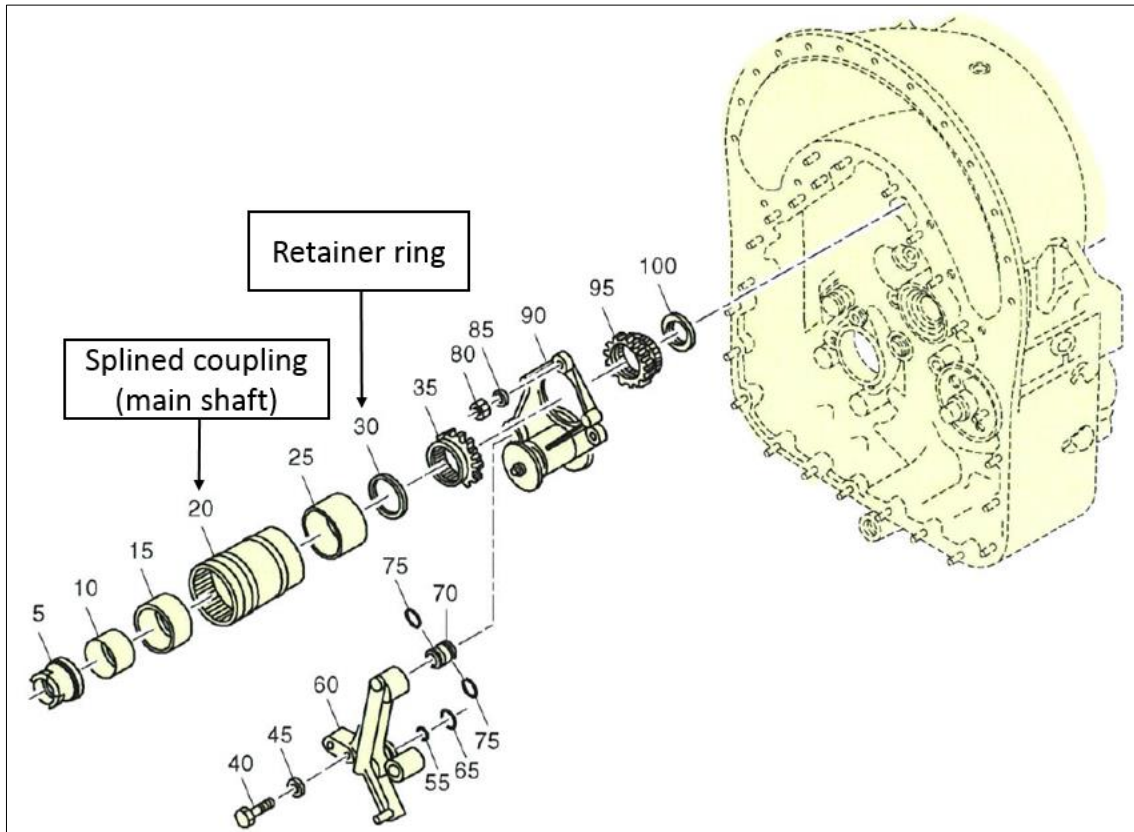
Figure 1: Engine accessory gear assembly

The engine installed in the aircraft was the Honeywell (previously Garrett) TPE331-12UHR-701G. The operator's engine maintenance organisation found a retainer ring within the engine accessory gear assembly had failed, which allowed the main shaft (which drives the propeller) to de-couple from the engine driven reduction gearbox (Figure 1).

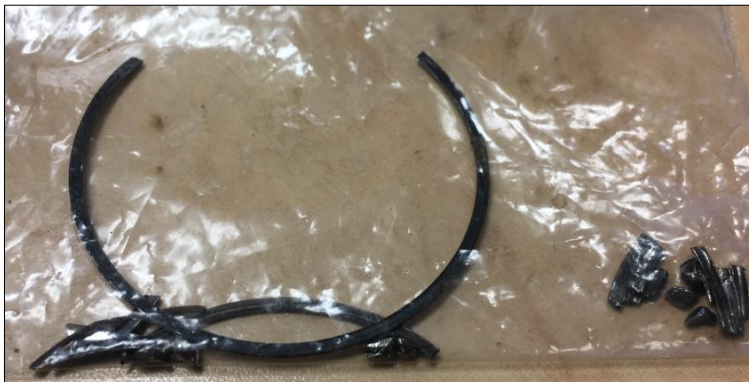
Figure 2: Retainer ring

The retainer ring was shipped to the maintenance organisation from Honeywell in December 2008 as part of a batch of 10 with a certificate of conformance from the part manufacturer and Honeywell. It was fitted new to the incident engine in December 2009 at the last engine overhaul, about 2,429 hours prior to the failure. The maintenance organisation introduced this practice of replacing the retainer ring at each overhaul based upon their previous service experience of this part failing. December 2009 was the last overhaul of the accessory gear assembly prior to the failure.

In October 2015, Honeywell added temporary revision 72-241 to the maintenance manual procedure: *removal and installation of accessory gear assembly*, to direct the replacement of the retainer ring at each exposure. Figure 2 depicts the failed retainer ring.

- The retainer ring failed within the prescribed maintenance interval.
- There was no prior warning of an impending failure of the retainer ring.
