Misaligned take-off involving Beechcraft B200, VH-XGV

ATSB Transport Safety Report
Aviation Occurrence Investigation
AO-2016-142
Final – 9 February 2017

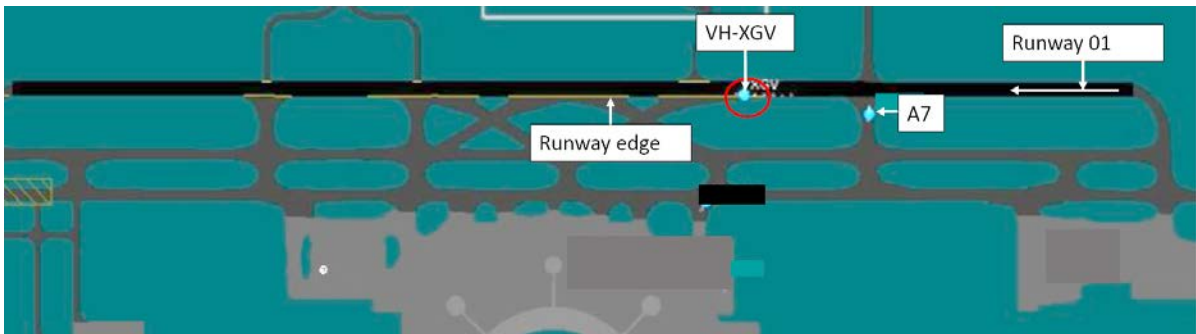
Figure 1: VH-XGV commencing take-off on runway 01

The pilot taxied the aircraft to holding point A7 (Figure 1).

At about 2011, the aircraft commenced the take-off run. During the take-off, the pilot realised that the aircraft was not on the centreline, and steered the aircraft right towards the centreline prior to the aircraft becoming airborne. A subsequent runway inspection found damage to a runway edge light and the aircraft sustained minor damage to the nose landing gear.

Animation of the recorded radar data from Brisbane Airport showed the aircraft commencing take-off on the runway edge, then moving across to the centreline.

- The pilot lined the aircraft up and commenced take-off on the runway edge lighting from an intersection (A7) departure.
- The misalignment of the aircraft was influenced by the pilot rushing due to perceived pressure to commence the take-off when the line-up clearance was given, the issuing of a frequency change while the pilot was completing the line-up checks as well as lining up the aircraft on the runway, the lack of taxiway lead-on lights to the runway, and limited brightness of the aircraft taxi light.
