Near collision involving Cessna 172S, VH-USL, and parachutists

Lower Light (ALA), South Australia, 6 November 2016

ATSB Transport Safety Report
Aviation Occurrence Investigation
AO-2016-147
Final – 17 January 2017

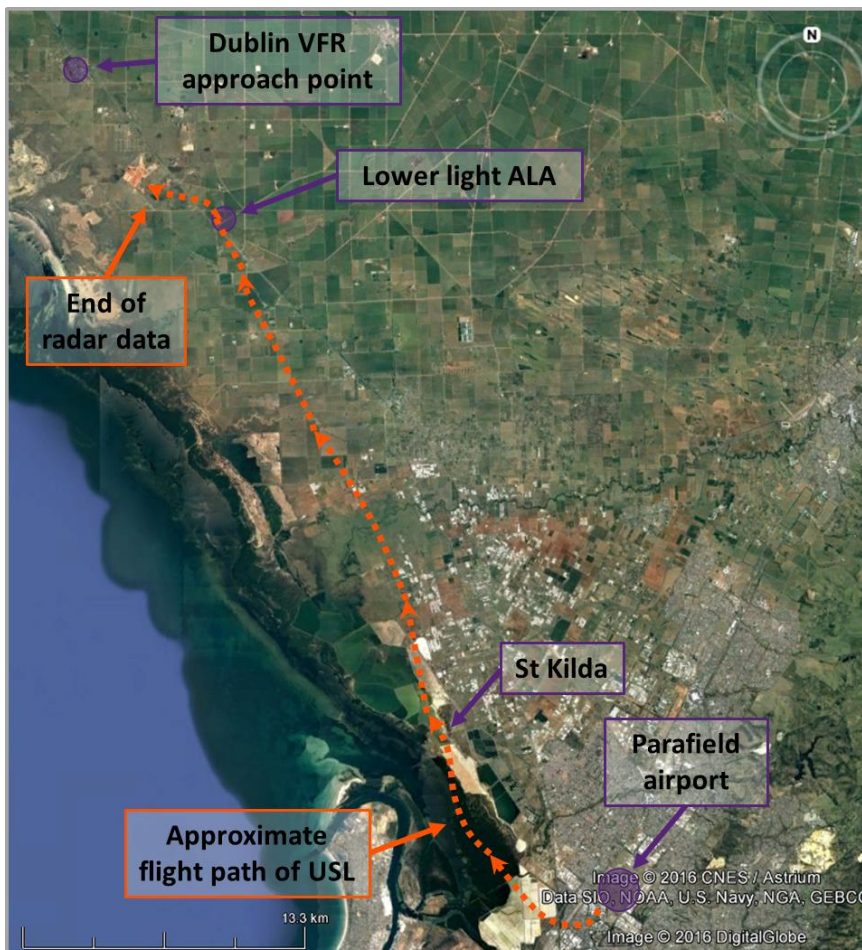
Figure 1: Approximate flight path of USL from Parafield to just past the Lower Light ALA

During the initial climb, the pilot engaged the autopilot. As the aircraft started to climb at a faster rate than expected, the pilot disconnected the autopilot and continued on to St Kilda (Figure 1).

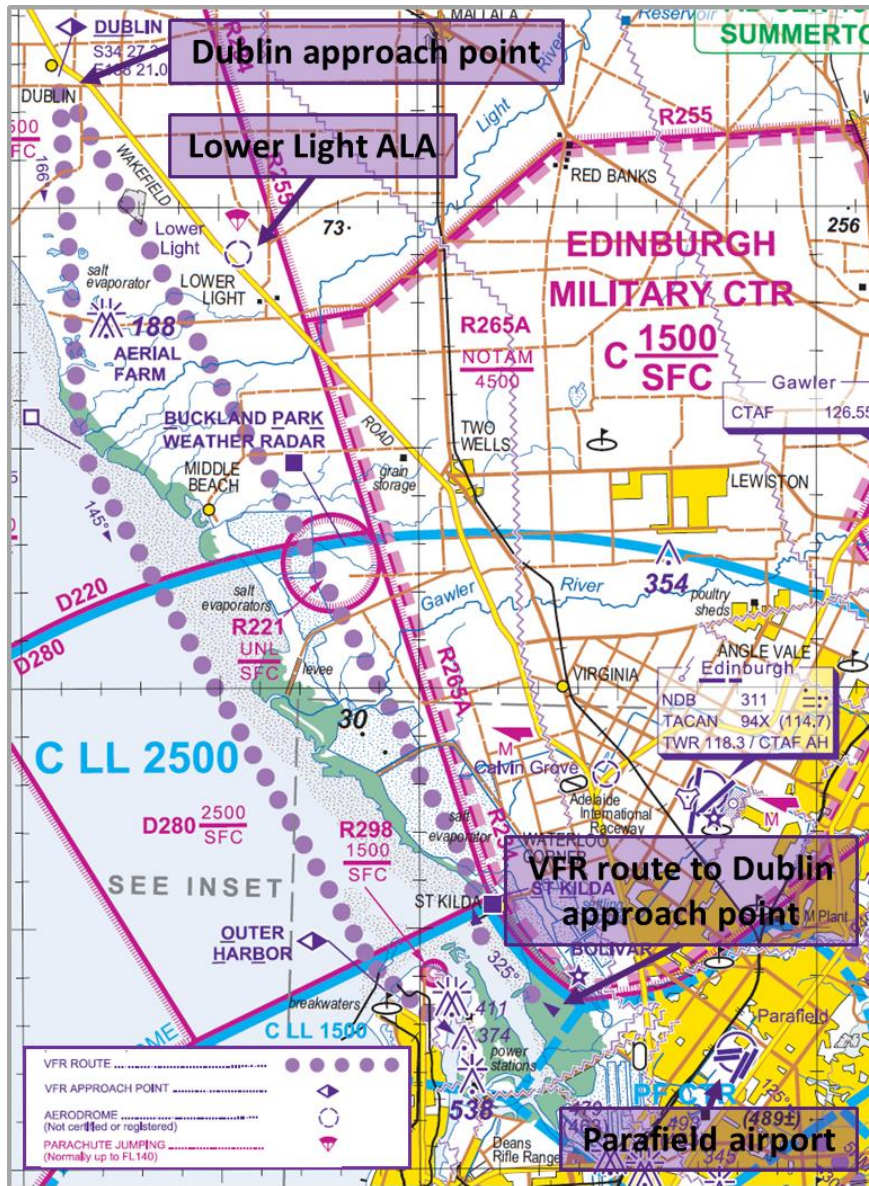
Figure 2: Visual Terminal Chart showing Dublin, Lower Light ALA, VFR route

When the aircraft reached 1,000 ft, the pilot again engaged the autopilot and the autopilot again started to change the attitude of the aircraft, not as expected, and the pilot disconnected the autopilot. After passing St. Kilda, the pilot initiated a climb to 2,500 ft and navigated along the VFR route towards Dublin (Figure 2). In the cruise, the pilot continued to attempt to get the autopilot to engage but it did not respond as they expected. The pilot reported that they made regular checks and would look from inside the cockpit to outside to check the aircraft was maintaining a direction to Dublin and that no other aircraft were in the vicinity.
