Collision with terrain involving Robinson R44, VH-YMJ

near Riversleigh ALA, Queensland, 12 November 2016

ATSB Transport Safety Report
Aviation Occurrence Investigation
AO-2016-150
Final – 9 February 2017

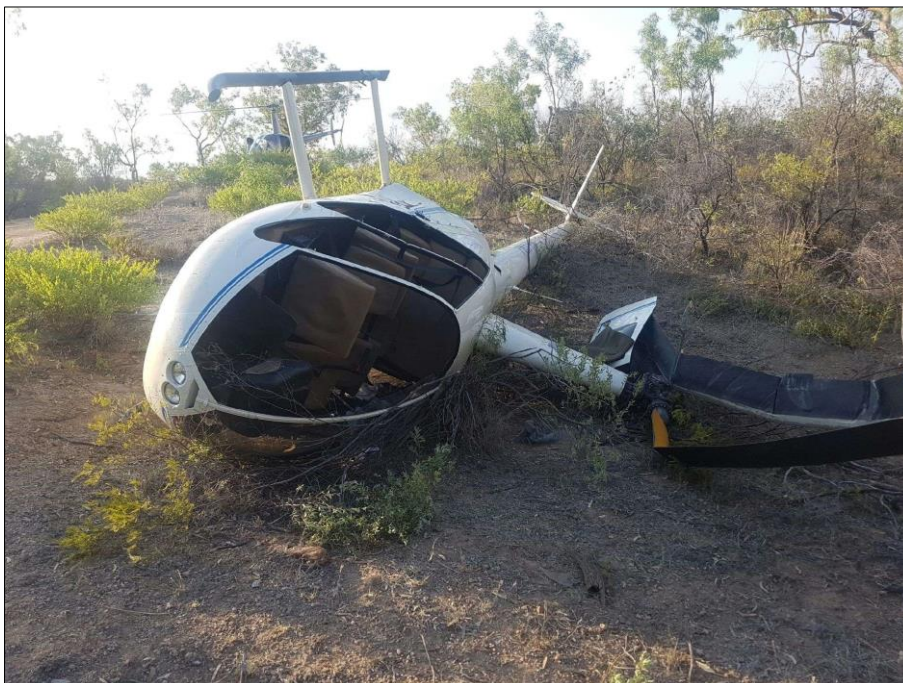
Figure 1: VH-YMJ accident site

As the helicopter approached the ground, the pilot raised the collective lever¹ to cushion the landing. The right skid of the helicopter landed first, on the side of the road and the left skid landed off the side of the road below the right skid, which resulted in the helicopter rolling onto the left side before coming to rest (Figure 1). One passenger received minor injuries and the helicopter was substantially damaged.

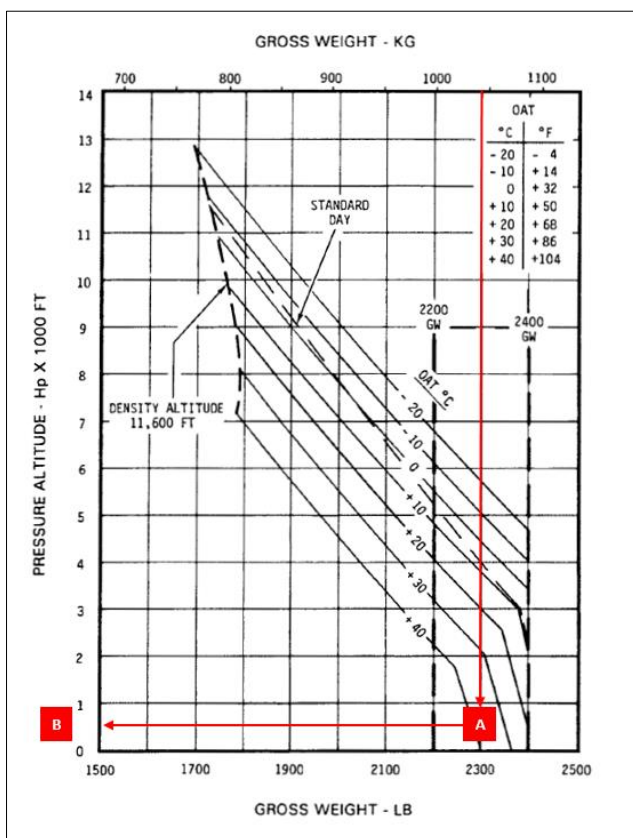
Figure 2: R44 HOGE performance

If the wind speed dropped during the initial climb, then the helicopter could have been below translational lift at 100-130 AGL when the descent started. In this case the helicopter would have been in the hover out of ground effect⁴ (HOGE) flight regime (Figure 2). At the reported temperature and AUW, this would place the helicopter at the limit of the hover altitude for the power available (point B, Figure 2).

Two possible scenarios for insufficient power are a shift in wind direction to the right side of the helicopter or a decrease in head wind strength. In the first scenario, a shift in wind direction to the right would demand more left tail rotor pedal to maintain take-off heading and decrease the power available from the engine for main rotor thrust. In the second scenario, a decrease in wind strength just after translational lift would place the helicopter inside the HOGE flight regime and at the limit for the take-off AUW and temperature.
