# Collision with terrain involving de Havilland Canada DHC-2, VH-AWD

70 km NNE Hamilton Island, Queensland, 13 March 2017

**ATSB Transport Safety Report**  
Aviation Occurrence Investigation  
AO-2017-031  
Final – 24 May 2017

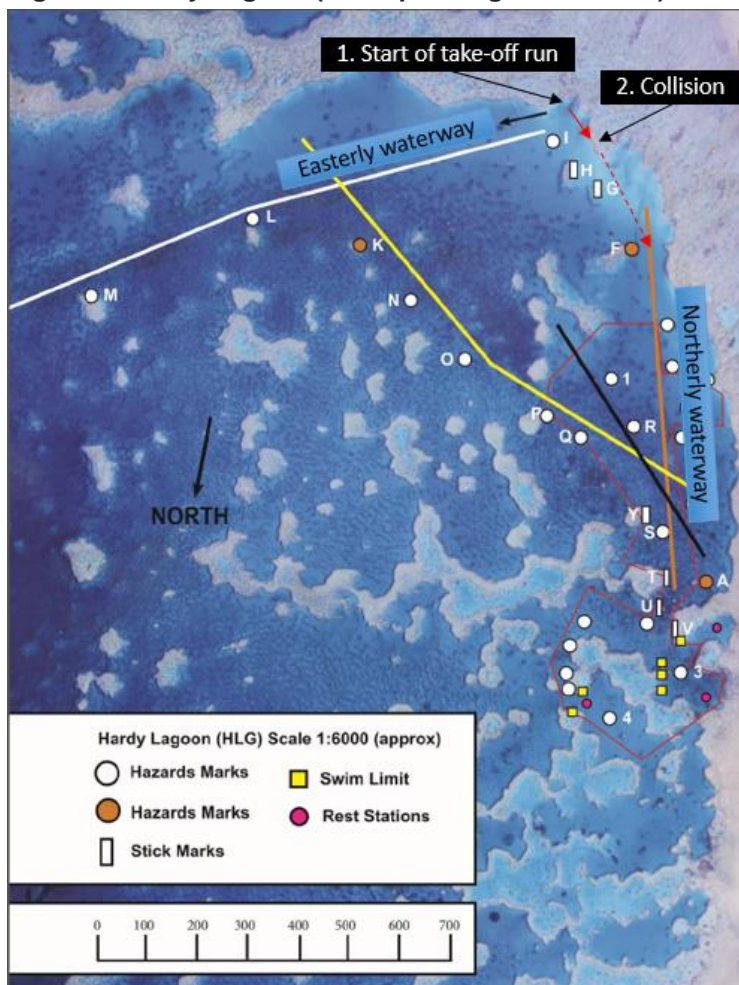
Figure 1: Hardy Lagoon (north pointing downwards)

The wind effect on the aircraft indicated to the pilot that the northerly waterway was the most into wind waterway. In order to maximise the take-off distance available the pilot applied power to start the take-off run from a position to the south-east of the northerly waterway, while aiming to join the waterway at buoy F (Figure 1). Shortly after applying full power, and before the aircraft entered the northerly waterway, both floats struck submerged reef, which brought the aircraft to a stop.

The tide was at 0.6 m at the time of the collision, which occurred outside of the waterways. When the tide is above 2.5 m, the aircraft can manoeuvre around Hardy Lagoon outside of the dimensions of the ALA without striking reef. Below the 2.5 m tidemark, it was known that the reef could be struck when manoeuvring the aircraft outside the dimensions of the ALA. However, the pilot believed that their chosen track from buoy I to buoy F, where they would join the northerly waterway, was clear of underwater terrain. There were no hazard marks on the left side of their track towards buoy F, but this was outside the prescribed waterway.

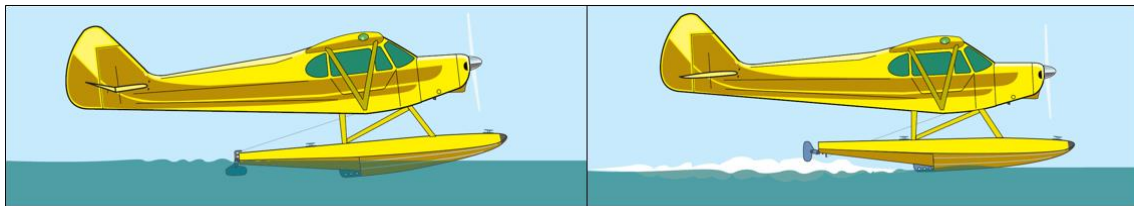
**Figure 2: Seaplane in the plow (left) and planing (right)**

The application of power to start the take-off pushes the centre of buoyancy aft, due to increased hydrodynamic pressure on the bottom of the floats. This places more of the seaplane's weight towards the rear of the floats which sink deeper into the water. This results in a higher nose attitude, reduced forward visibility, and creates high drag, which requires large amounts of power for a modest gain in speed (Figure 2 left). This phase of the take-off is known as in the plow.

As speed increases, hydrodynamic lift on the floats and the aerodynamic lift of the wings supports the seaplane's weight instead of the buoyancy of the floats. This allows the pilot to lower the nose attitude, which raises the rear portions of the floats clear of the water (Figure 2 right). This is the planing position, which reduces water drag and permits the seaplane to accelerate to lift-off speed. The pilot reported this was about 25-30 kt for the DHC-2.

At the time of the attempted take-off, the tide was close to the low point, but the reef struck by the aircraft was still submerged. The sun angle was low, which increased the amount of sunlight reflected from the water surface. At the speed of the collision, the aircraft nose attitude was at the highest angle for the take-off run, which combined with the sunlight reflection to severely restrict the pilot's ability to detect submerged reef.
