Collision with terrain involving Bell Helicopter 206B, VH-PHP

6.5 km east-north-east of Maitland Airport, New South Wales, on 6 October 2022

Aviation Occurrence Investigation (Short)

AO-2022-048

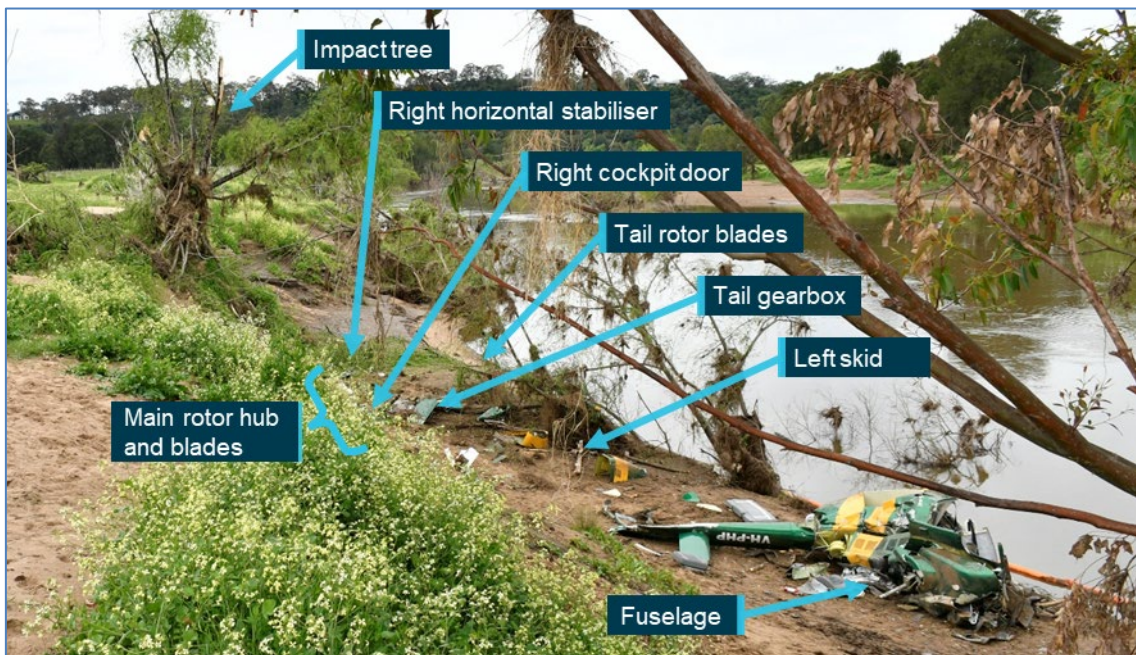
Figure 5: Wreckage trail

All major aircraft components were accounted for at the accident site except for 2 parts of a main rotor blade. There was no evidence of a birdstrike identified in the wreckage.

The 2 parts unaccounted for were a 2 ft long outboard section of the main rotor blade leading edge and the associated blade tip weight. It was assessed that the leading edge and tip weight were likely projected into the swollen river during the impact sequence due to the helicopter heading, the pattern of damage, and fracture surfaces of the recovered adjacent leading edge, trailing edge and tip sections.

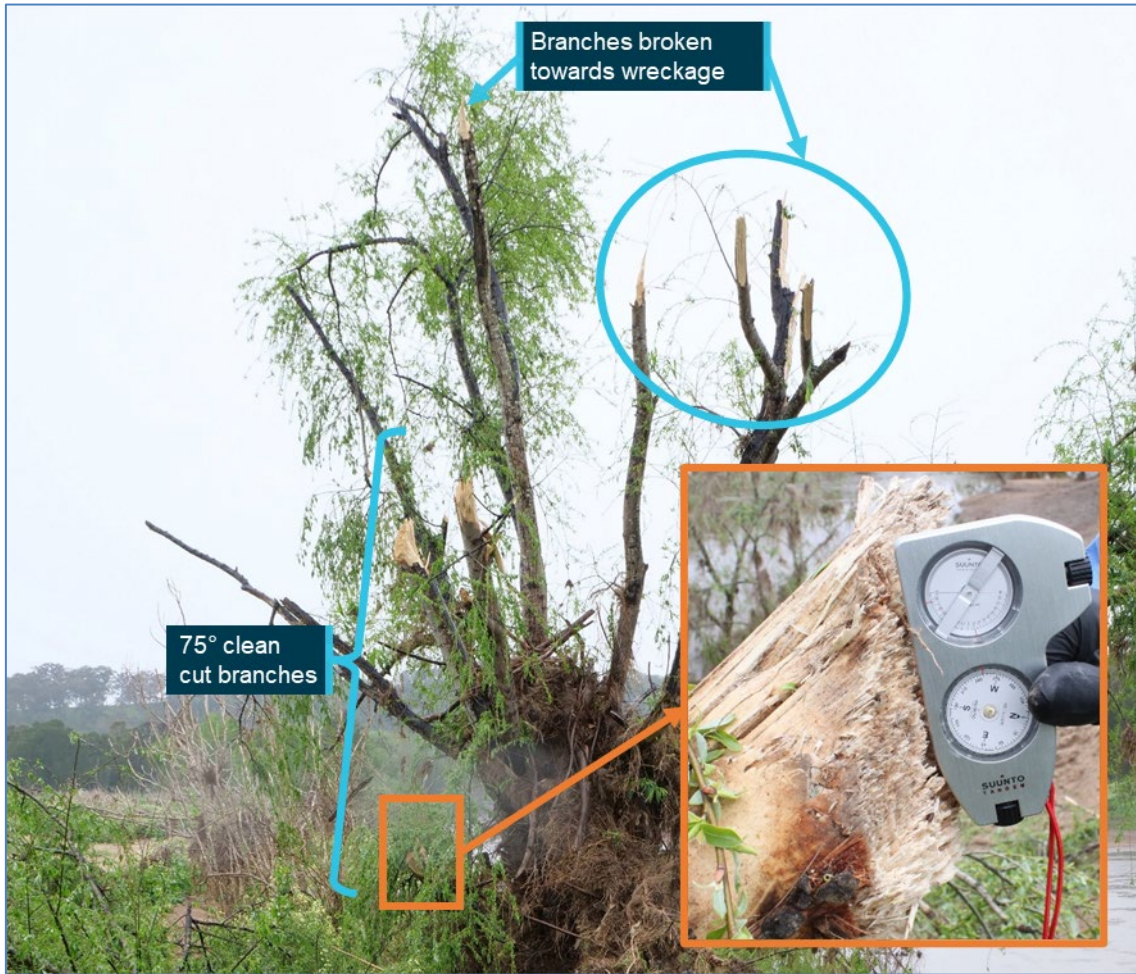
Figure 6: Initial impact tree

Some lower branches of the tree (Figure 6) were cut at 75° from the horizontal and the multiple cuts were at about 75° to each other suggesting they were cut by the main rotor system. Other branches higher up on the other side of the tree were snapped off in the general direction of the wreckage.
