Flight below minimum altitude involving Cessna Citation 510, VH-IEQ

15 km west of Bankstown Airport, New South Wales, on 16 November 2022

ATSB Transport Safety Report

AO-2022-061

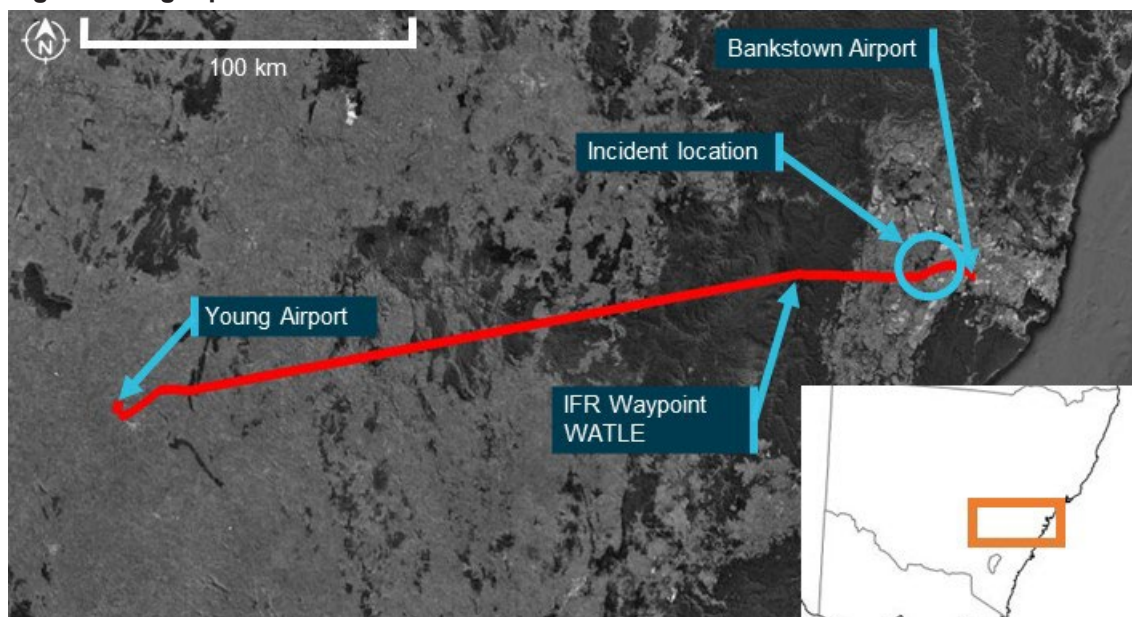
Figure 1: Flight path of VH-IEQ and incident location

Image showing flight path of aircraft (red line) on a map, with take-off, arrival and location of flight below lowest safe altitude. Source: Google Earth and Geoscience Australia, annotated by the ATSB

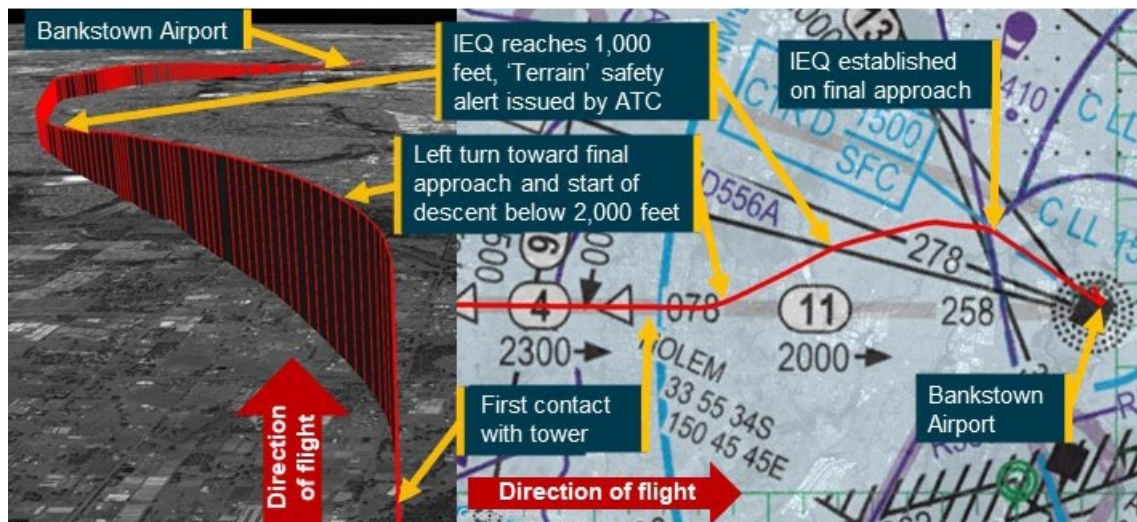
Figure 2: Flight path of VH-IEQ showing descent to 1,000 ft and approach to land

At the time the safety alert was issued and while maintaining at 1,000 ft, flight track data showed that the aircraft started to change track to the right by 15° to 075° for about 2 NM (3.7 km). The aircraft then changed track again to the right toward the intersection of the Bankstown Airport control zone and the extended centreline of runway 11 centre. Just prior to entering the control zone at 2017:55, Bankstown Tower provided the aircraft with a clearance to land, which was acknowledged by the pilot. At this time, the aircraft turned toward runway 11 centre and started to descend from 1,000 ft. An uneventful landing on runway 11 centre was conducted at 2019:56.

Note: Image showing flight path of aircraft (red line) on a low level enroute chart (right) and from the perspective of the approach from the NOLEM waypoint (left).

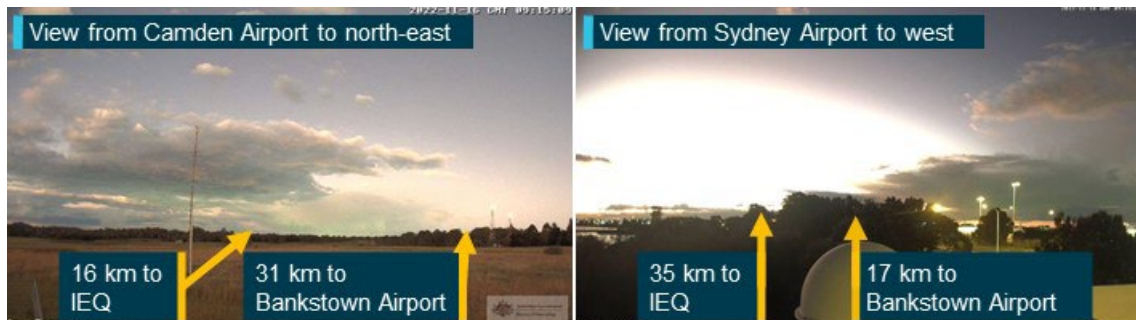
Figure 3: Images from weather cameras at Camden and Sydney Airports

Images from weather cameras at the time of the incident located at Camden and Sydney Airports facing the direction of the aircraft and Bankstown Airport are shown in Figure 3. The images show that less than half of the sky is covered by cloud, with the cloud tops illuminated by the sun. There were no weather cameras operating at Bankstown Airport.

The Bureau of Meteorology advised that these weather cameras were configured 'to work in low light and will use the light available to provide the best image', that is, the images shown in Figure 3 'look brighter than the actual conditions experienced by the pilot'. However, relatively clear atmospheric conditions are shown by the images, with well-defined silhouettes of ground-based features.

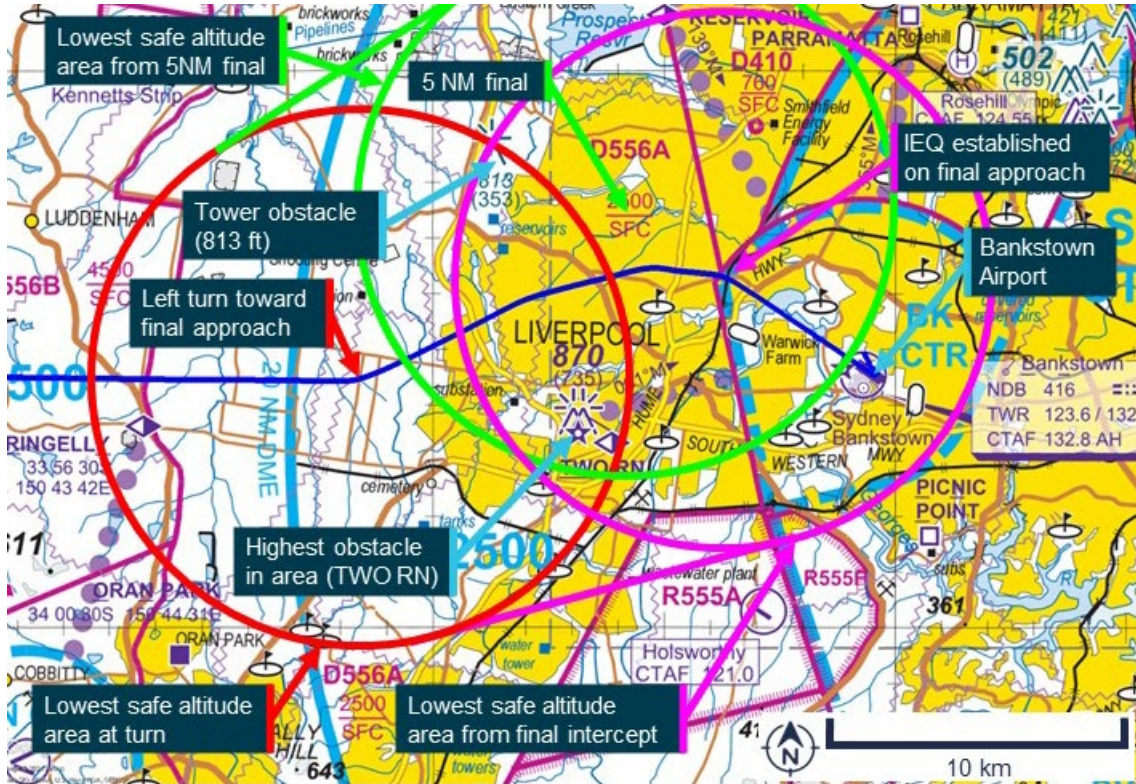
Figure 4: Area applicable to lowest safe altitude calculations for VH-IEQ between flight path deviation and the extended centreline of runway 11 centre at Bankstown Airport

Paragraph 4.5 applied to the incident flight after the pilot intentionally flew off-track toward final approach for runway 11 centre with the last positive fix being the waypoint NOLEM. Based on this, the ATSB calculated the LSALT for the aircraft between NOLEM and being aligned with runway 11 centre. An extract of the visual terminal chart applicable to the area is shown in Figure 4.

This area is shown for the incident between the red circle labelled 'Lowest safe altitude area at turn' and the magenta circle labelled 'Lowest safe altitude area from final intercept' in Figure 4. Calculations were also performed in the circumstance where the aircraft flew to an extended 5 NM final for runway 11 centre, the earliest point of descent when using the PAPI, and this is depicted by the green circle labelled 'Lowest safe altitude area from 5 NM final' in Figure 4.

Figure 4 also shows 2 charted obstacles in the area. This indicated that paragraph 4.3(a) from AIP GEN 3.3 applied to this part of the flight. The highest obstacle in the area to be considered for LSALT was the tower 'TWO RN' at 870 ft above mean sea level, located about 2.5 NM (4.6 km) to the right of track, as labelled in Figure 4. Another tower was present about 2.5 NM (4.6 km) to the left of track at a height of 813 ft. Based on this, the LSALT for the aircraft during this segment of the flight was 1,870 ft.

- While conducting a visual approach to Bankstown Airport, the aircraft descended 800 ft below the lowest safe altitude for operations at night, reducing the assurance for separation from terrain and ground-based obstacles.
