# In-flight engine failure involving Sikorsky S-76C helicopter, VH-EXU

Snapper Platform, Bass Strait (74 km east of Longford, Victoria) | 11 July 2013

**ATSB Transport Safety Report**  
Aviation Occurrence Investigation  
AO-2013-124  
Final – 20 October 2016

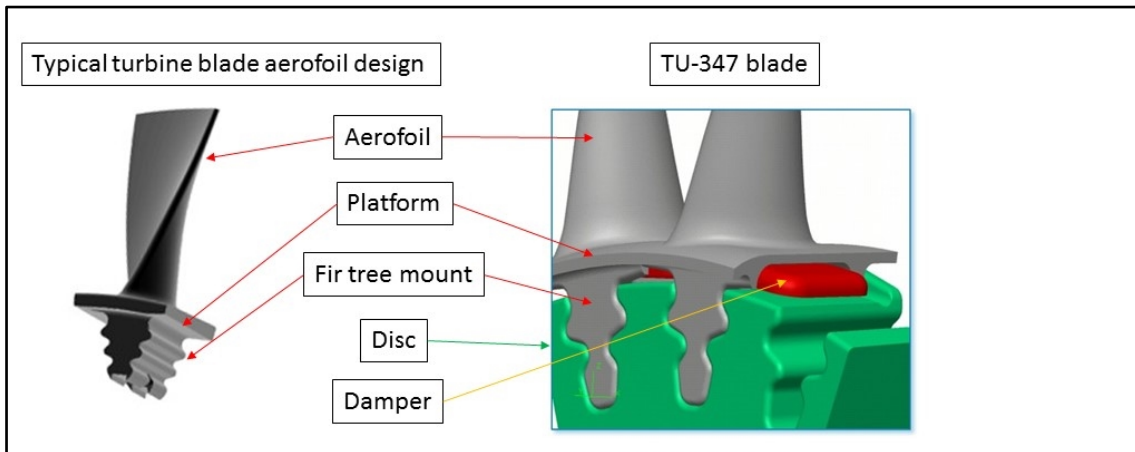
**Figure 3: TU-347 detail**

The HP2 turbine of the right engine in EXU had TU-347 incorporated when the Module 3 was last overhauled.

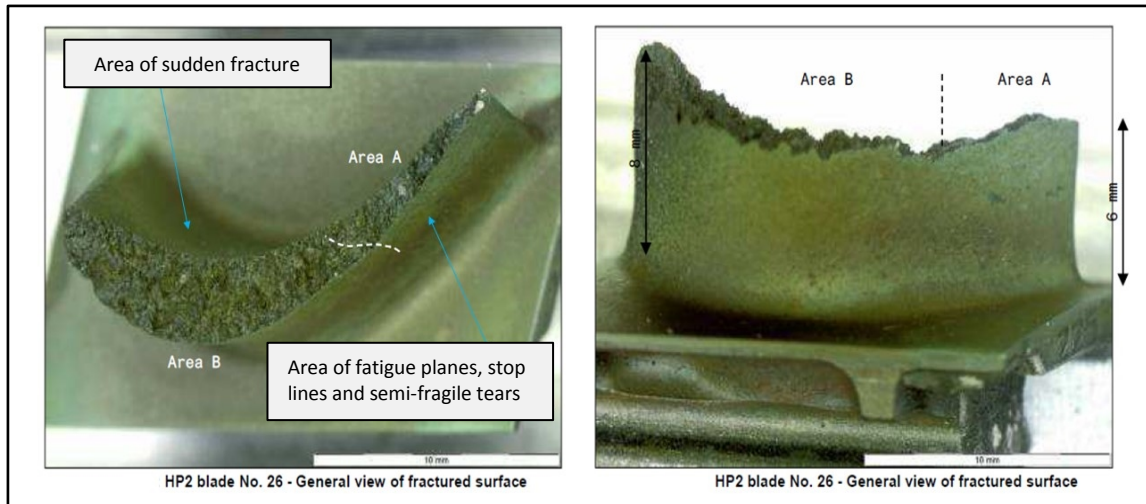
**Figure 4: Blade No. 26 fracture surface examination**

Inspection of the fracture surface revealed two distinct regions nominated as area A and area B. Area B included the leading edge and accounted for approximately 83 per cent of the fracture surface. Area A included the trailing edge and covered the remaining 17 per cent of the fracture surface (Figure 4).

The blade No. 26 area B fracture surface was typical of overstress and sudden fracture. Several isolated areas of fatigue crack propagation near the trailing edge of the blade (Area A) were noted; however, the origin could not be determined. There was no evidence of blade creep or sign of foreign object damage.

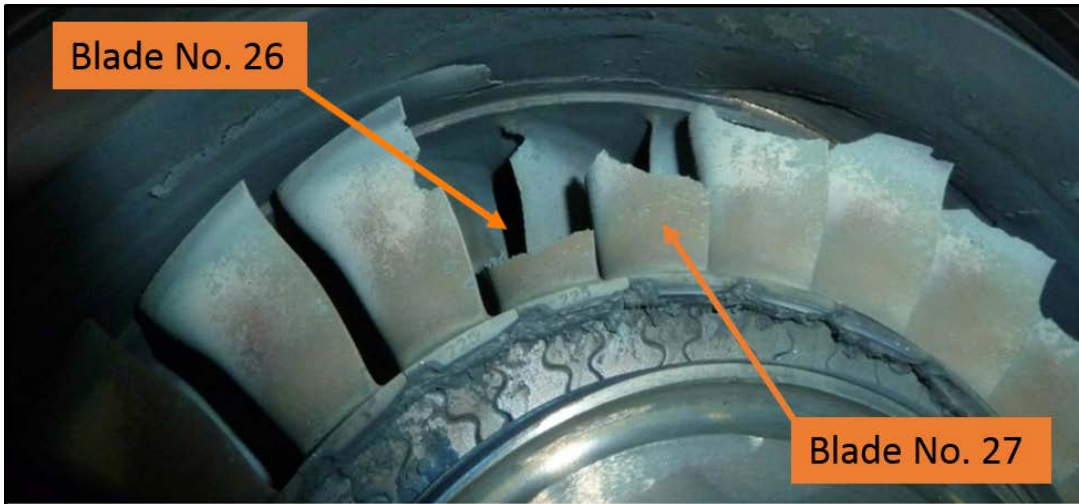
**Figure 5: Blade No. 26 and damage to the adjacent blades**

The examination of Module 3 revealed significant damage in the turbine area. This included fracture of the No. 26 blade of the GG high pressure turbine assembly second stage wheel (HP2) with resulting impact damage to, and loss of material from a number of adjacent blades. The GG turbine rear bearing also exhibited signs of significant damage associated with heavy rubbing on the races and flattening of the bearing rollers.

The blade No. 27 fracture surface was consistent with static overstress resulting from the impact of blade No. 26. This phenomenon also explained the damage observed on a number of the other blades. No significant metallurgical discrepancies were identified between the blades that were examined.

The fractured No. 26 blade and adjacent damaged blades are shown in Figure 5.

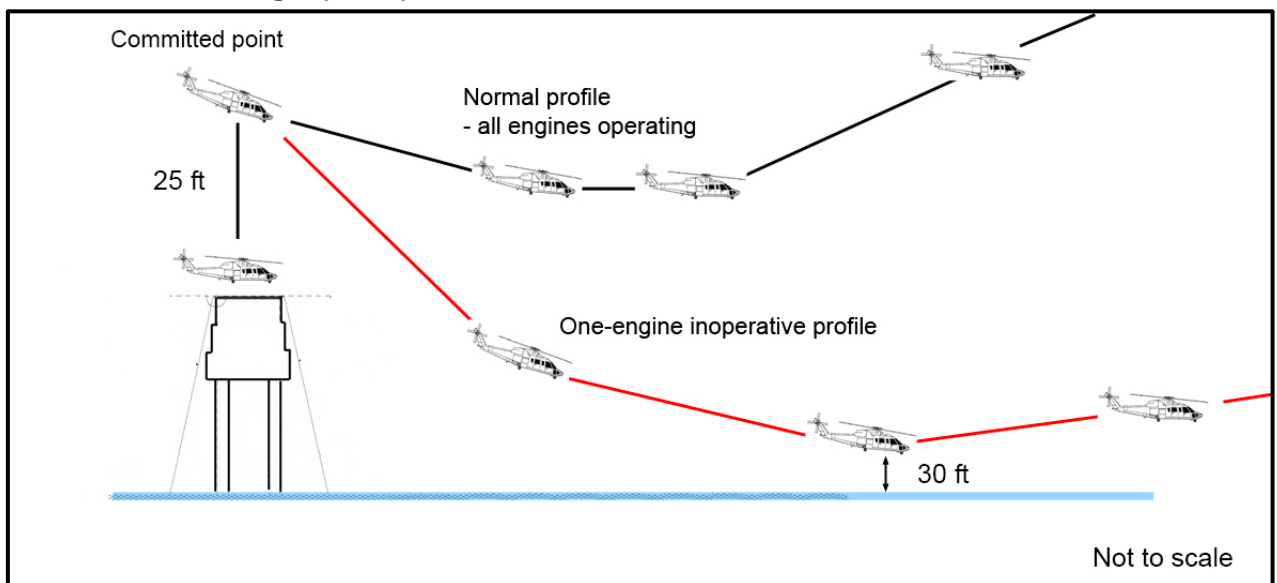
**Figure 7: Elevated helideck profile showing a representation of the operator’s Category B departure with all engines operating (in black) and an estimation of the departure profile for the occurrence flight (in red)**

Figure 7 provides a representation of the operator’s Category B departure from an offshore platform with all engines operating and an estimation of EXU’s profile following the engine failure.
