# Collision with terrain involving Piper PA25-235/A9 Pawnee, VH-NLP

10 km west of Darlington, Victoria on 20 March 2015

**ATSB Transport Safety Report**  
Aviation Occurrence Investigation  
AO-2015-030  
Final – 16 March 2017

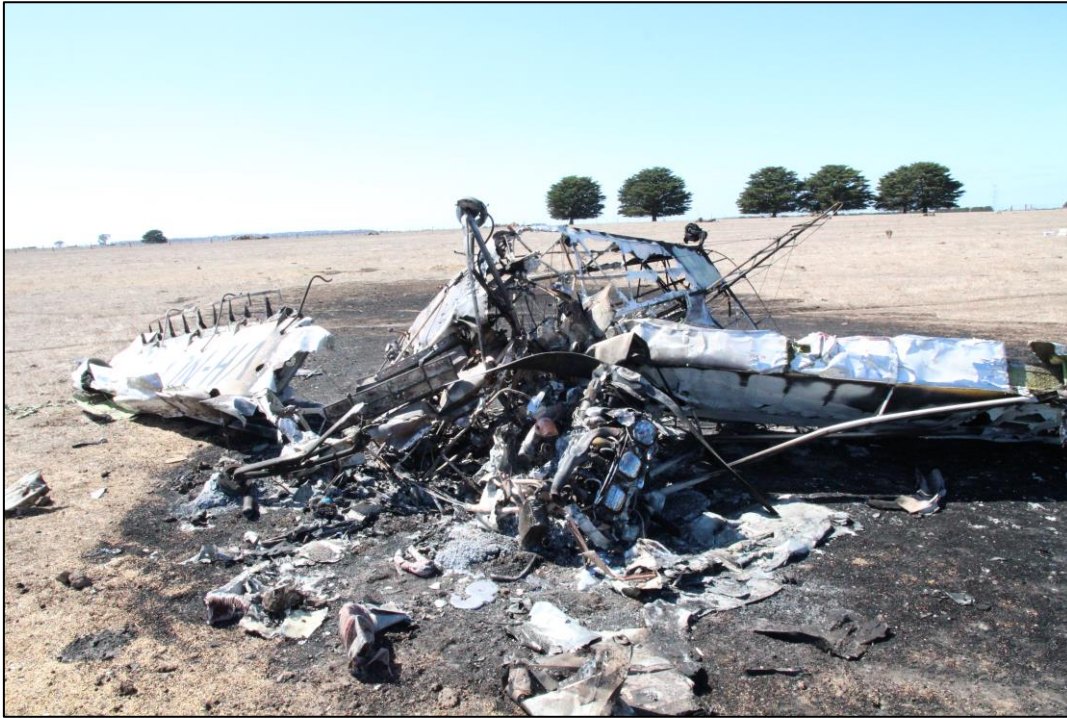
The wreckage was located in the eastern-most paddock of the three to be baited. Examination of the accident site indicated that NLP impacted terrain nose-down, in an almost vertical orientation. The aircraft came to rest about 7 m from the initial impact point. The forward fuselage and cockpit sustained significant damage as a result of the initial impact, and a post-impact fire consumed the the internals of the aircraft's global positioning system equipment, the majority of the fuselage and the inboard wing sections (Figure 1). Damage to the leading edge of each wing also indicated a vertical impact. ATSB analysis based on estimates of the aircraft's speed, the almost vertical impact angle and the energy absorbed by the aircraft indicated that the impact forces imparted to the pilot would normally be expected to result in fatal injuries.

Examination of the propeller, along with evidence from the impact crater, indicated that the propeller was rotating under a level of power at the time of impact. Flight control continuity was confirmed. Due to the level of damage, the flap position could not be determined.

No pre-existing anomalies were identified at the accident site that would have precluded normal operation of the aircraft.

**Figure 1: Aircraft wreckage (looking east), showing the lower surface of the aeroplane. Note the significant damage to the forward fuselage and cockpit area and the extent of the fire damage to the fuselage and inboard wing sections**

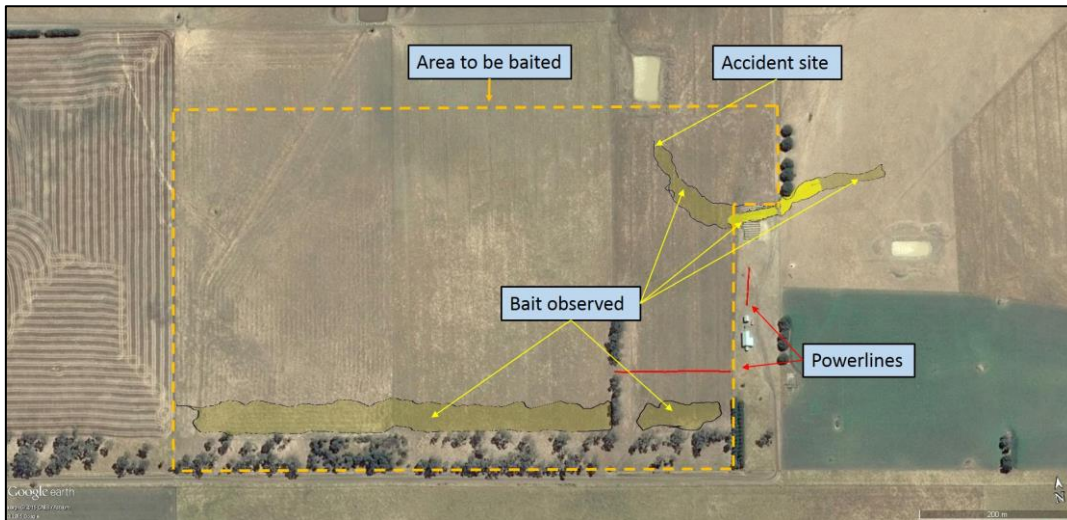
Insect bait was found in a straight and regular swathe along the southern fence line of the paddock, consistent with a bait application run (Figure 2). This swathe ran for the entire length of the planned baiting area and was about 36 m wide. Additionally, a bait swathe of varying width and density from the middle of the adjacent paddock was observed outside and to the top-right of the baiting area. This continued in an arc to the initial impact point. This swathe initially decreased from about 16 m down to 7 m wide, then increased to 30 m wide before tapering off towards the accident site.

**Figure 2: Area to be baited (outlined by the yellow dashed line), with dispensed bait shaded in yellow and higher-concentration bait shown as bright yellow**

The spread width of the bait throughout the initial application run was about 36 m. Consistent with the aircraft owner's standard bait application height of between treetop height and 100 ft (30 m), a witness observed VH- NLP (NLP) conducting runs at treetop height, or about 50 ft (15 m) above ground level. This reported height, and the known spread width on the first run, was used as a basis for determining the approximate height of NLP between the grain release in the adjacent paddock through to the accident site.

The spread width decreased from 16 m to 7 m, before increasing again to a width of 30 m. This indicates that NLP was below the previous application height, and continued to descend before climbing until about 70 m from the accident site. From this position the aircraft descended and impacted the ground. This is consistent with an attempt by the pilot to regain height after descending in the latter stages of the repositioning turn.
