Hard landing involving an Airbus A330-323, 9M-MTA

Melbourne Airport, Victoria, 14 March 2015

ATSB Transport Safety Report
Aviation Occurrence Investigation
AO-2015-032
Final – 5 April 2017

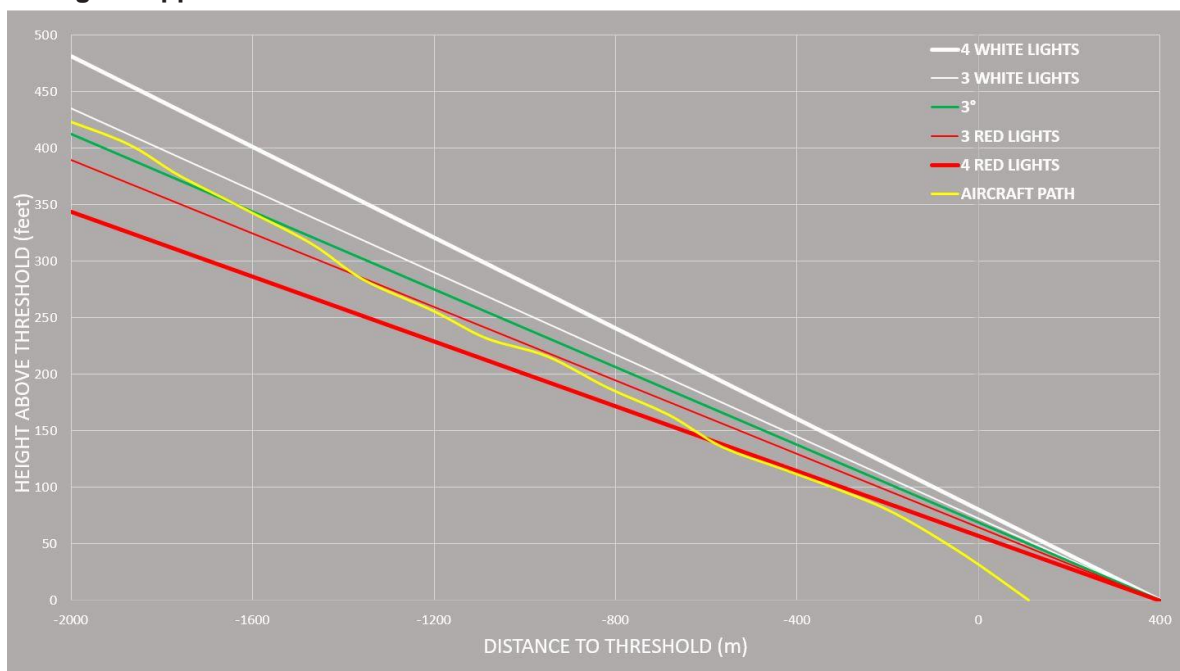
Figure 2: Aircraft path relative to the PAPI indications the pilots would have observed during the approach

As the aircraft passed 300 feet above ground level (AGL) a rate of descent of 960 feet per minute was recorded. This neared the operator's maximum stabilised approach limit of 1000 feet per minute when below 500 feet AGL. As well as a high rate of descent, actual exceedances of the operator's stabilisation criteria included:

Figure 2 displays in green the ideal glide path during an approach and the PAPI thresholds in red (low) and white (high). The yellow is the actual path of the aircraft derived from the flight data. Just below 150 feet 4 red light would have been indicated to the crew.

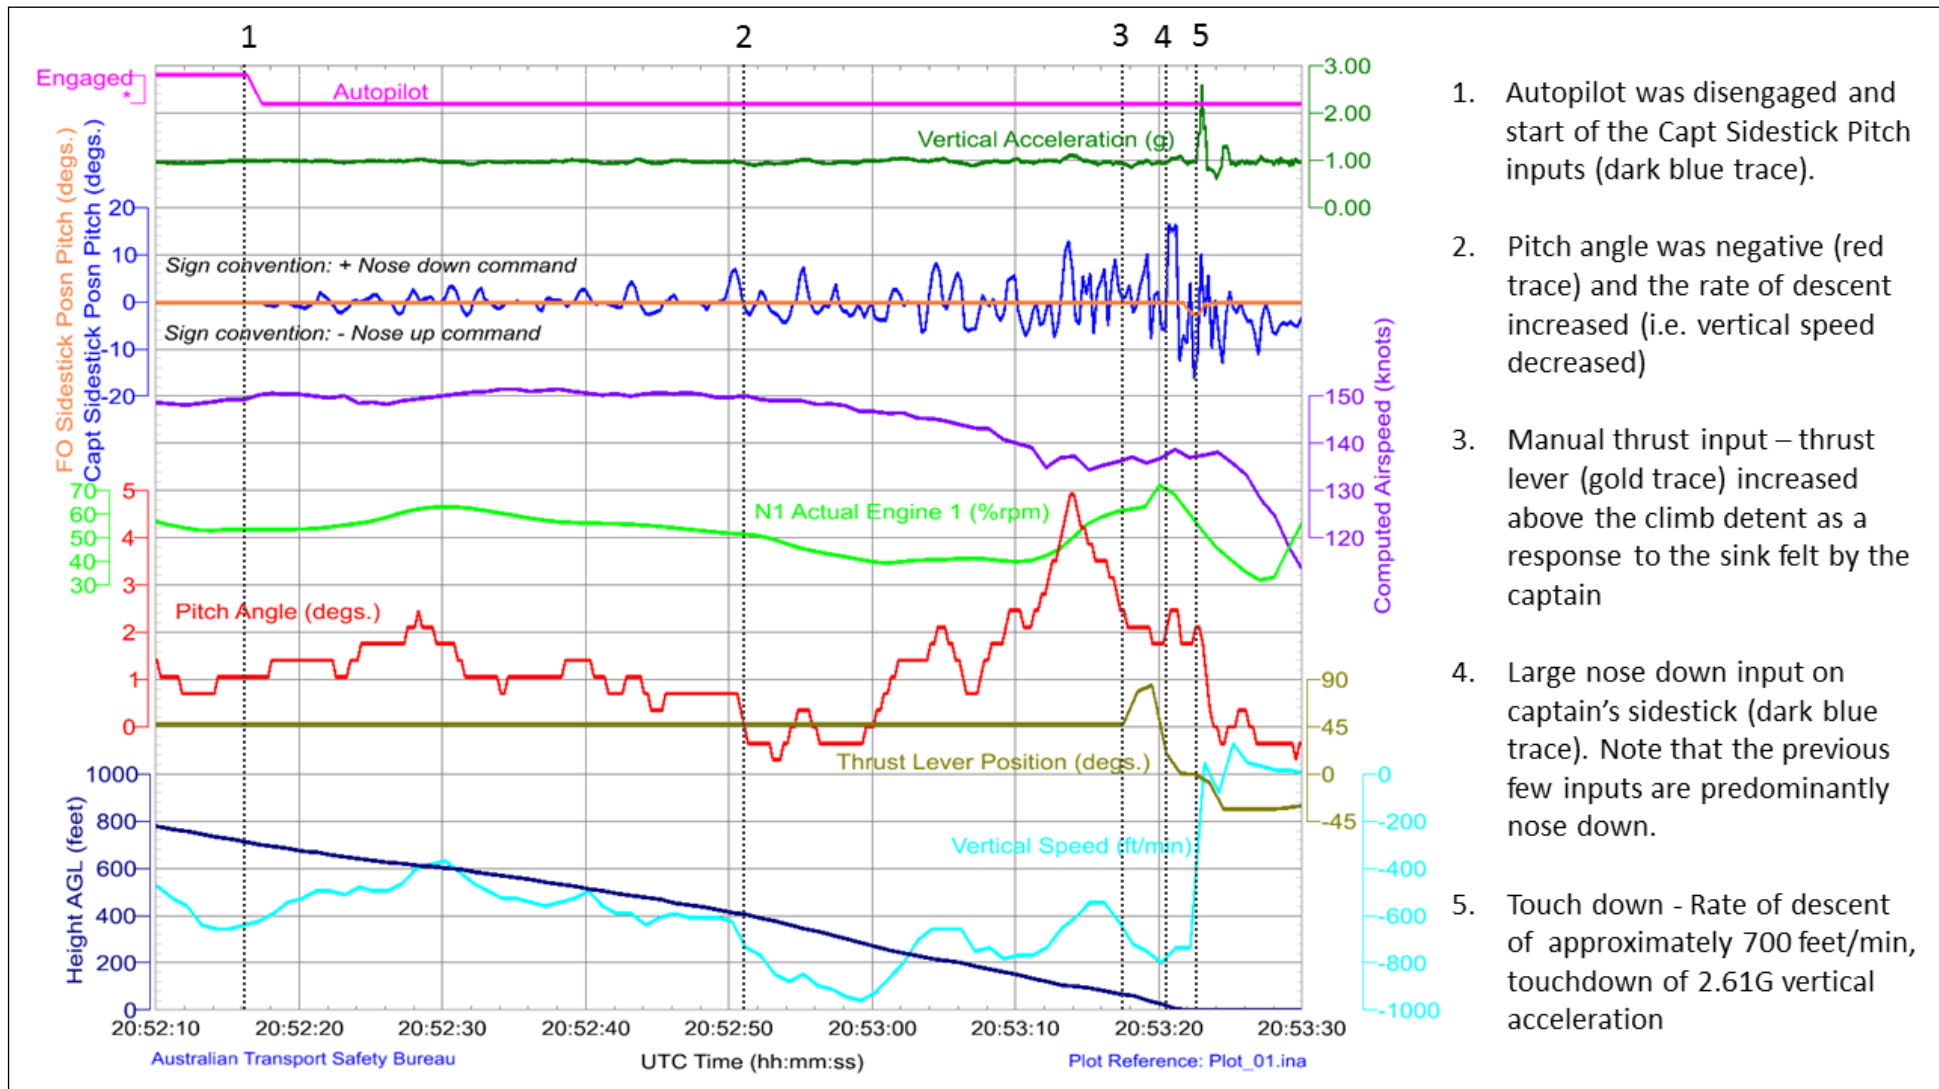
Figure 4: Graphical representation of the flight data from the incident approach

Flight data showed that the PF disengaged the autopilot at approximately 700 feet above ground level (AGL) and from that point until touchdown there was an increase in the frequency and magnitude of sidestick pitch control inputs by the PF (Figure 4).

Shortly after this action, the aircraft touched down at a vertical speed of approximately 700 feet per minute and a vertical acceleration of 2.61 G was recorded. The aircraft also touched down at approximately 170m (560 feet) from the landing threshold, short of the normal touchdown zone of between 304m (1000 feet) and 609m (2000 feet).

1. Autopilot was disengaged and start of the Capt Sidestick Pitch inputs (dark blue trace).
2. Pitch angle was negative (red trace) and the rate of descent increased (i.e. vertical speed decreased)
3. Manual thrust input – thrust lever (gold trace) increased above the climb detent as a response to the sink felt by the captain
4. Large nose down input on captain’s sidestick (dark blue trace). Note that the previous few inputs are predominantly nose down.
5. Touch down - Rate of descent of approximately 700 feet/min, touchdown of 2.61G vertical acceleration
