Collision with coral reef involving a de Havilland Canada DHC-2, VH-AWI

Hardy Lagoon (ALA), Queensland, on 25 June 2015

ATSB Transport Safety Report
Aviation Occurrence Investigation
AO-2015-069
Final – 13 April 2016

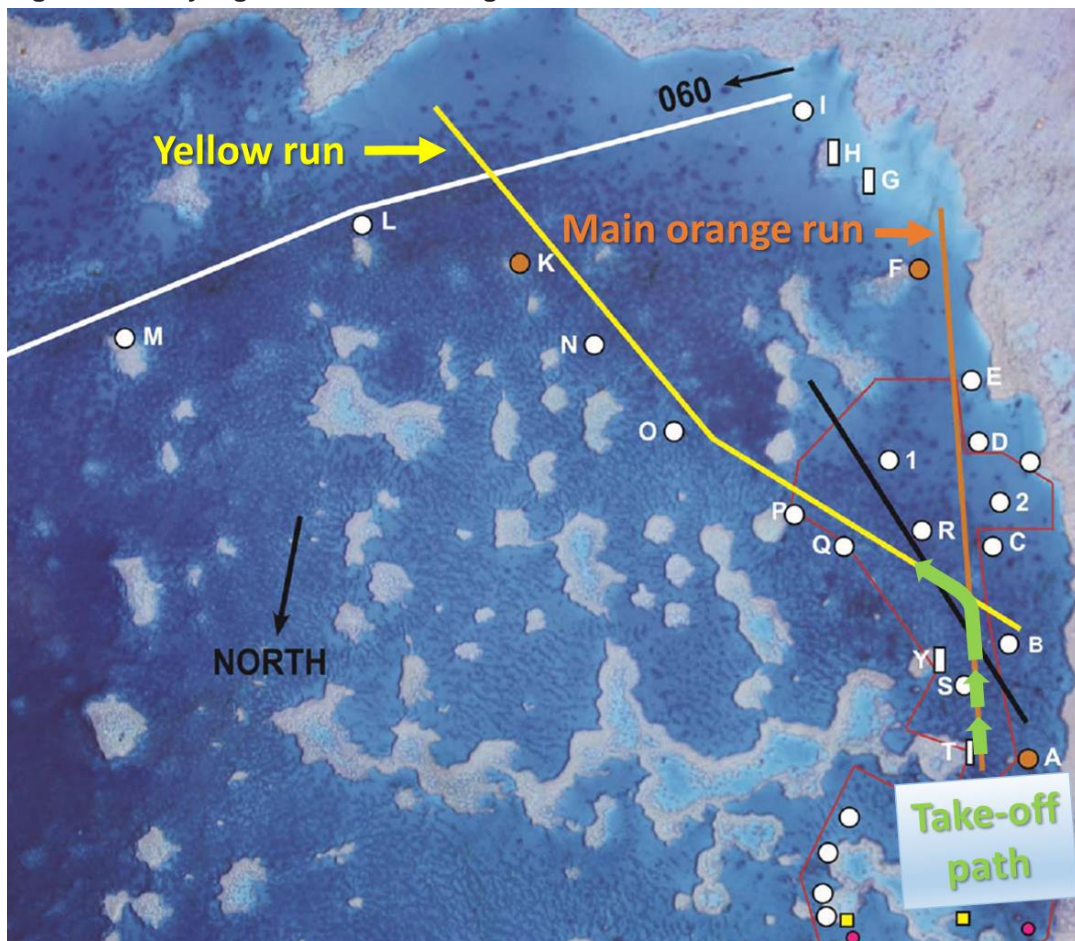
Figure 1: Hardy lagoon aircraft landing area.

The Hardy Lagoon ALA had marker buoys to identify the location of the bommies² that were near each of the four take-off and landing areas. The main take-off run (orange run) to the south, started at buoy A, and continued onto buoys B, C, D, E, F (Figure 1, orange line). The take-off run to the east-south-east (yellow run), started at buoy B, and continued onto buoys Q, P, O, N, K (Figure 1, yellow line). As per company policy, the pilot elected to start the take-off at buoy A on the orange run and then turn onto the yellow run. This combination of take-off runs allowed the pilot the maximum take-off distance, for the aircraft's take-off weight.

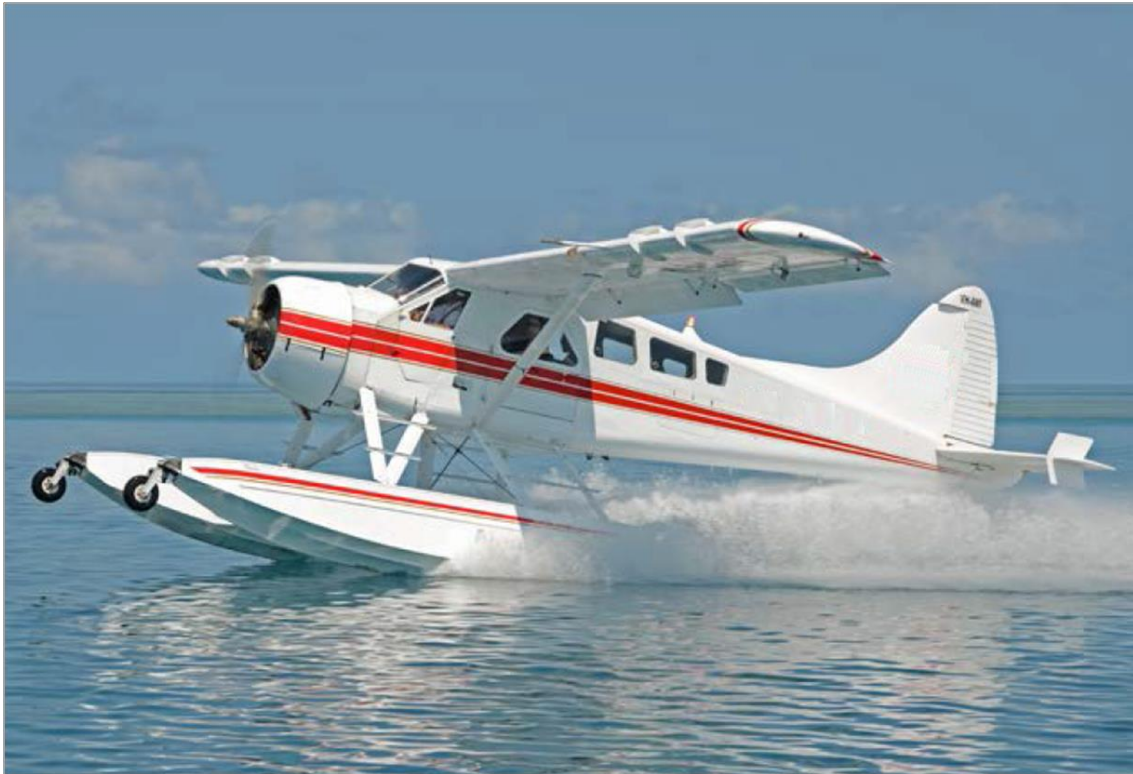
The pilot looked inside the cockpit to check the engine instrumentation and to see if the engine had reached full power. At this stage, the aircraft had not risen onto the step⁴ (Figure 2). When the pilot looked outside again, they noticed that the nose of the aircraft had drifted too far to the left. The nose had lined up on the left side of the buoy Q, which marked the location of the Q bommie. The pilot attempted to apply more right rudder, but had already applied full right rudder. AWI then hit and passed over the Q coral reef bommie and the pilot closed the engine throttle. AWI continued moving forward and the pilot shut down the engine and lowered the flaps to help slow the aircraft. The left front float slid onto the P bommie and the aircraft came to a stop.

Figure 2: AWI conducting a water take-off (not the occurrence take-off). Note the high nose attitude, skids sitting up out of the water as the aircraft is ploughing through the water. AWI has not gained enough speed in the take-off to reach the step, where the nose would be lower and the aircraft would glide along the water on the floats.

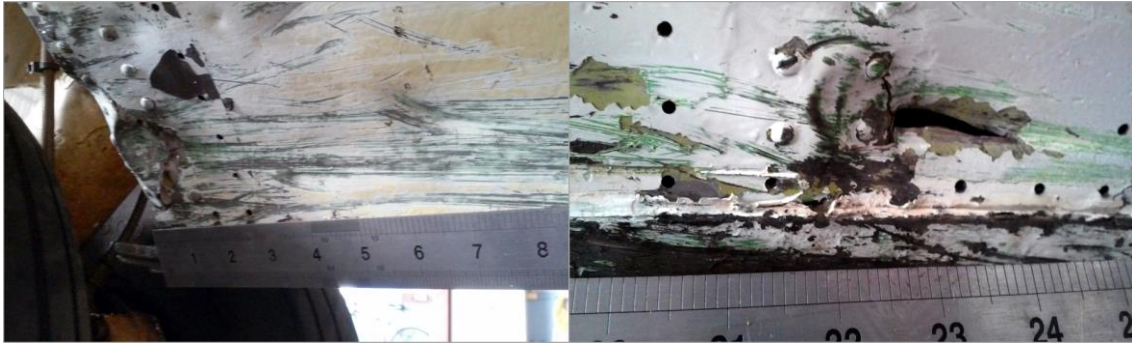
The pilot and seven passengers were uninjured and the aircraft sustained minor damage (Figure 3).

Figure 3: Damage to AWI floats included two holes on the bottom side of each float compartment immediately forward of the wheel well.

As a result of this occurrence, the aircraft operator has advised the ATSB that all company pilots will be made aware of the serious incident and conduct recurrent training on the Hardy Lagoon ALA.

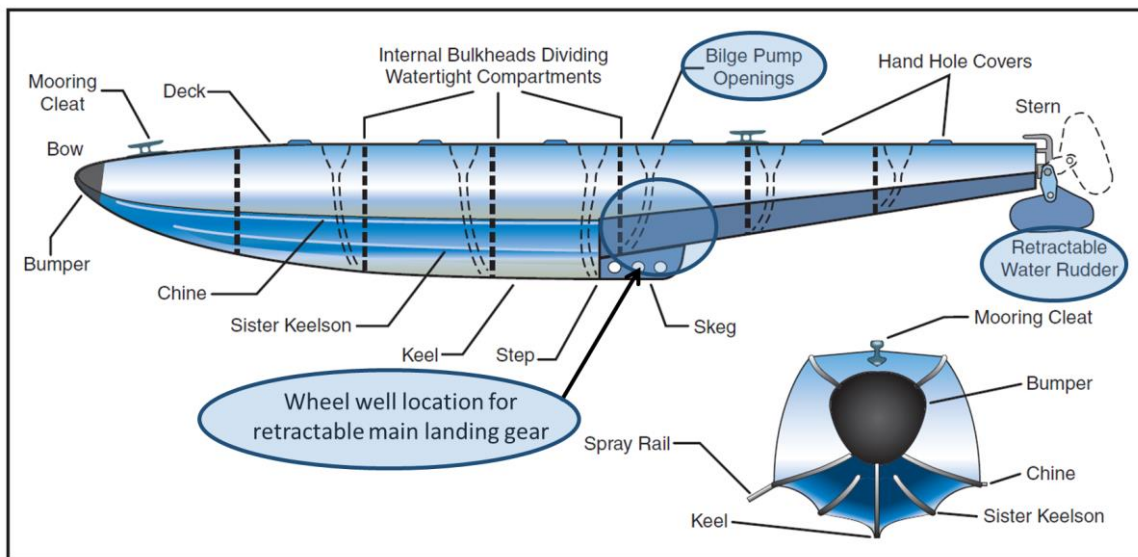
After consultation with the chief pilot, who was also at Hardy Lagoon, the pilot attempted a second take-off on the orange run, without any passengers on board. The pilot aborted the take-off at about buoy E, as the aircraft would normally be on the step at this point. The pilot taxied back to the moored boat, shut the aircraft down, and then pumped out water from the compartments in the floats (Figure 4). They then attempted another take-off on the orange run, again without success.

Figure 4: Example cross-section view of the float compartments. Note the bilge pump openings to remove water from the float compartments during the pre-flight inspection, the retractable water rudder used for directional control while taxiing and the location of the wheel well for the retractable main landing gear.
