Loss of control and collision with terrain involving Pitts Model 12, VH-JDZ

8 km south-west of Maitland Airport, New South Wales, 8 July 2015

ATSB Transport Safety Report
Aviation Occurrence Investigation
AO-2015-074
Final – 29 July 2016

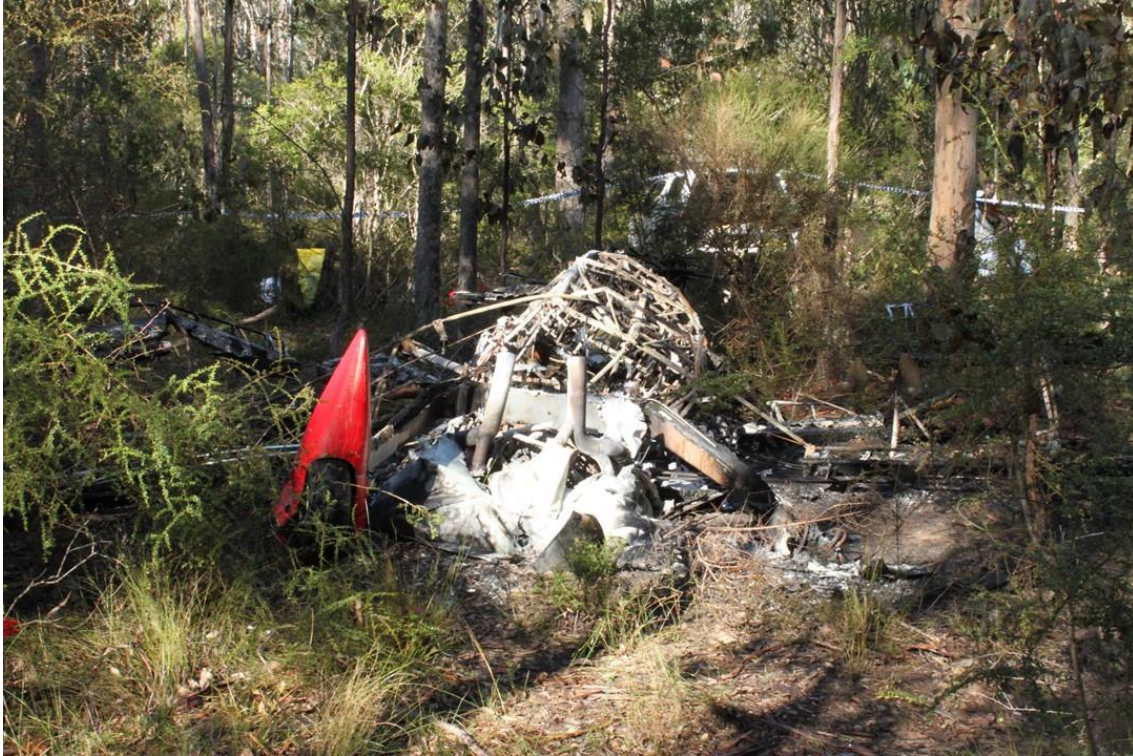
The aircraft was located from the air at about 1712 and ground crews arrived at the site shortly after. The aircraft had collided with terrain in thick bushland in the area in which aircraft regularly conducted aerobatics and close to where the previously-discussed aircraft disappeared from primary surveillance radar. The pilot was fatally injured and there was an intense post-impact fire. The fire could not be extinguished with the available resources and was monitored until it self-extinguished (Figure 1).

Figure 1: Accident site viewed from the front of the aircraft and showing the surrounding thick vegetation and minimal structural damage to the wings and airframe (consistent with the reported vertical descent)

- damage to the aircraft's tubular structure was consistent with impact with trees and/or terrain
- what remained of the wooden wing spars showed little damage, consistent with little forward speed just prior to the impact with terrain

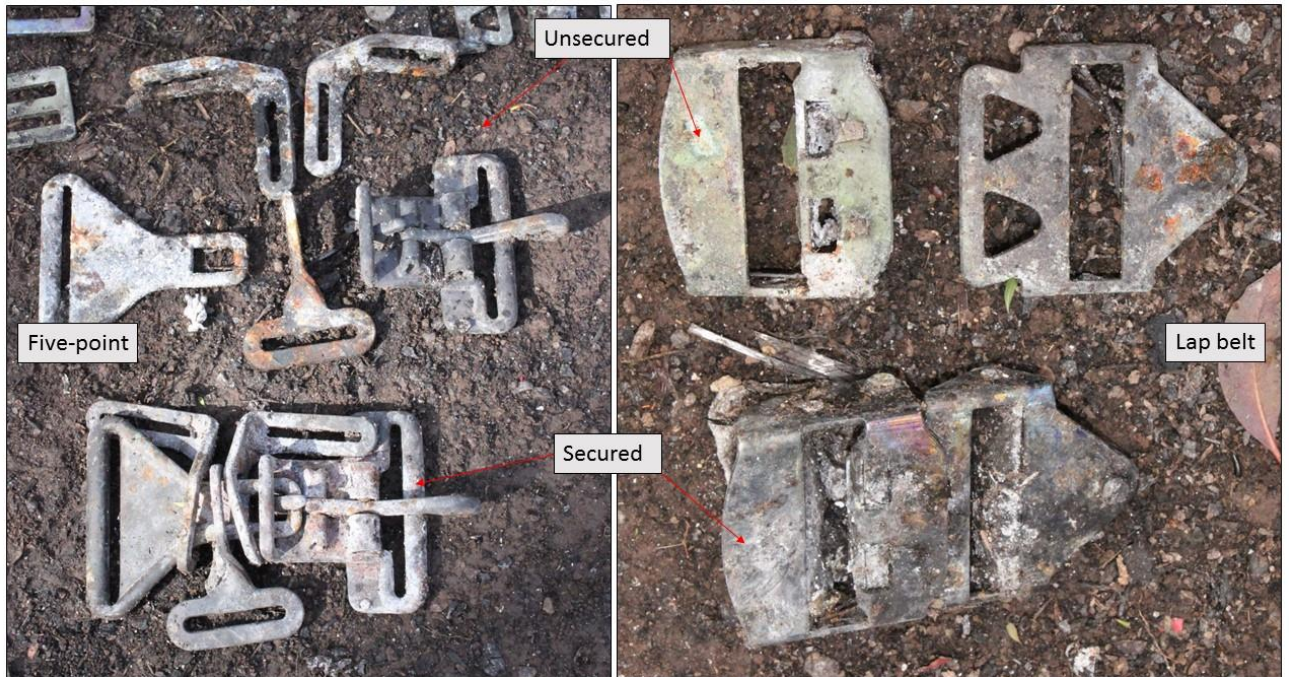
The webbing of both seat harnesses was almost entirely destroyed in the post-impact fire. Despite this level of damage, various buckles and harness adjust mechanisms were identified. Of these, one five-point harness buckle and one lap-belt harness buckle were found in the secured, or closed position. The other buckles were found unsecured (Figure 3). Refer to the section *Test and research* for more detail.

Figure 3: As-found five-point and lap-belt harness buckles. Of these four buckle sets, one of each type was secured (see the lower left and right images below)

The forward seat harness buckles were found unsecured during the wreckage examination. The post-impact fire hindered the ATSB's ability to determine if the harness had been secured in a non-standard manner prior to the flight, increasing the risk that they might unbuckle. In addition, although unlikely, the possibility that if buckled correctly the buckles may have come undone as a consequence of the impact sequence could not be discounted. Despite these possibilities, the ATSB concluded that the as-found insecurity of the front seat harness buckles suggested that they were not secured correctly as part of the standard pre-flight preparation for solo flight.

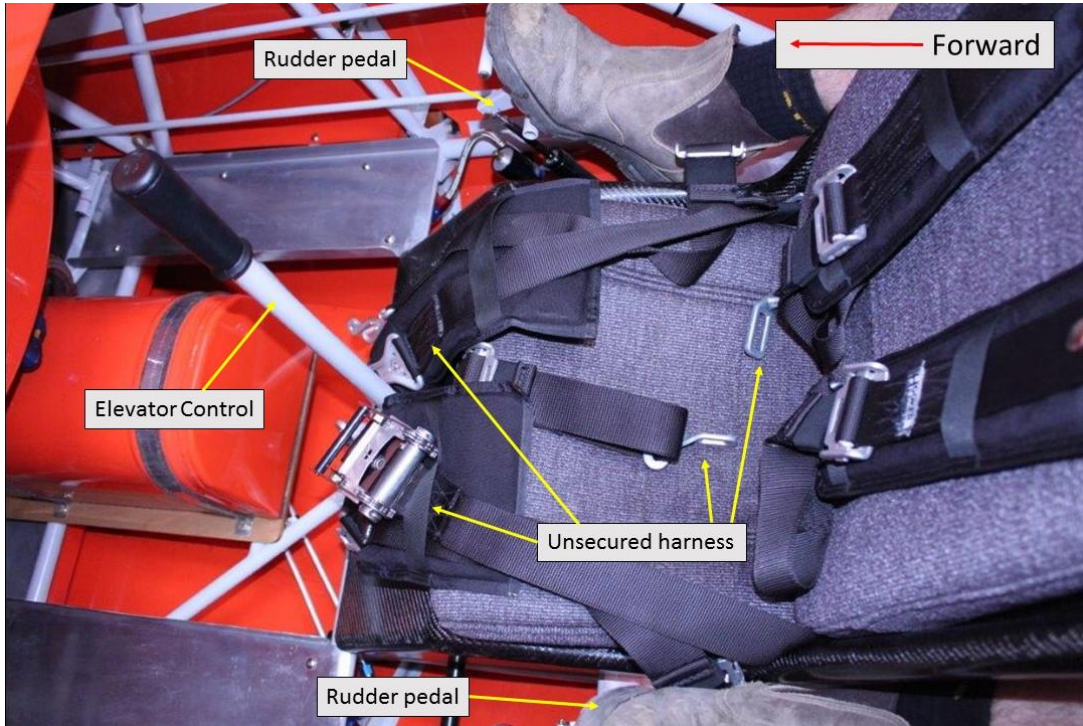
Figure 4: Unsecured forward seat harness, showing the potential for the harness to interfere with the flight controls, in particular during aerobatic manoeuvres

- The front seat buckles were found unsecured and, although unable to be determined if they were not secured correctly as part of the standard pre-flight preparation for solo flight, or they may have undone as a consequence of the impact sequence, any insecurity during aerobatic manoeuvres has implications for flight control fouling.

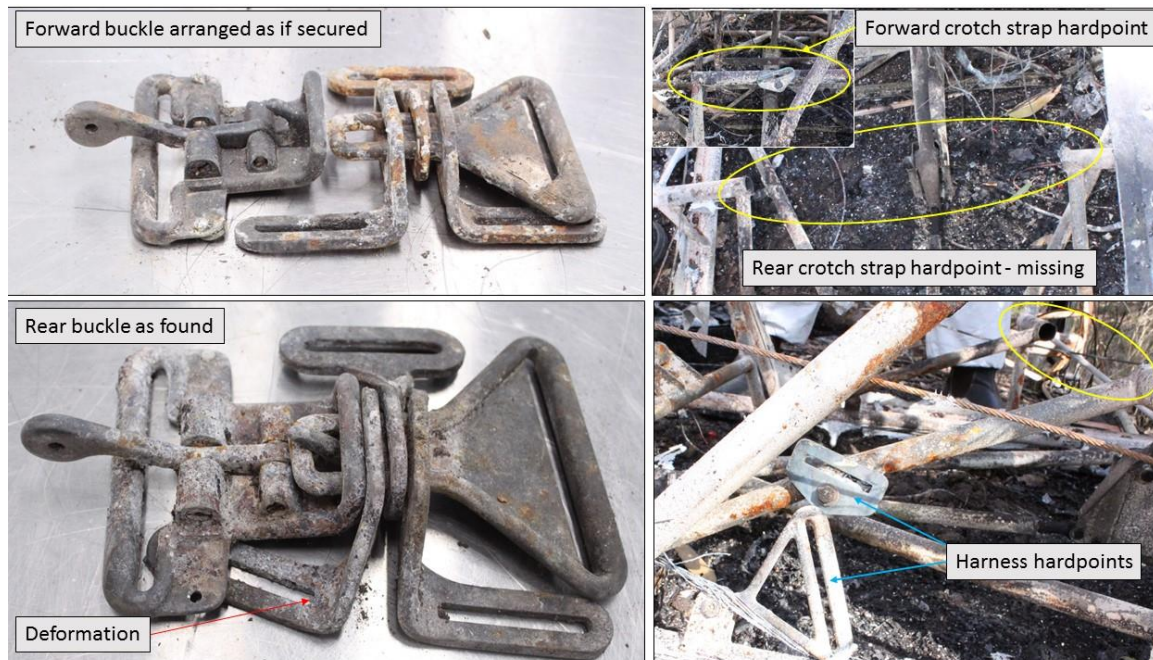
The rear pilot shoulder harness restraint cable that connected it to the airframe structure had fractured in overload. The tubular structure to which the rear pilot crotch strap was secured had fractured at each end of the tube, where it is welded to the airframe structure. In addition, components of the ‘secured’ rear five-point harness buckle showed signs of deformation (Figure A1).

Figure A1: Deformation to rear seat buckle in comparison with the forward buckle, and fracture of rear seat crotch strap hard point

Damage to the airframe and the severed harness cable at the rear pilot position was consistent with the pilot being secured in the seat at the point of impact. Therefore, the open buckles of the five point harness and lap belt were associated with the unoccupied, forward passenger seat.

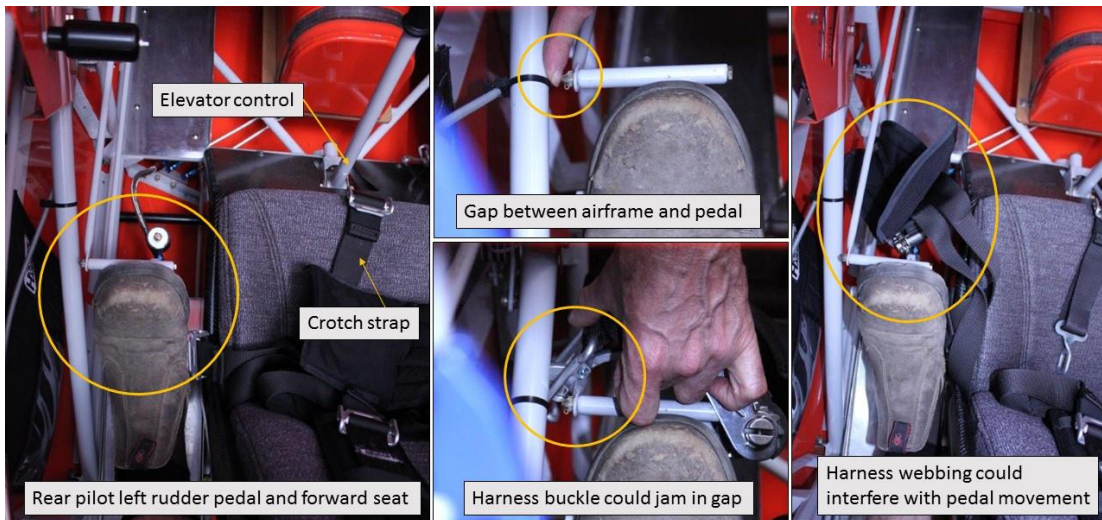
The rear pilot’s rudder pedals are positioned on either side of the forward seat base. A loose lap strap and associated buckle, from either the forward seat lap belt or five-point harness, were found to have the potential to interfere with rudder pedal operation. In addition, a buckle component could lodge between the rudder pedal and the diagonal tubular bracing of the airframe (Figure A2).

Figure A2: Possible rudder pedal interference from an unsecured forward seat harness

Access to the rudder pedals from the rear seat was limited and it would be very difficult to release a misplaced front seatbelt by hand. Also, due to the design of the rudder control system, rearward movement of one rudder pedal does not naturally impart a forward movement of the opposite pedal.¹⁸ Therefore, the cockpit layout and rudder design may inhibit the pilot’s ability to free an obstructed rudder pedal in flight.

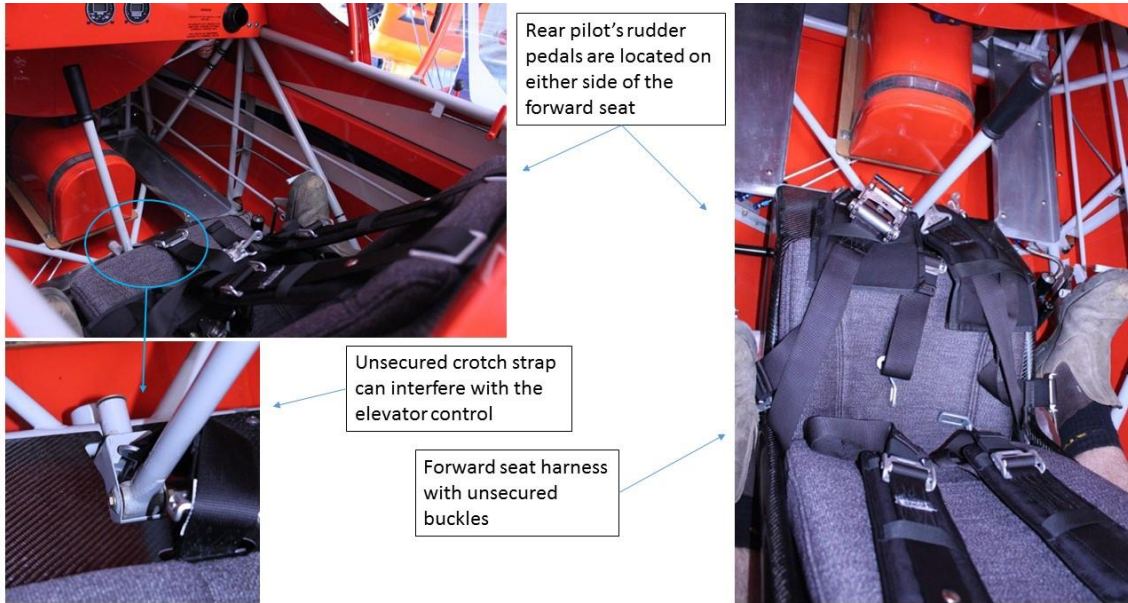
It was also noted that it was possible for the forward seat crotch strap and associated buckle to interfere with the forward seat elevator control stick (Figure A3). It would not be possible for a rear-seat pilot to remove this obstruction by hand during flight operations.

Figure A3: Possible elevator control interference from an unsecured forward seat harness
